# Performance Review

Washington County, Oregon  
Gravel Road Upgrade Program

**Final Report**  
**Chip Seal Performance Review**  
Washington County, Oregon

January 6, 2012

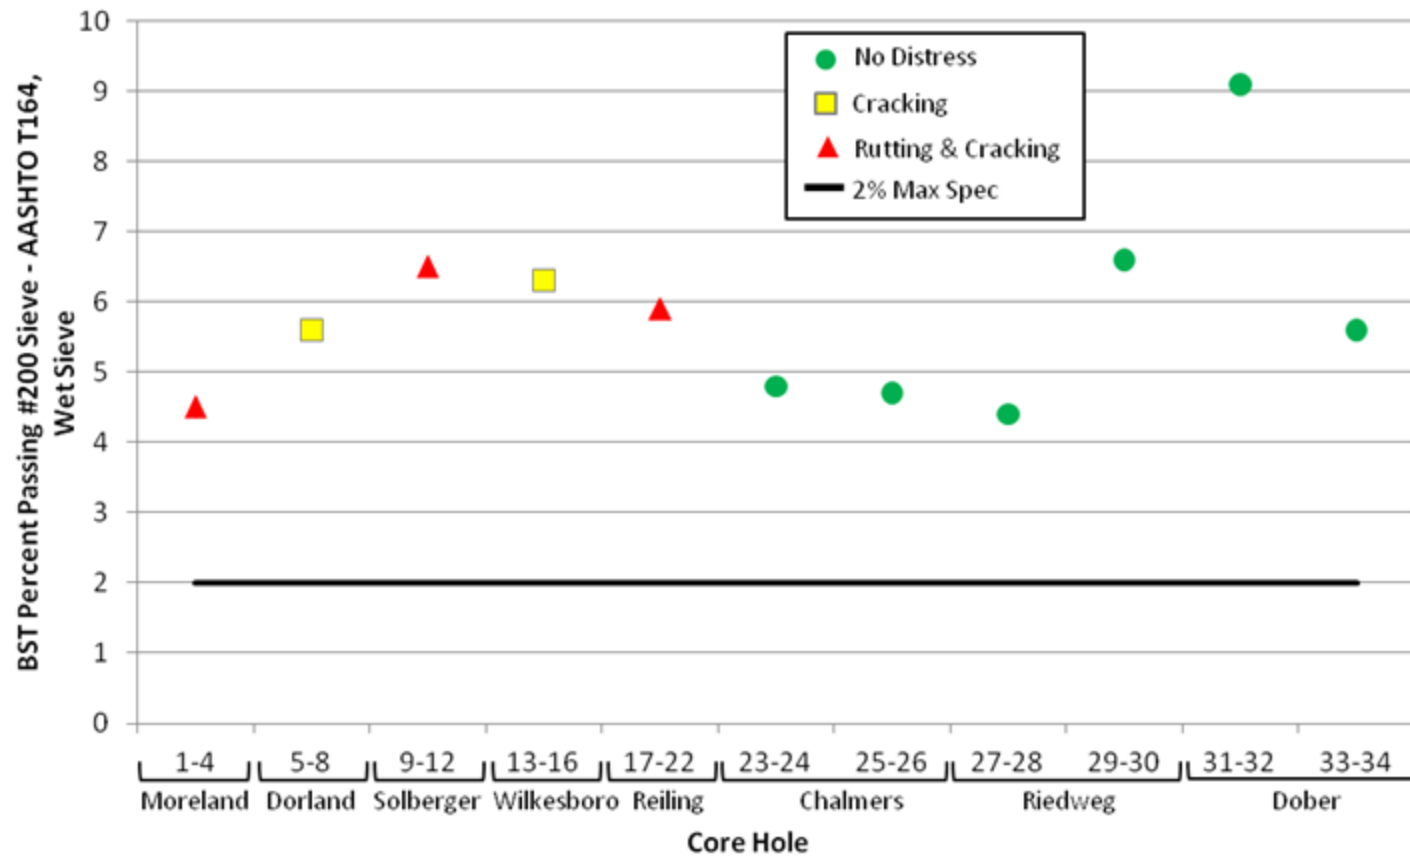
# Results - % P200 in BST

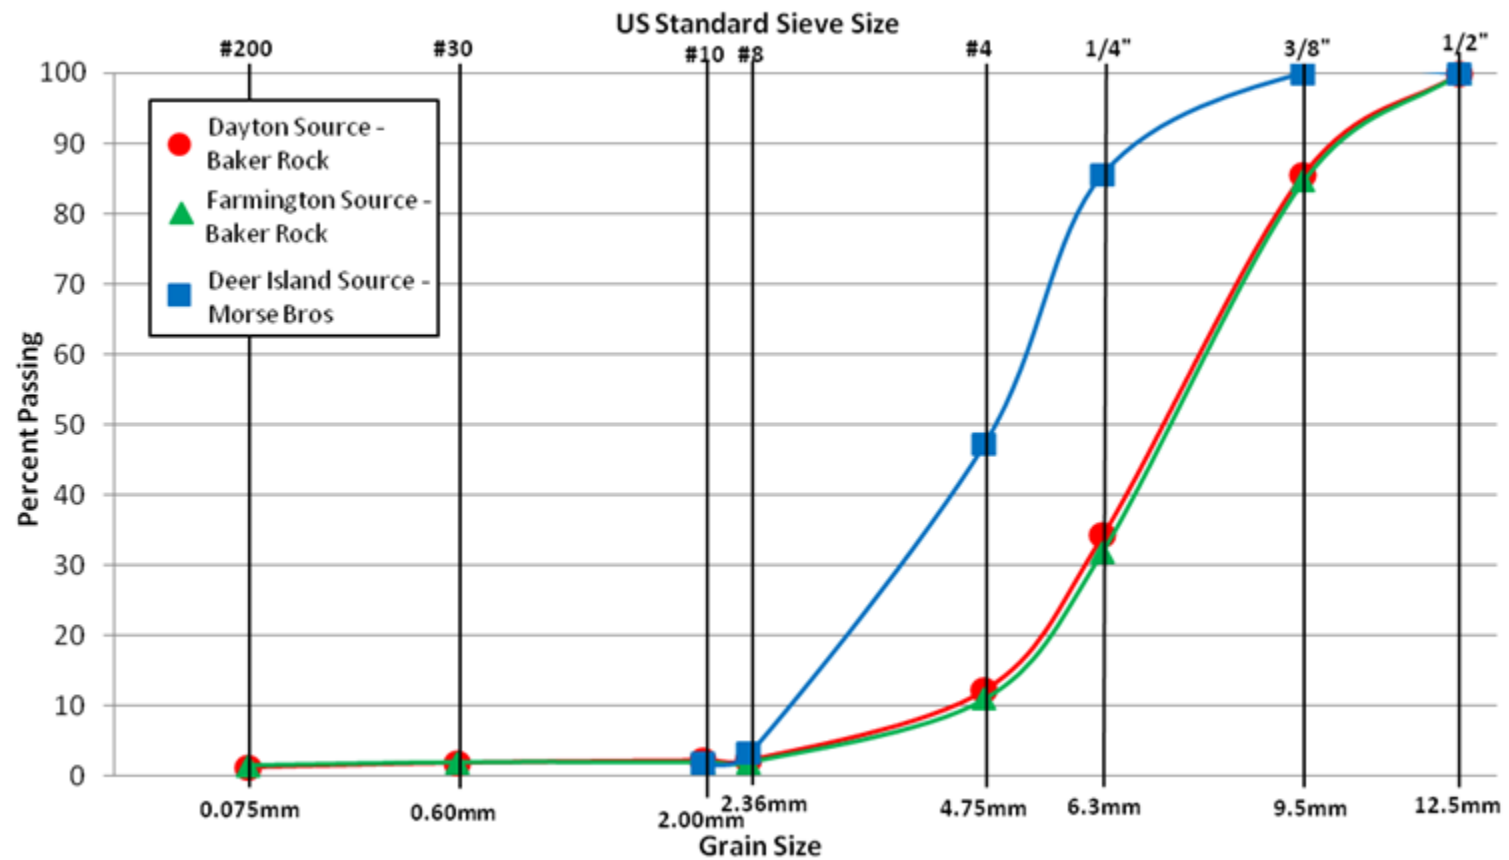
# Results - BST Gradation

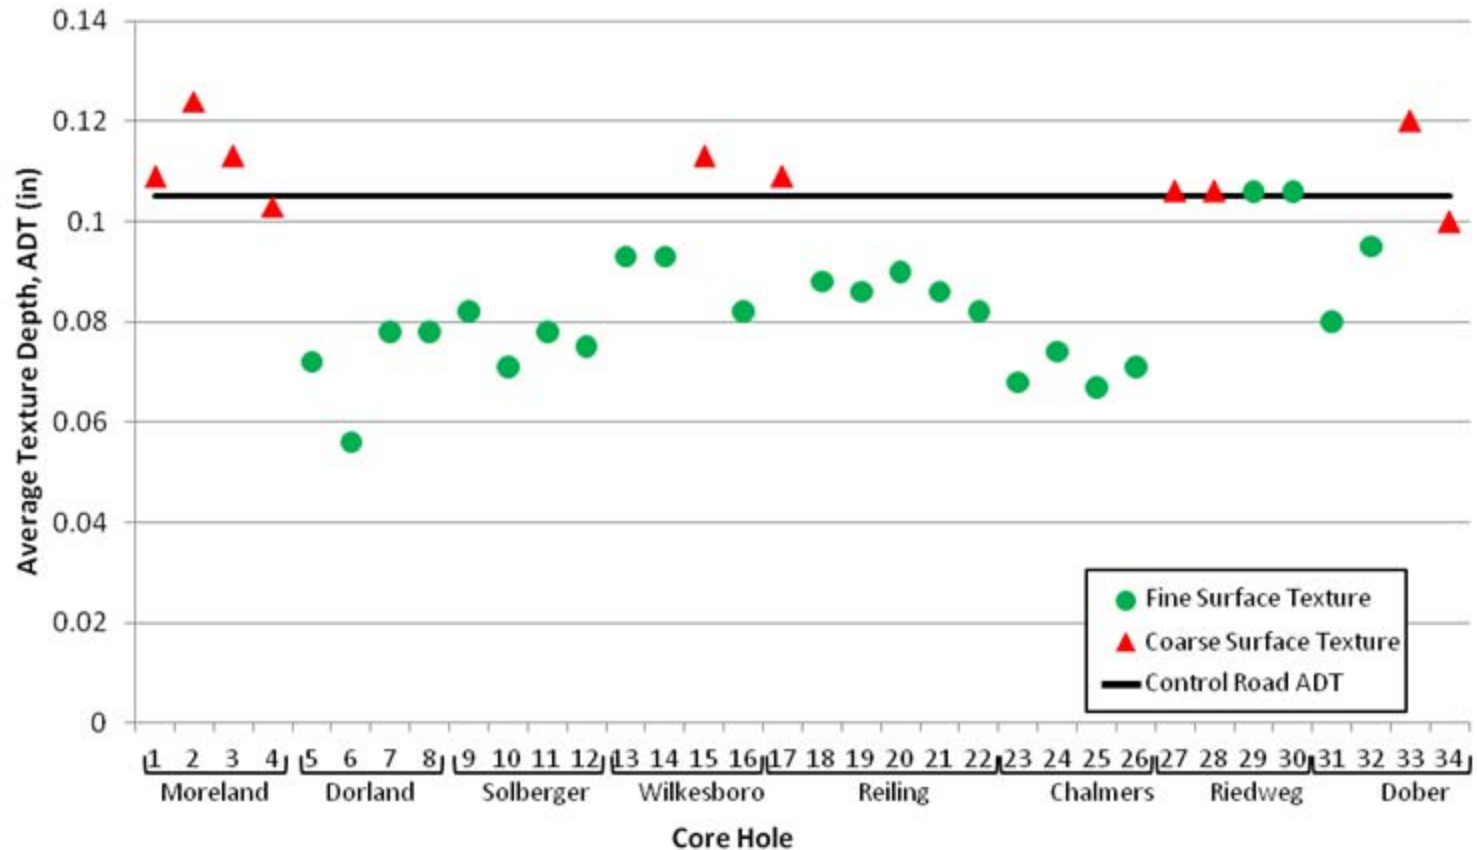
# Results - BST Texture

- **Materials**
  - BST Surface Texture related to source
  - BST Surface Texture adequate
- **Structural Capacity**
  - Failures due to inadequate base thickness
- **Construction Processes were generally acceptable**
  - Better performance when lag time between base rock placement and BST application < 10 days

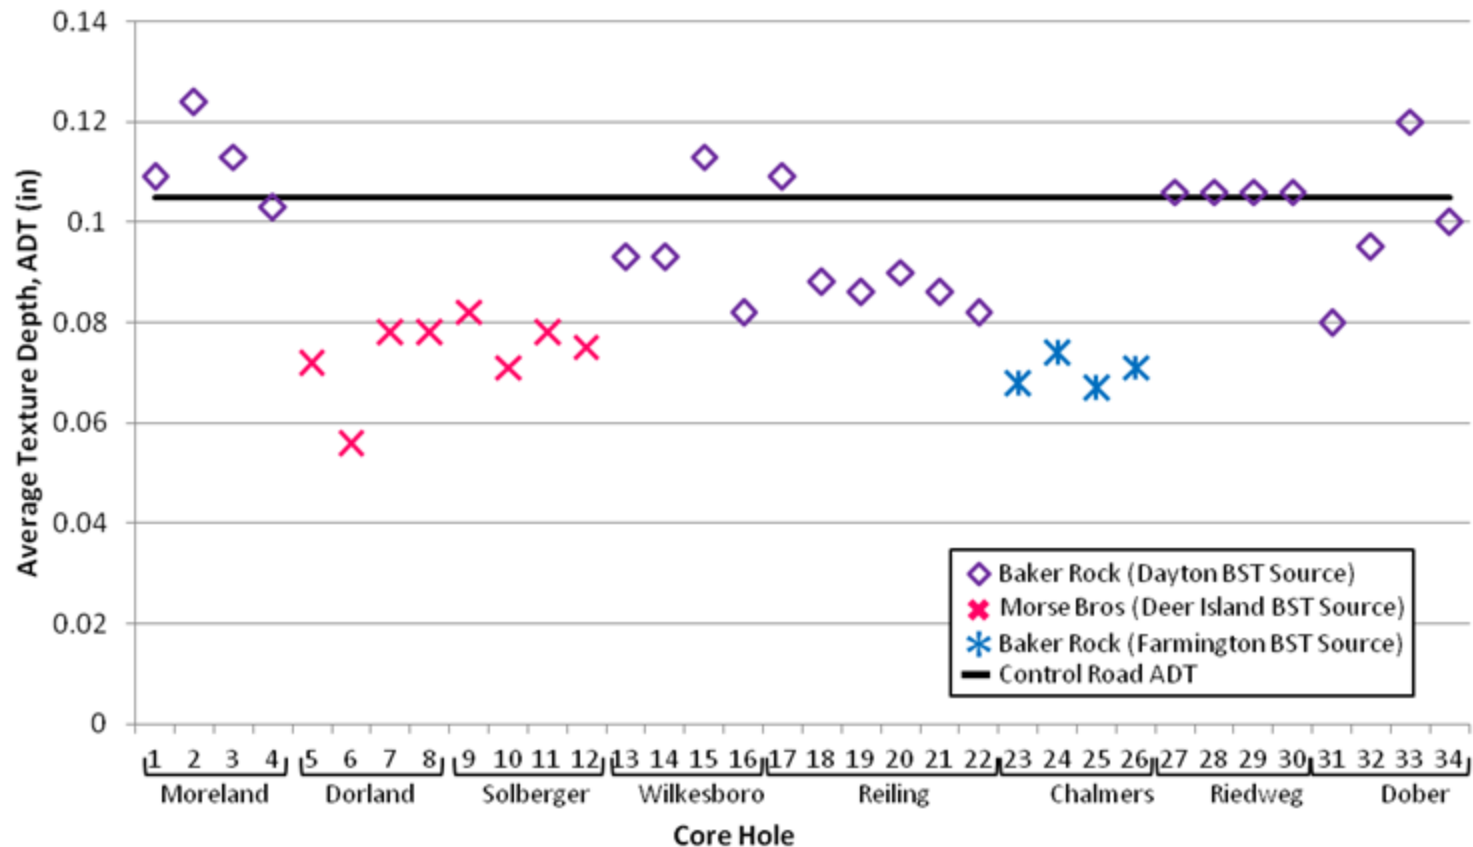
# Results - BST Texture / Source

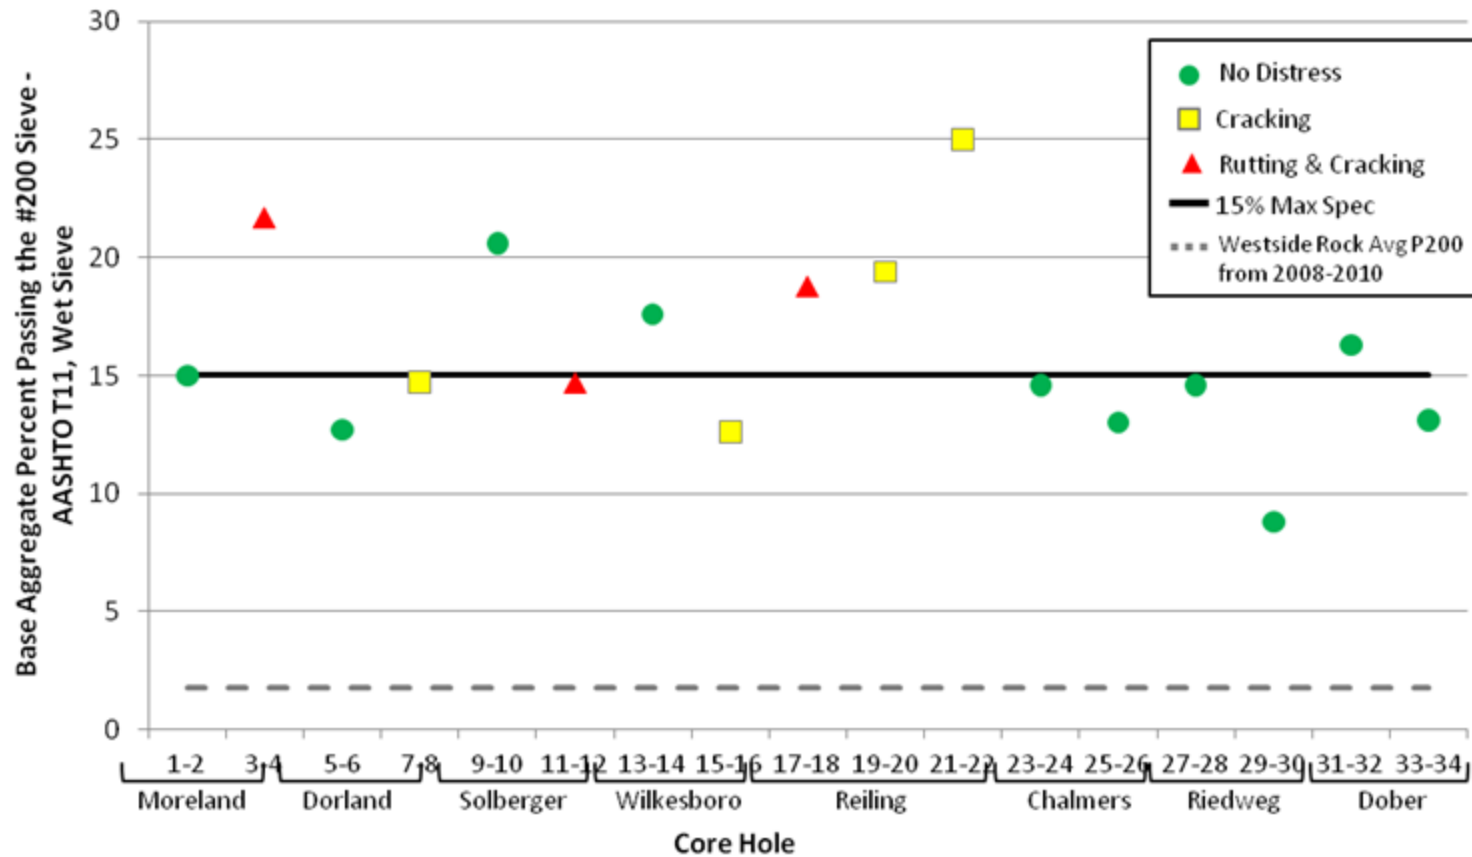
# Results - P200 in Base Rock

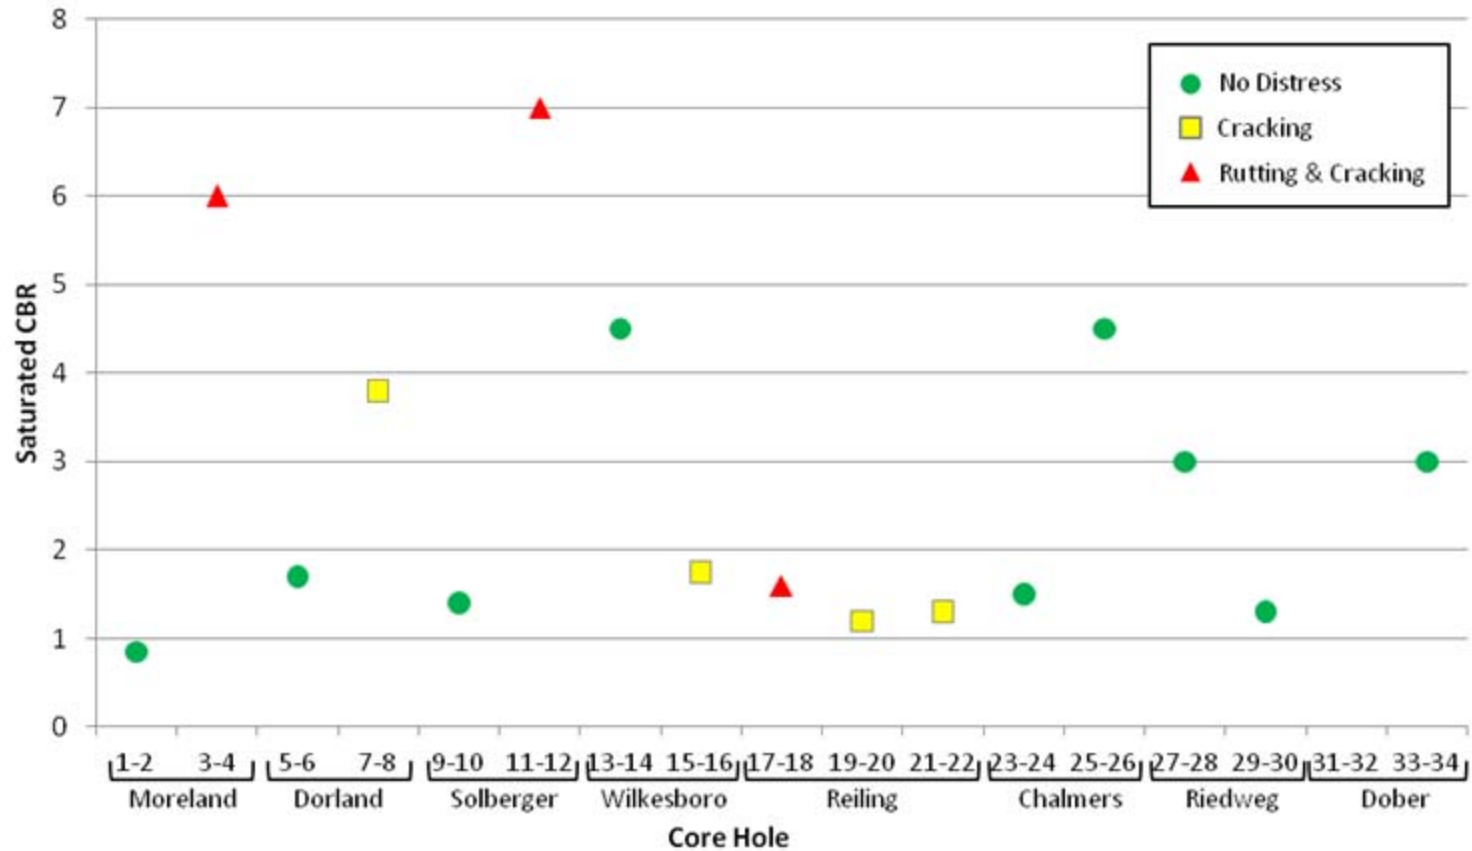
# Results - CBR

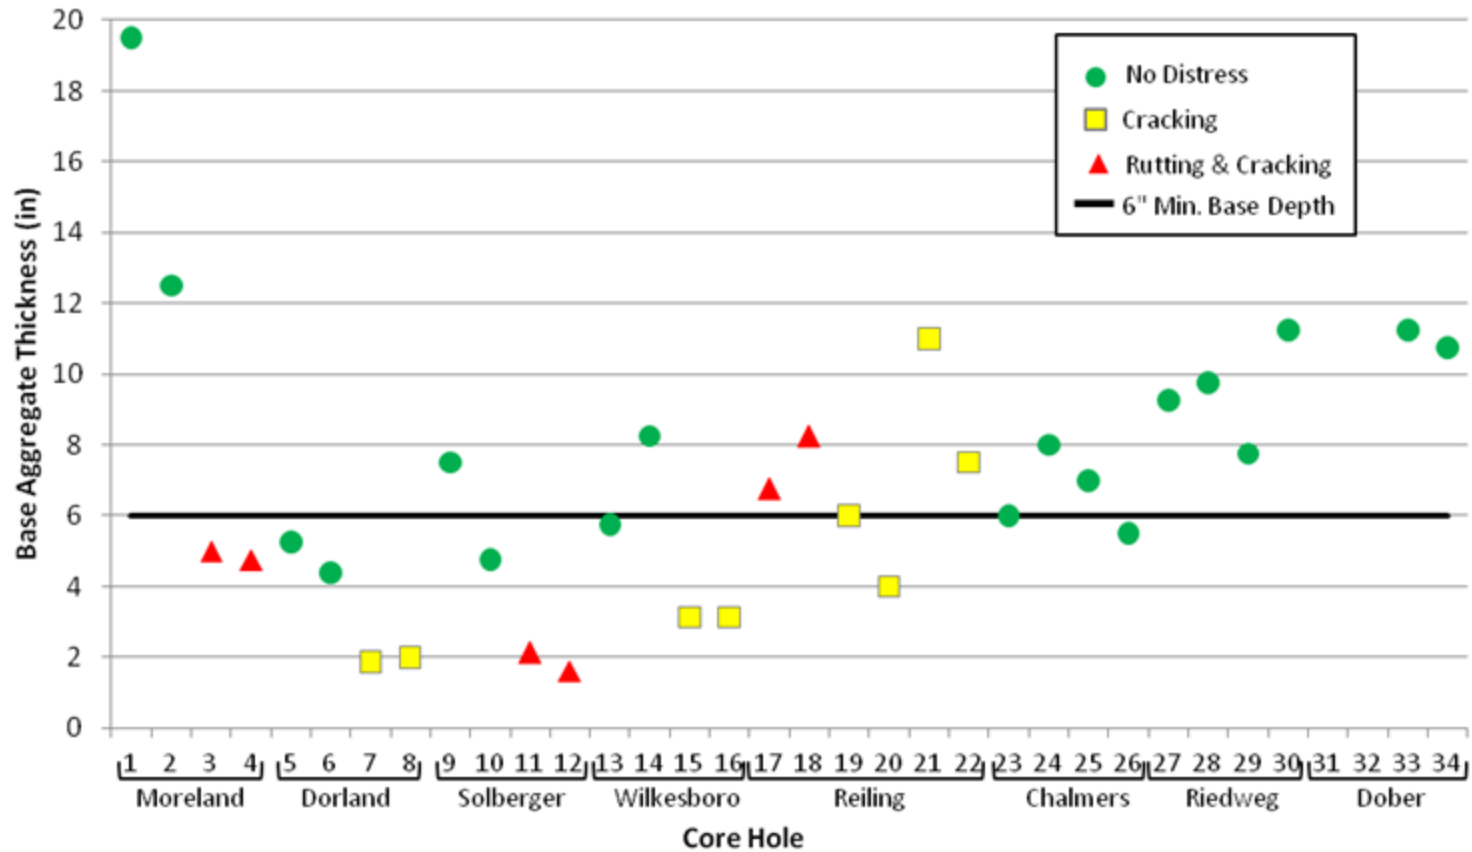
# Results - Base Thickness

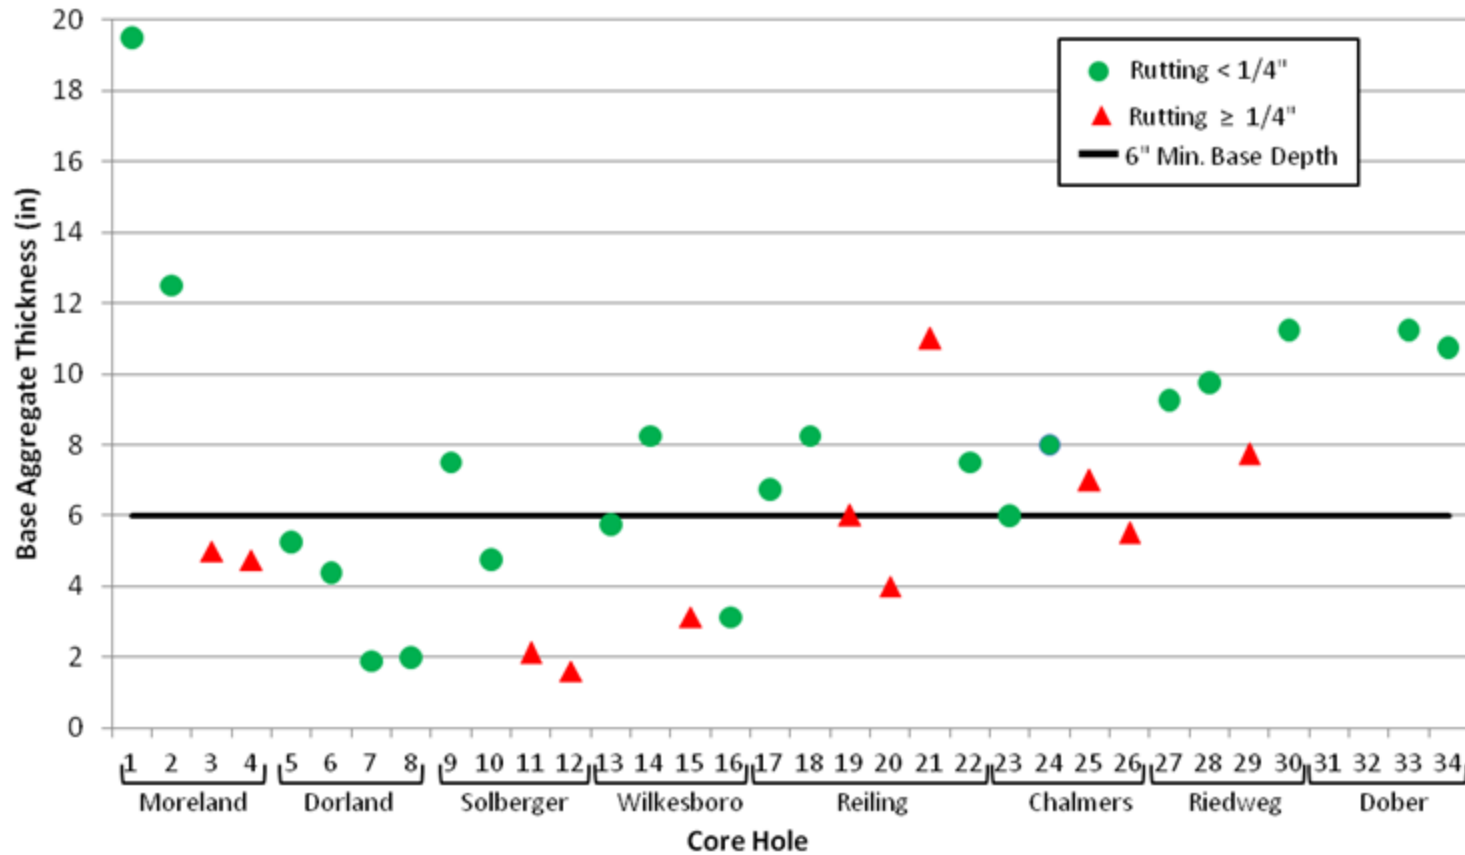
# Results - Base Thickness

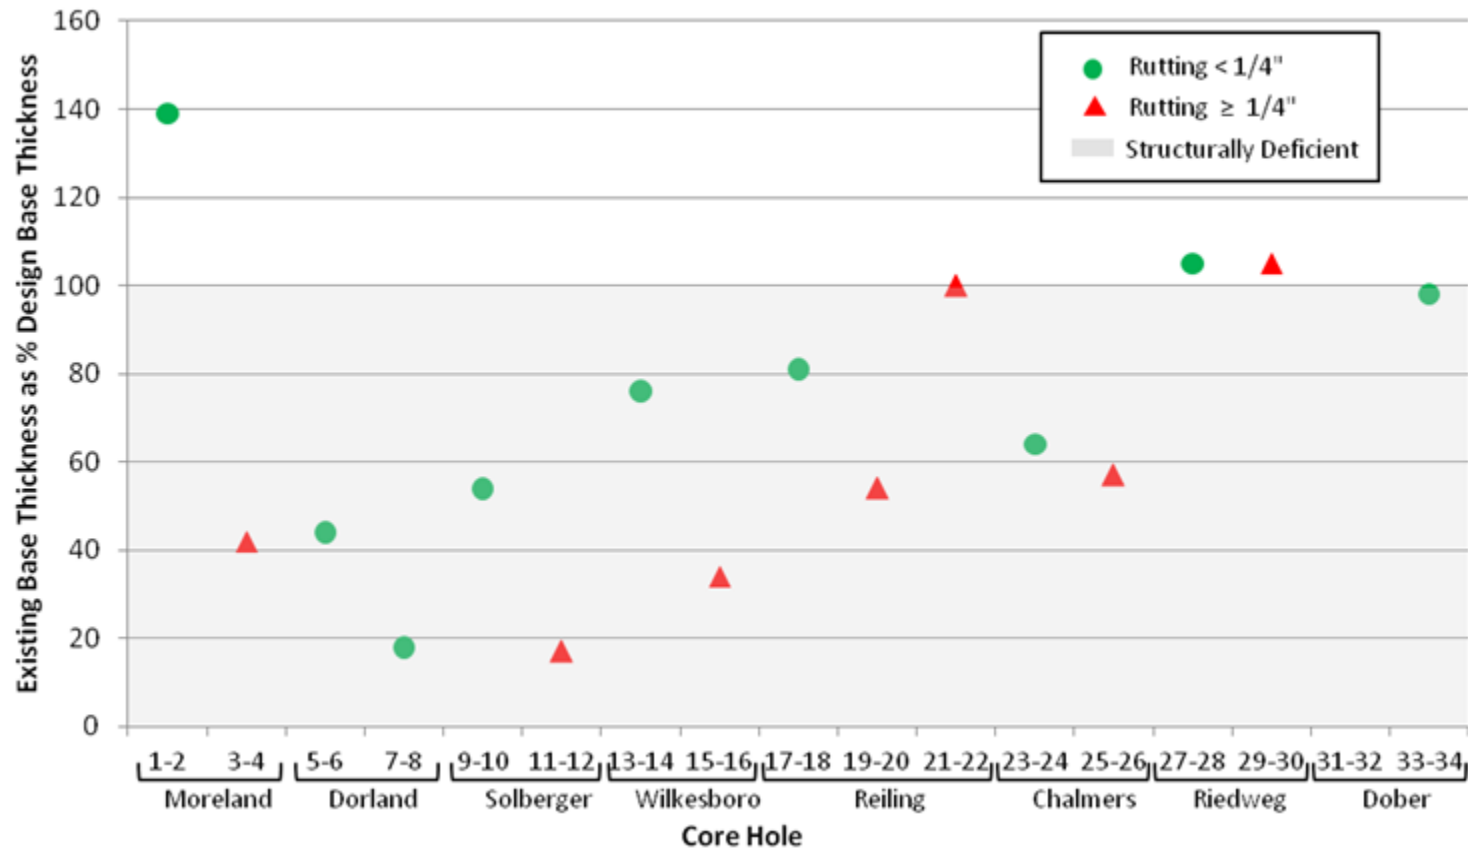
# Results - % Design Thickness

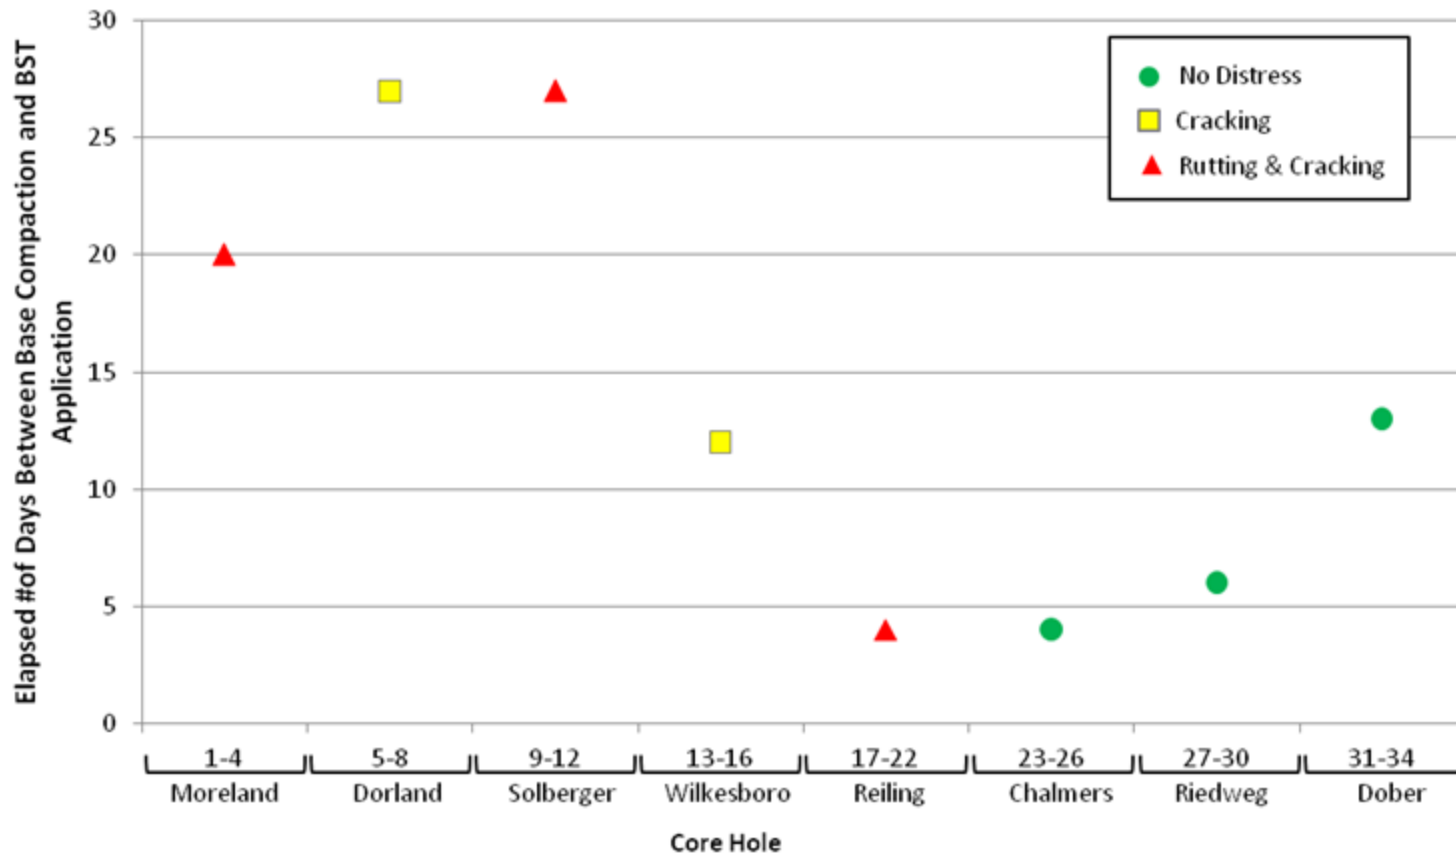
# Results - BST Lag Time
