# Geosynthetic In Construction

# Geosynthetic Pavement Interlayers

# **Geosynthetic Reinforced Chip Seal (GRCS)**

**Unmatched Value - Chip Sealing over Fabrics**

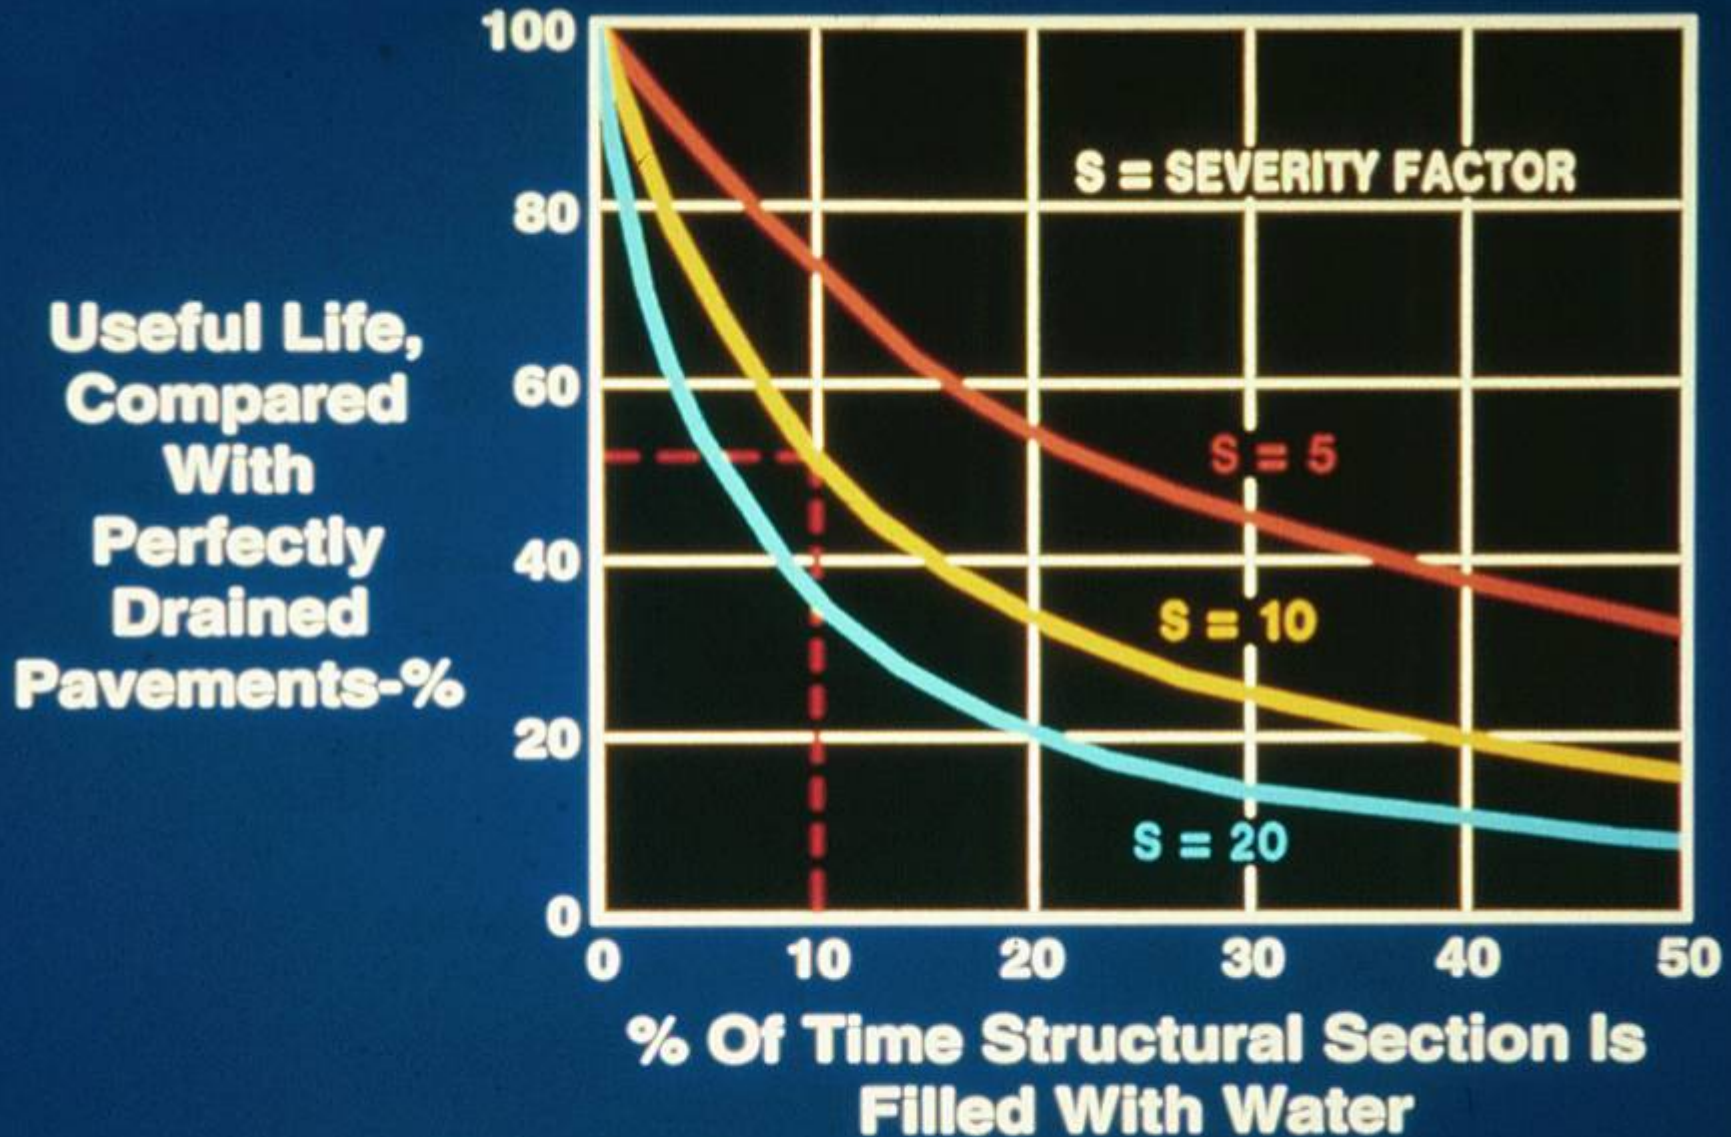
# Deteriorating Impact of Moisture Intrusion

*From Drainage Of Highway And Airfield Pavements  
By Harry R. Cedergren*

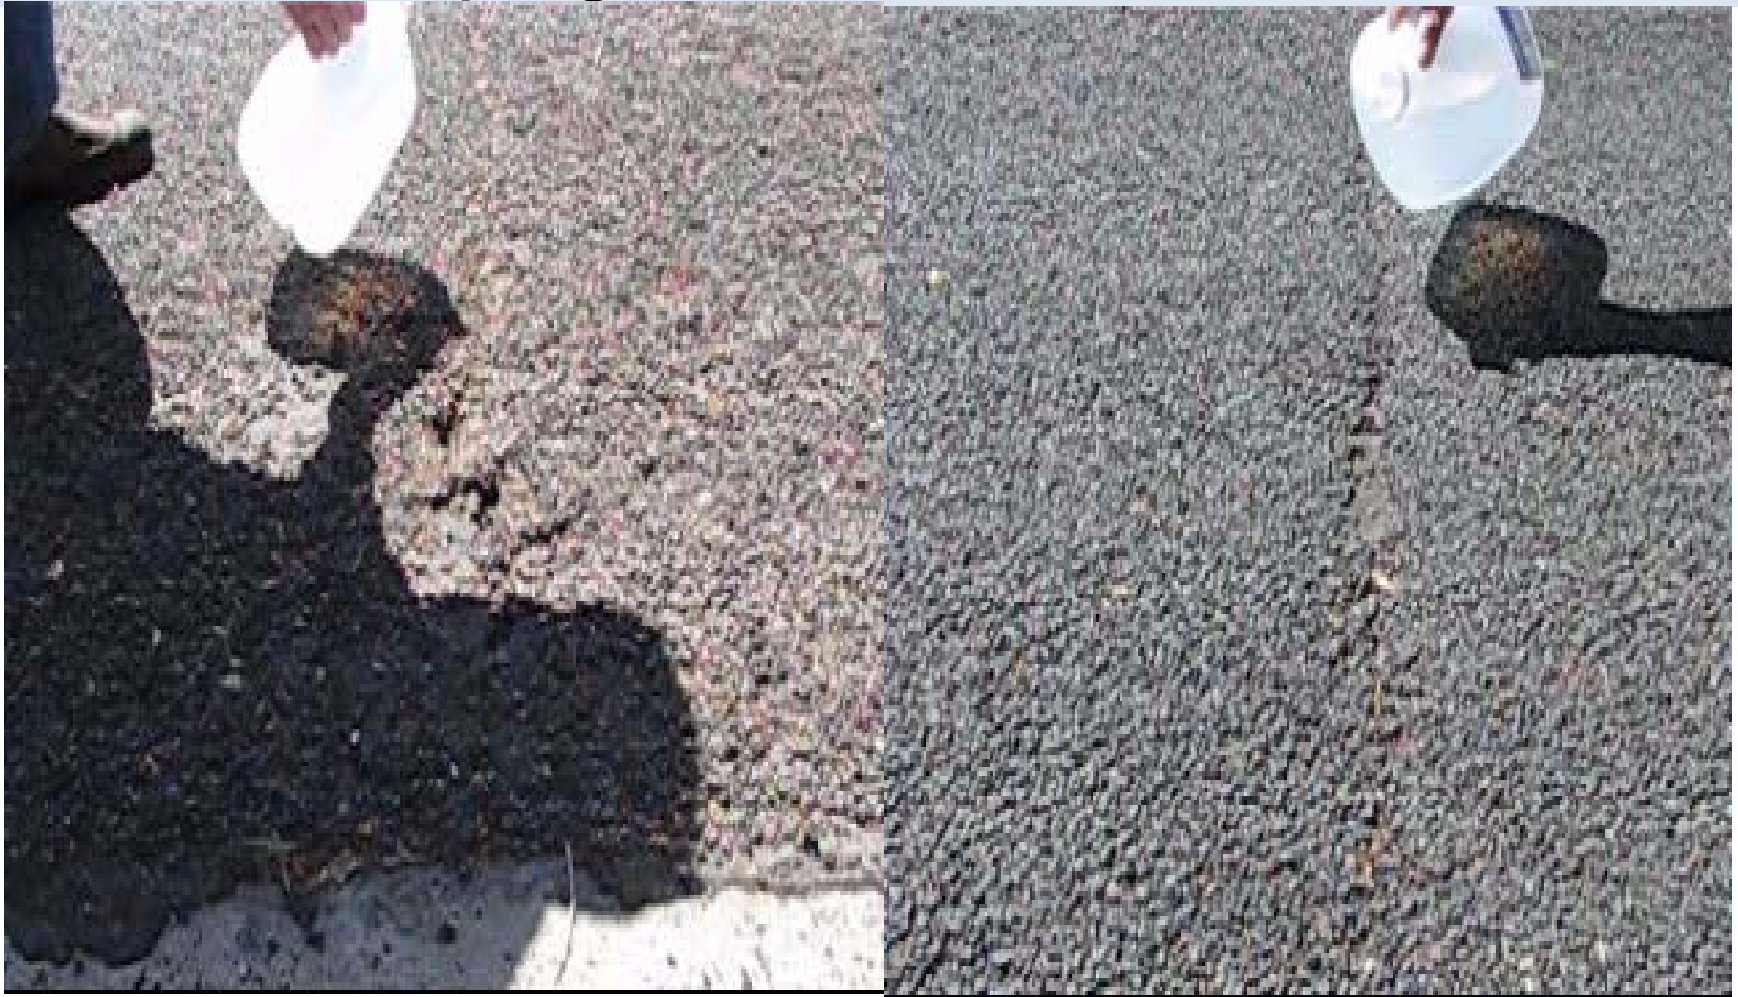
## Keeping Water out of the Base

No Moisture Barrier

With Moisture Barrier

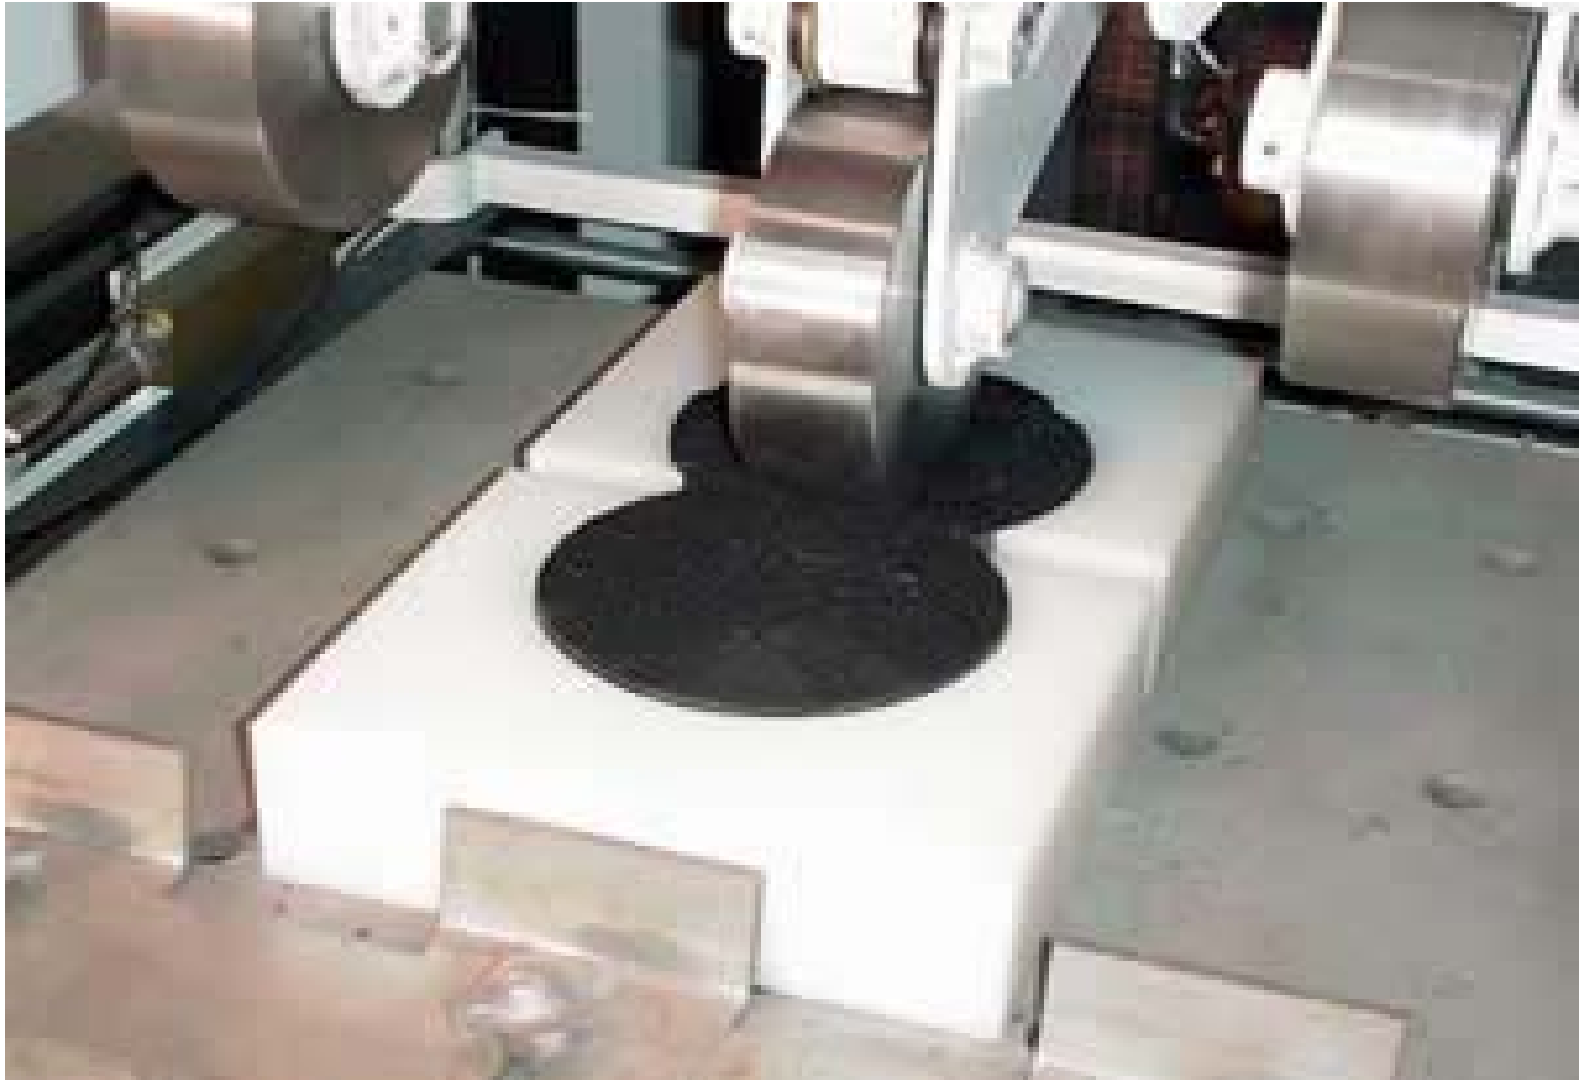
**Figure 5:** Asphalt Pavement Analyzer – Wheel Track

## The Asphalt Pavement Analyzer - Wheel Track

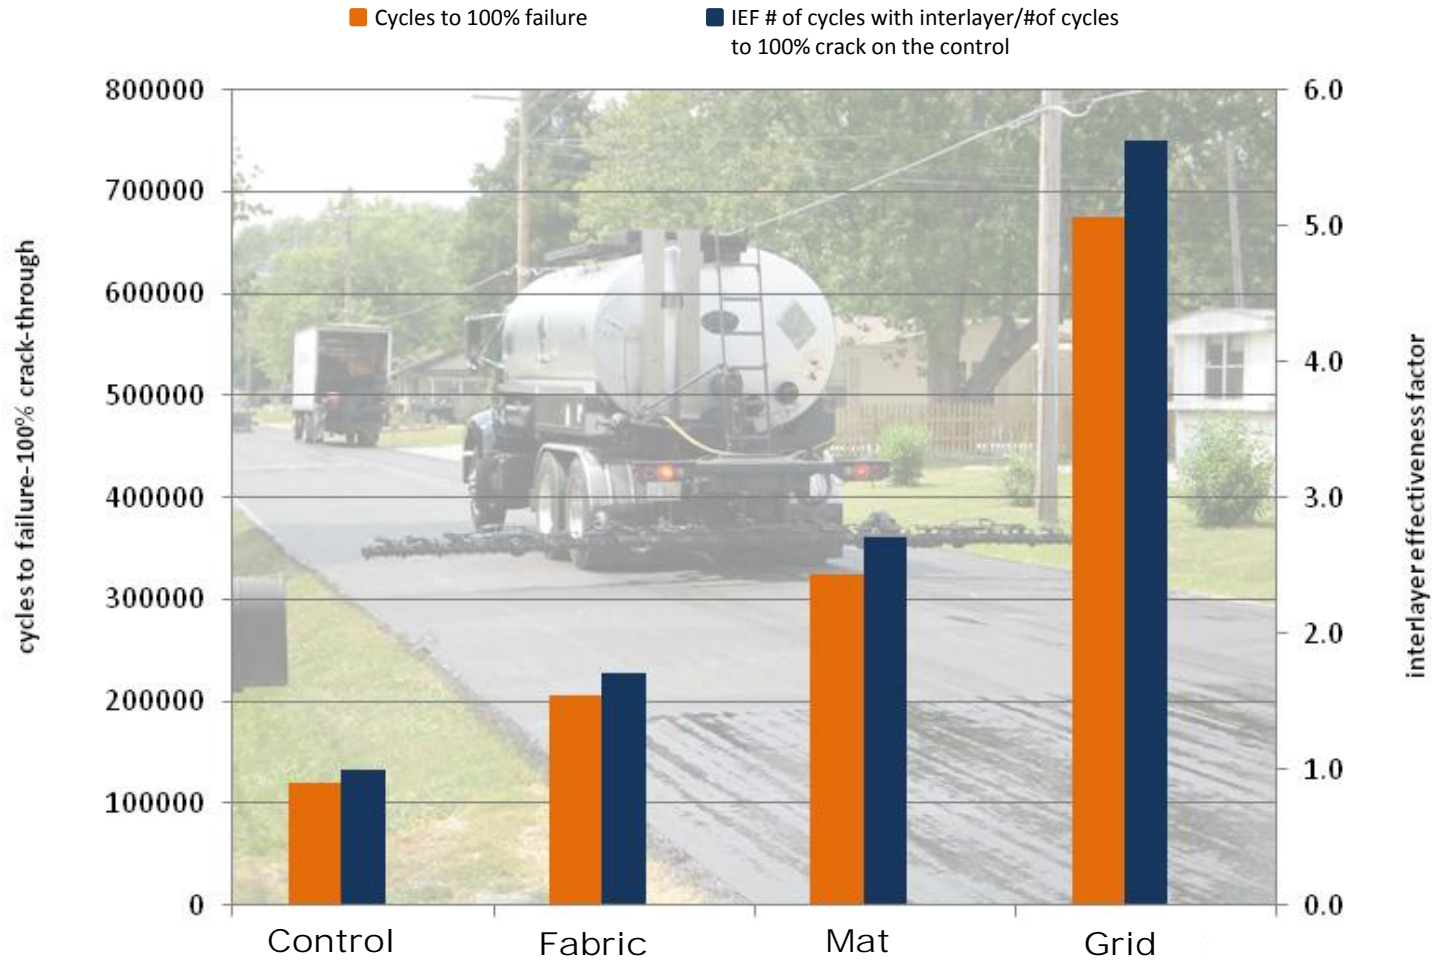
## Interlayer Effectiveness and Total Life Averages

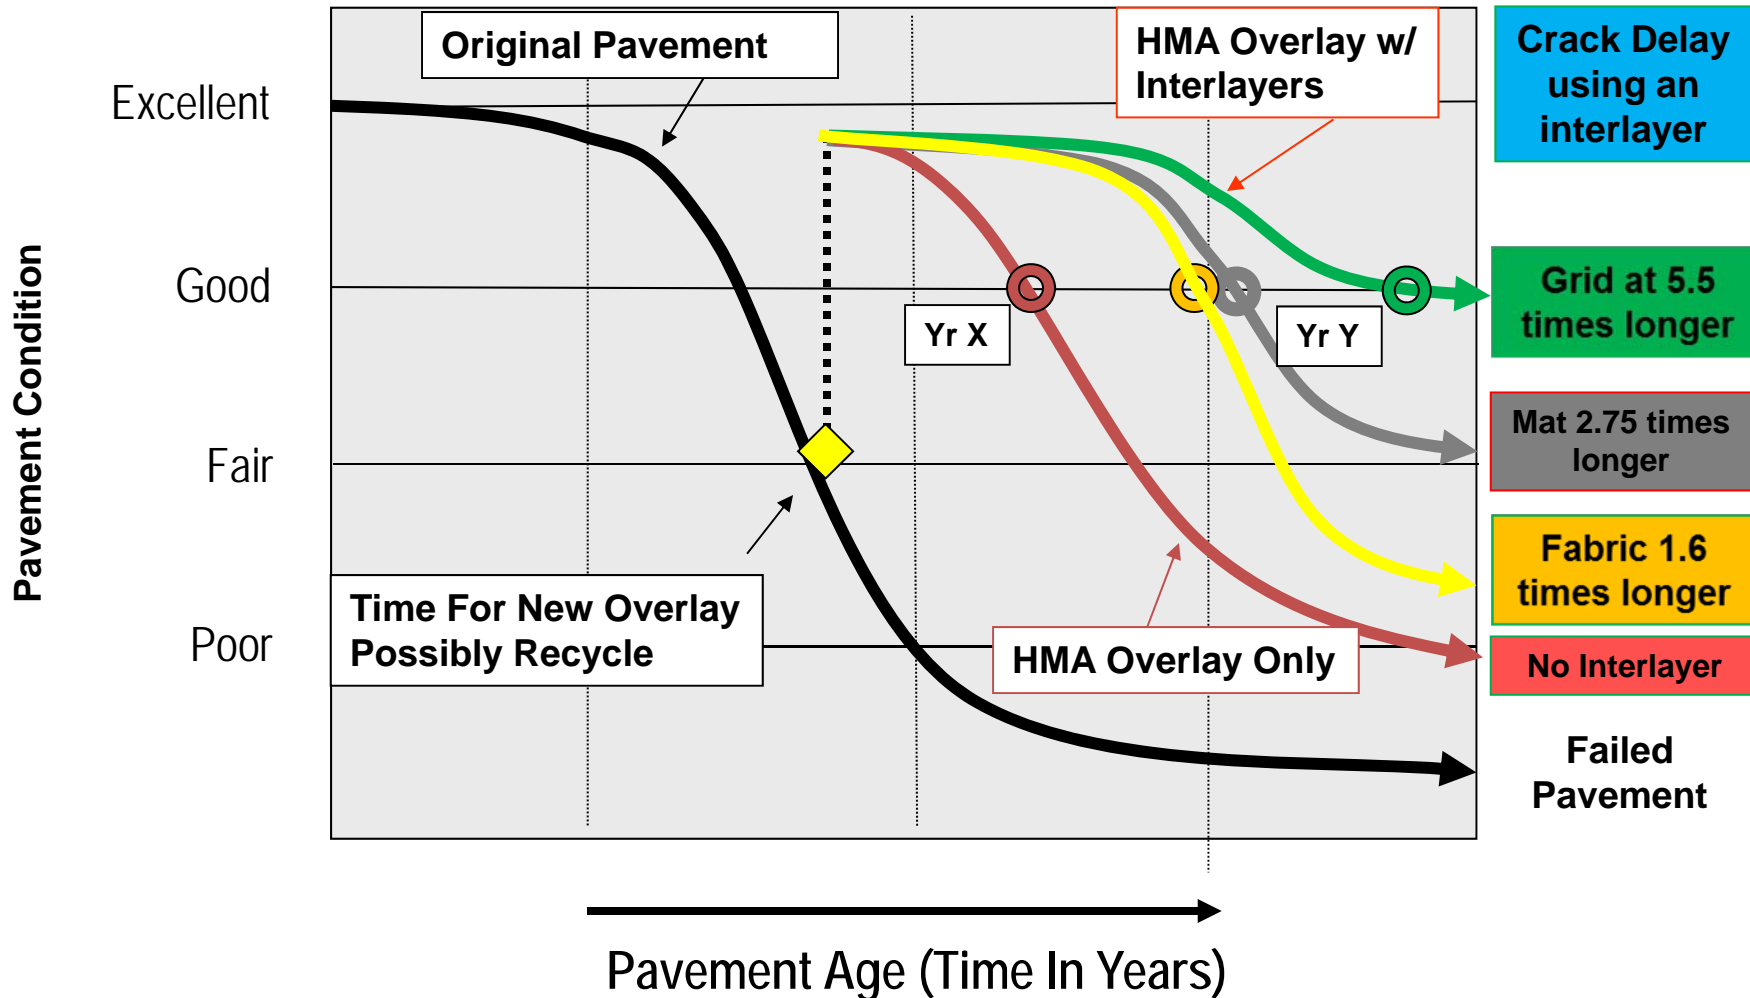
## Interlayer Impact on Pavement Deterioration Curve

### REHAB – OVERLAY PAVEMENT

Delay Deterioration - Extend Life (Yr Y – Yr X):

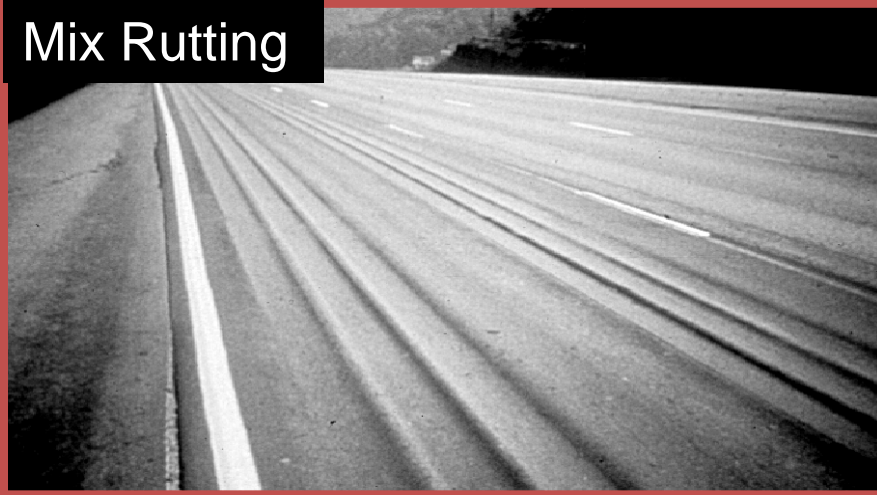
Mix Rutting

**Caution! Not all conditions interlayer appropriate!**

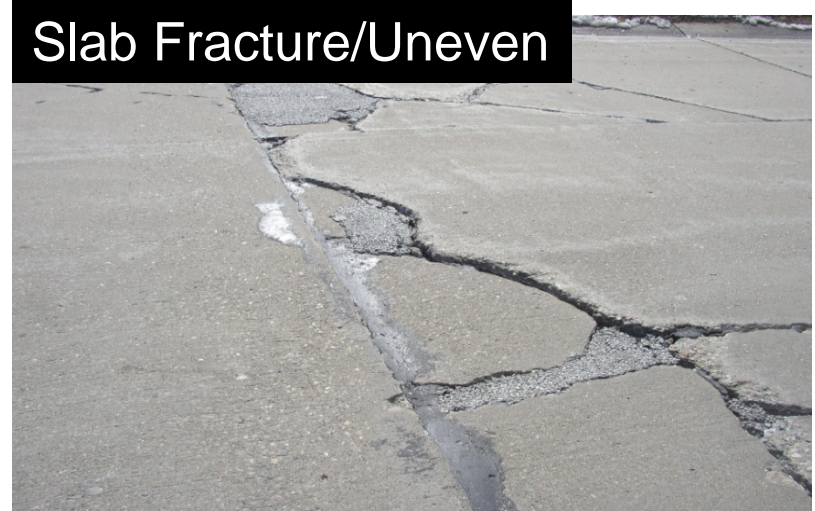
Slab Fracture/Uneven

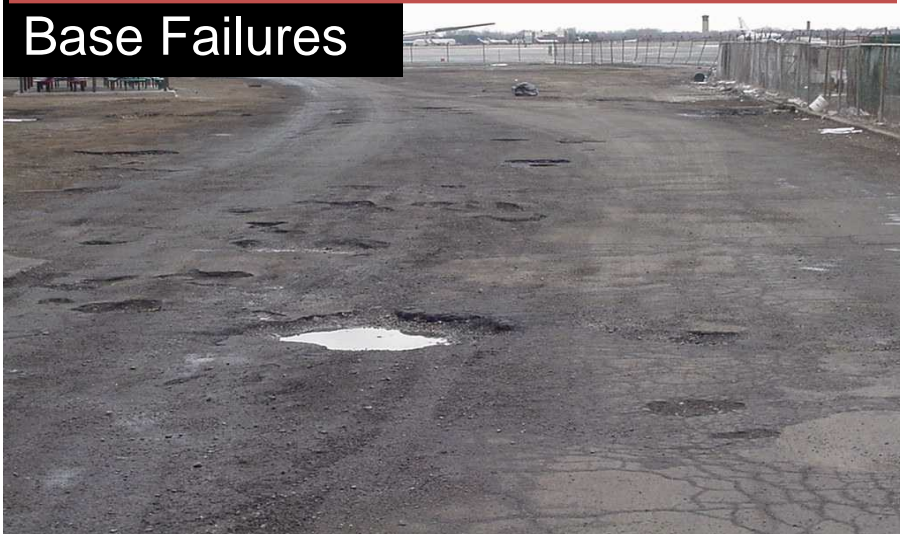
Base Failures

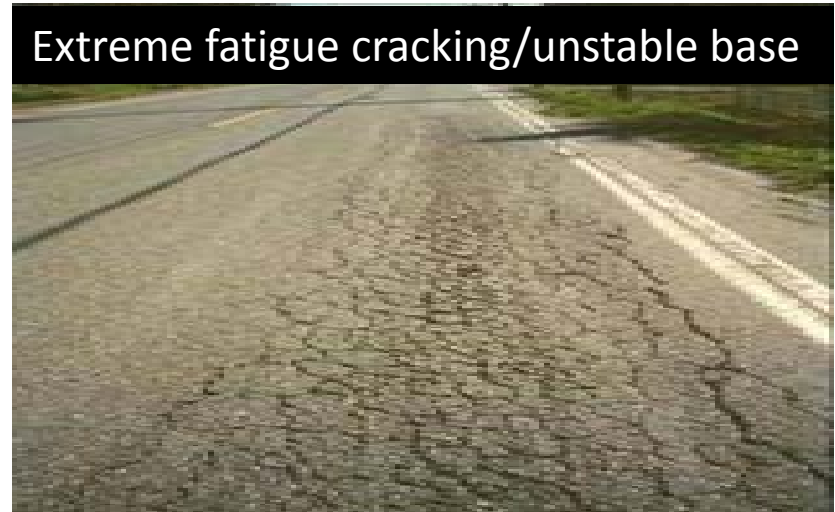
Extreme fatigue cracking/unstable base

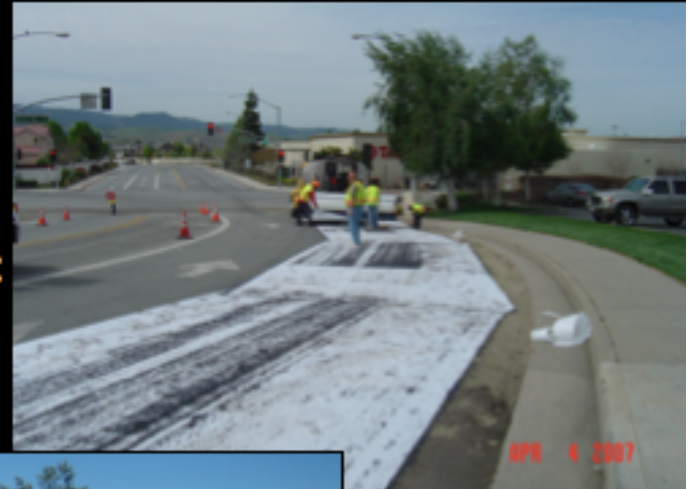
Before

**Overlay done 4/07:  
Heavy cracking, but good base.**

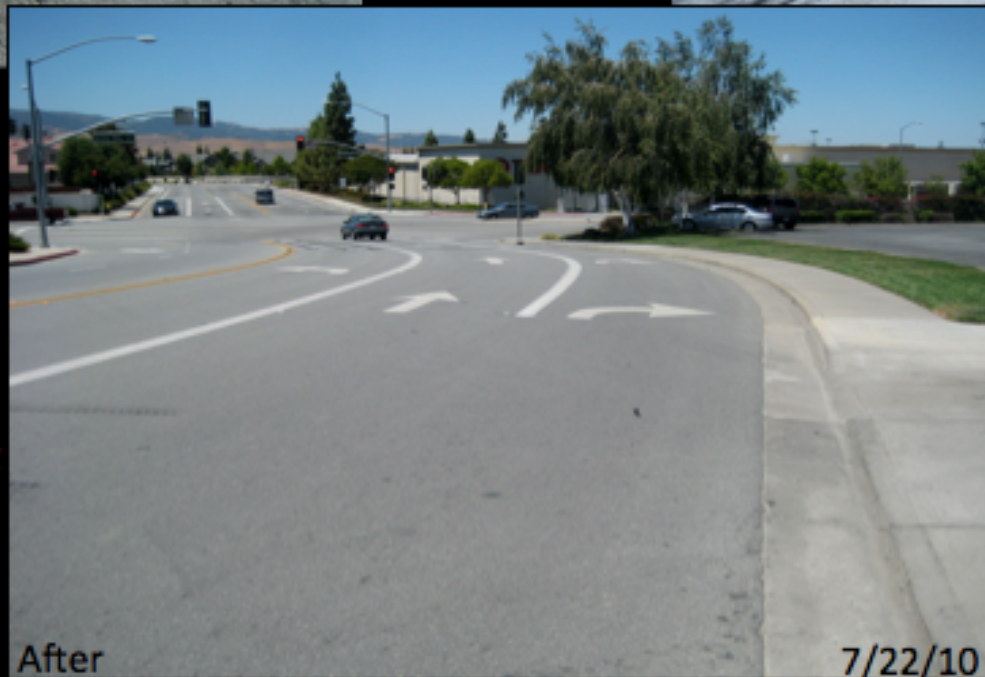
After

**Updated  
7/22/10:  
No reflective  
cracking  
found. Street  
is still in great  
condition.**

**NOTE: Other streets in the same project with Paving Fabric and SAMI as their Interlayer are both already showing cracking and fatigue.**

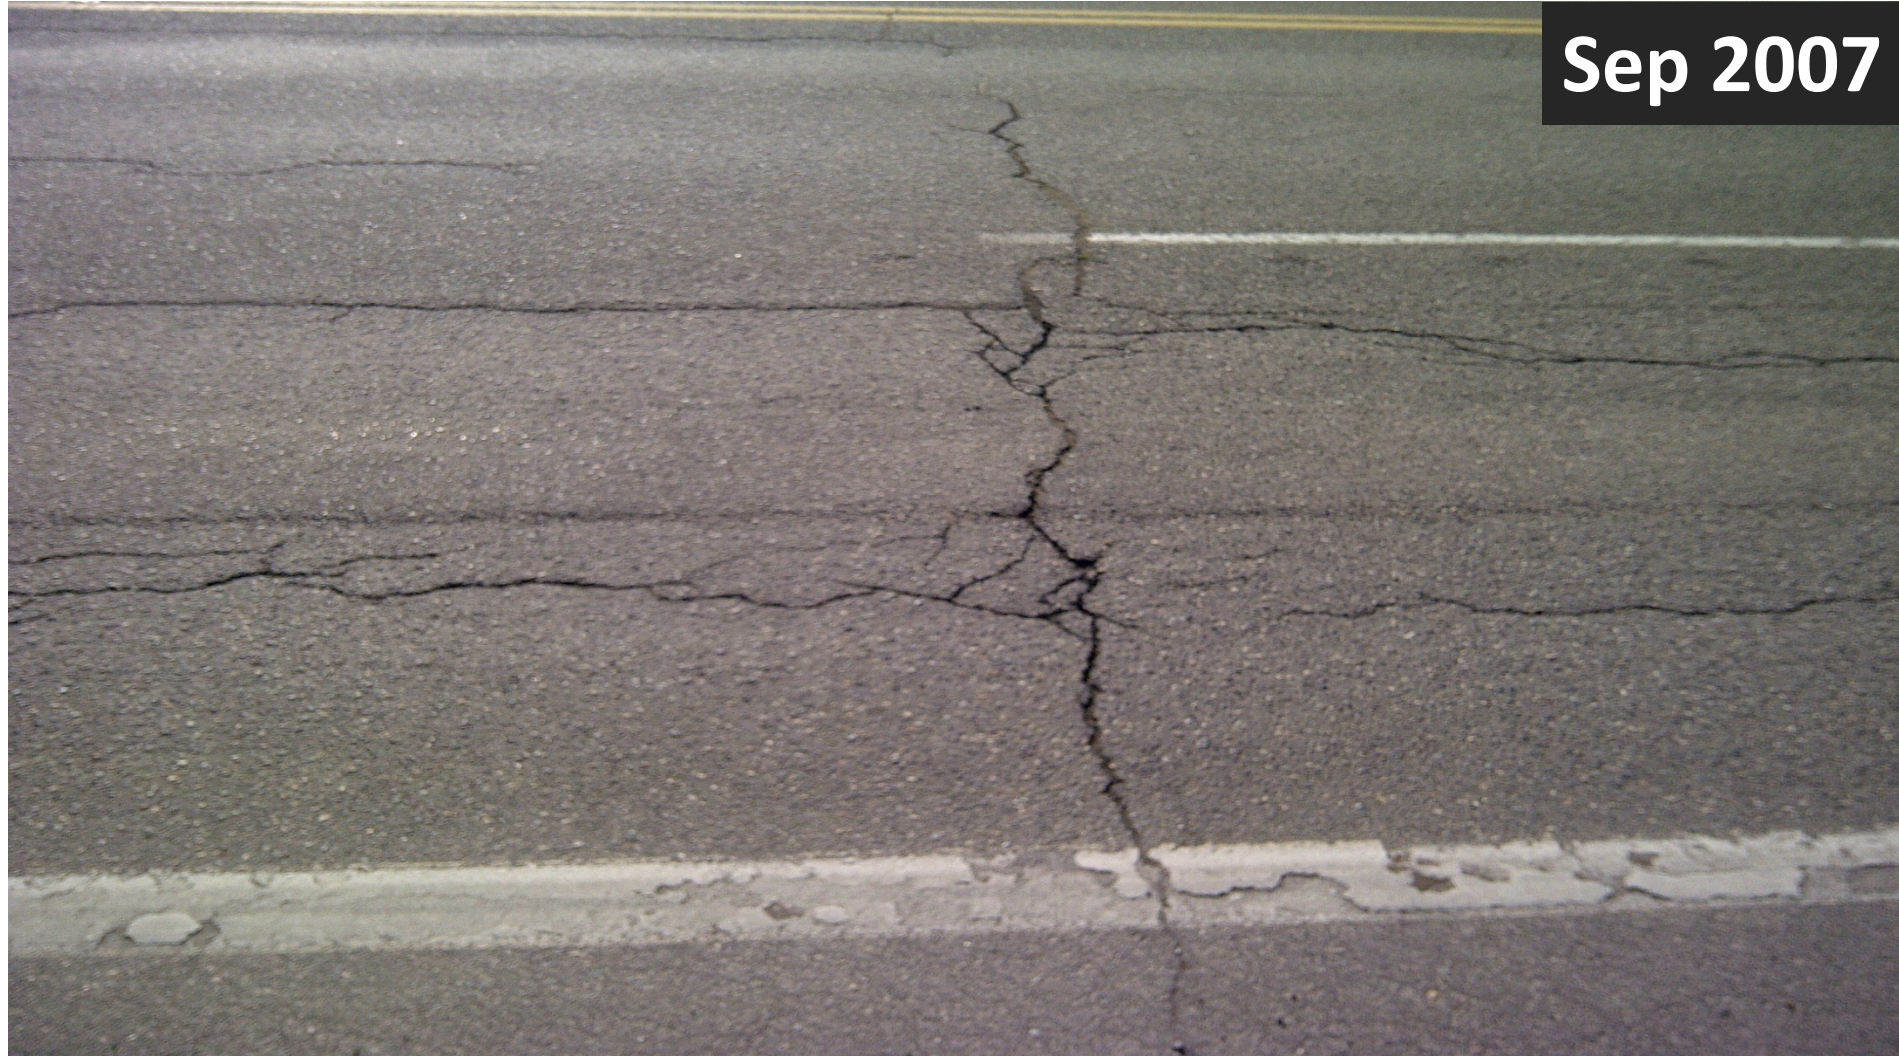
Lake Oswego-Boones Ferry - BEFORE

**Before TruPave Multi-Axial Paving**

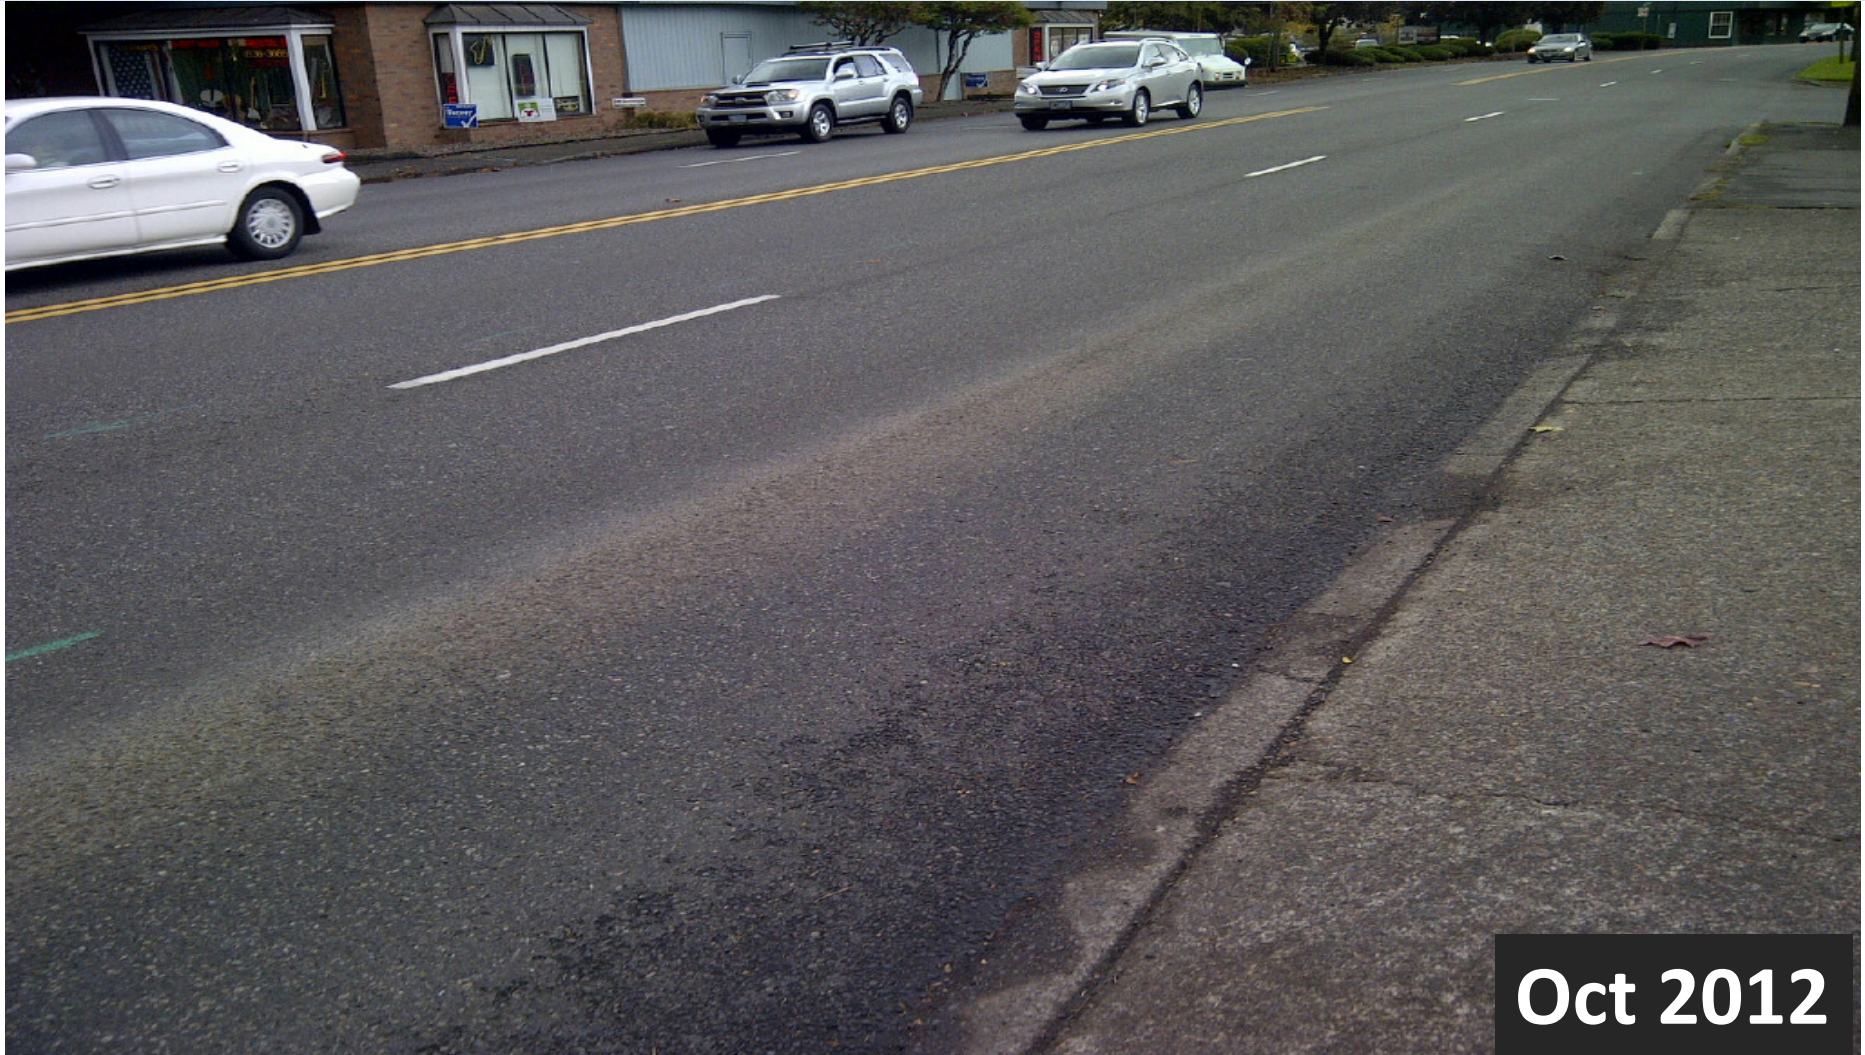
Lake Oswego-Boones Ferry

Oct 2012

TruPave Multi-Axial Paving Mat

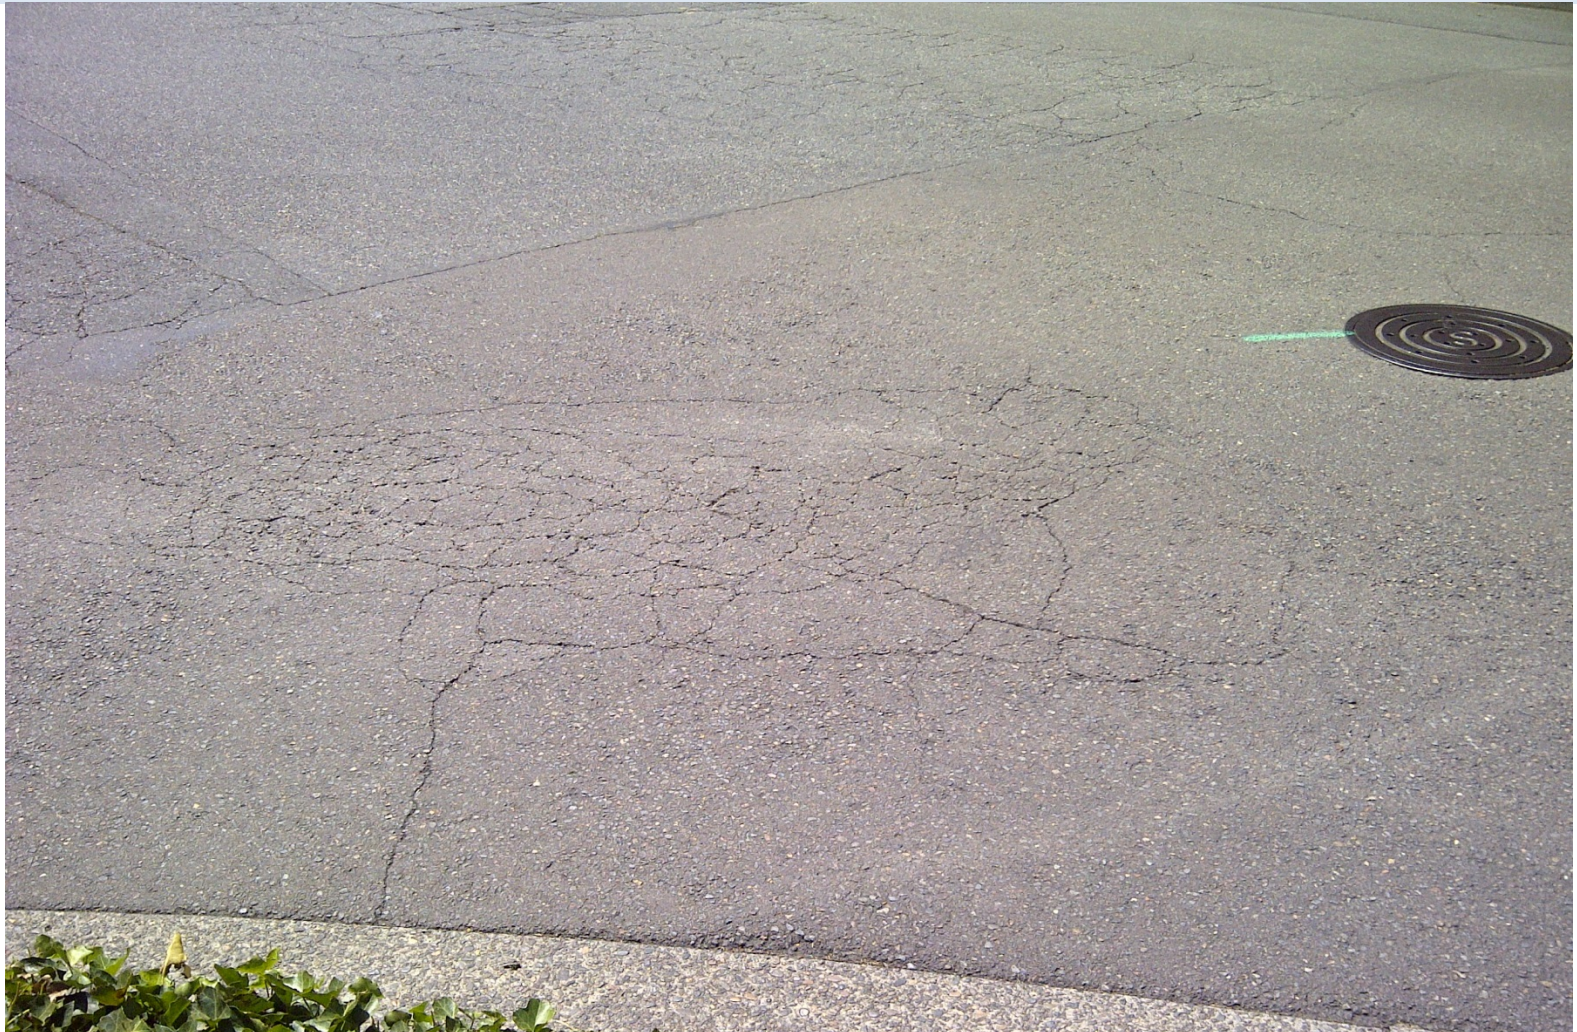
Lake Oswego-

**No Interlayer installed**

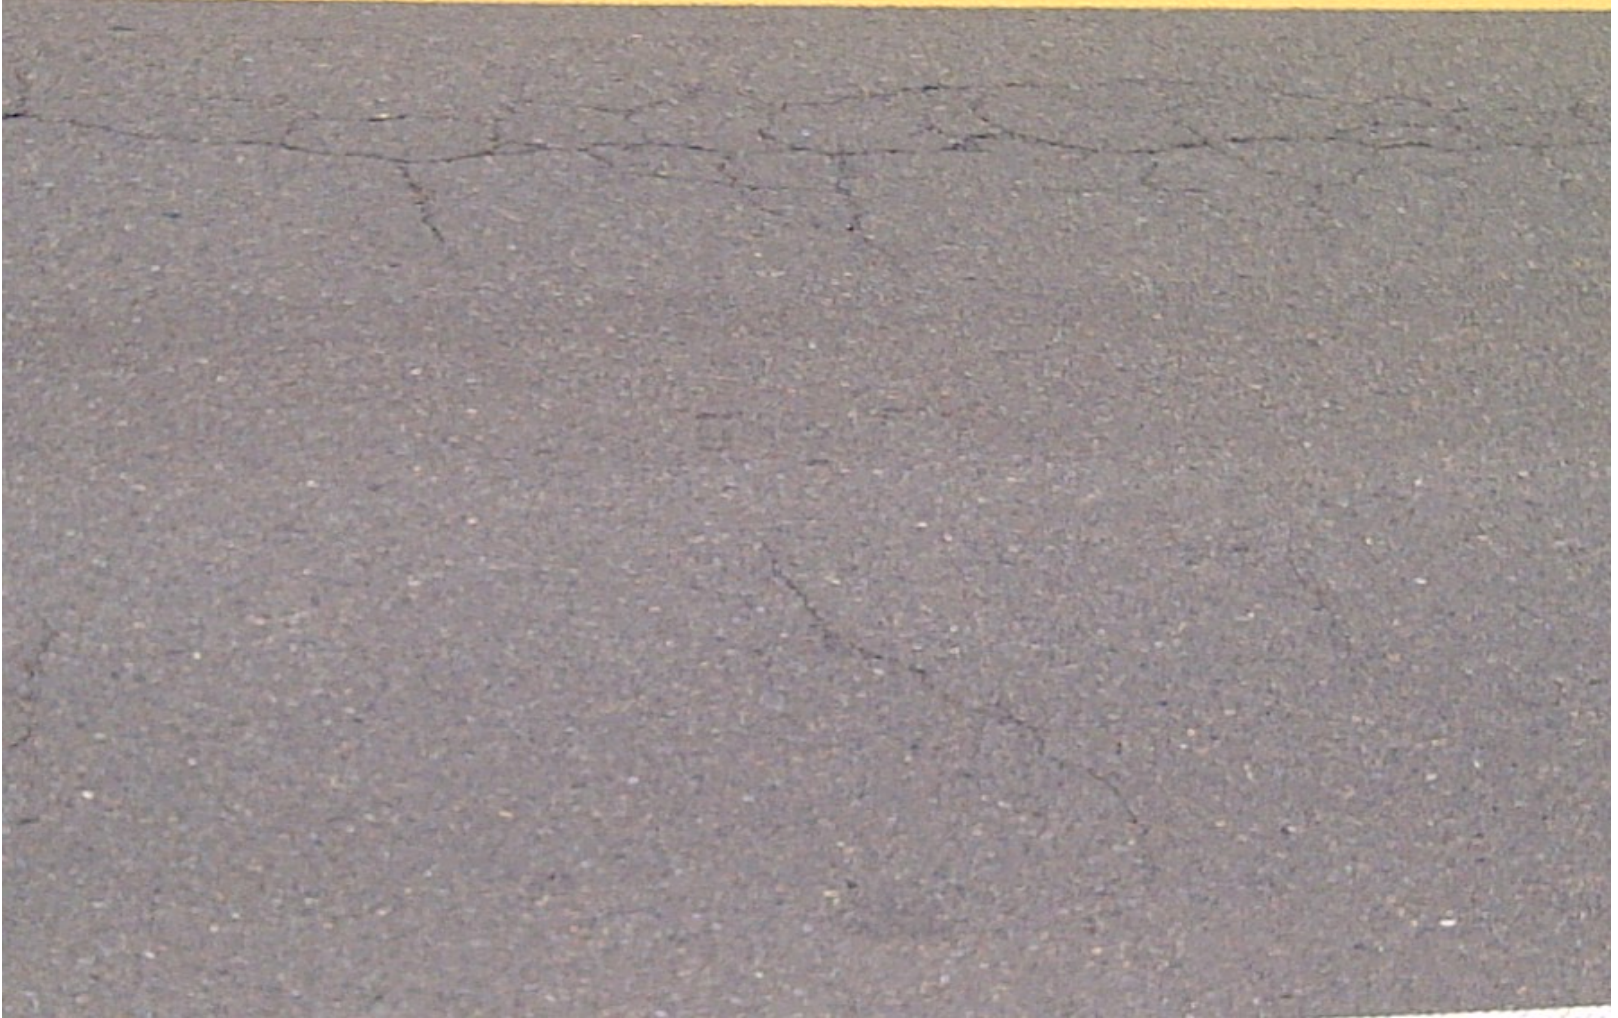
Lake Oswego-

**No Interlayer installed**

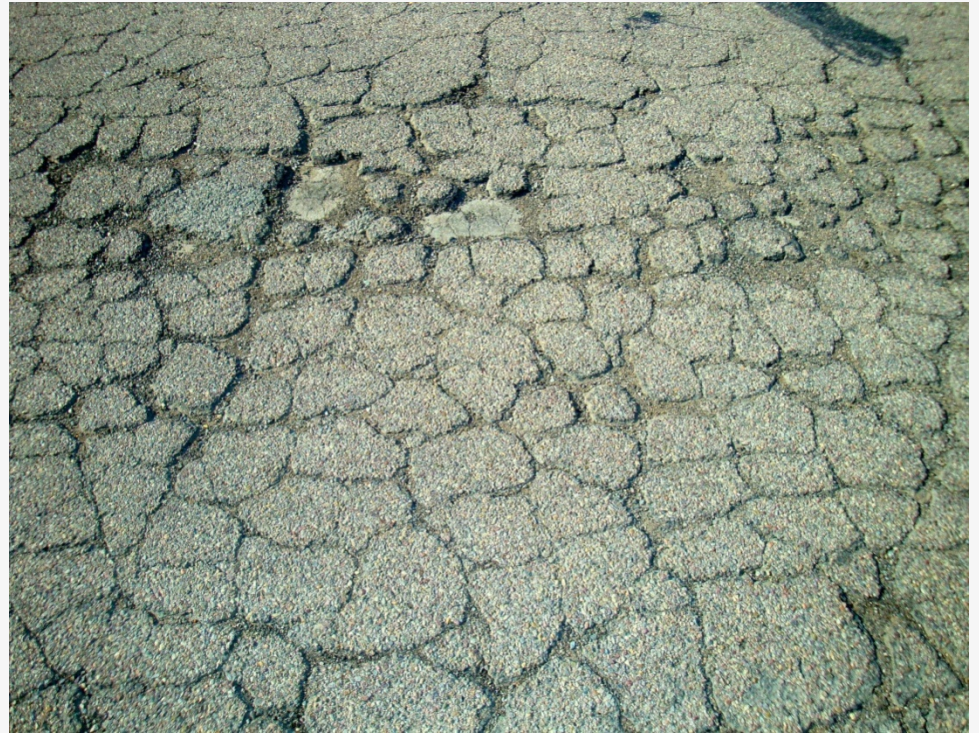
San Carlos St., San Diego

**Background:** Severe pavement failure & alligator cracking.

**Strategy:** Edge ground the street then thin leveling course over to force material down into failed areas and provide a uniform surface for the TruPave

**Install Date:** 2009

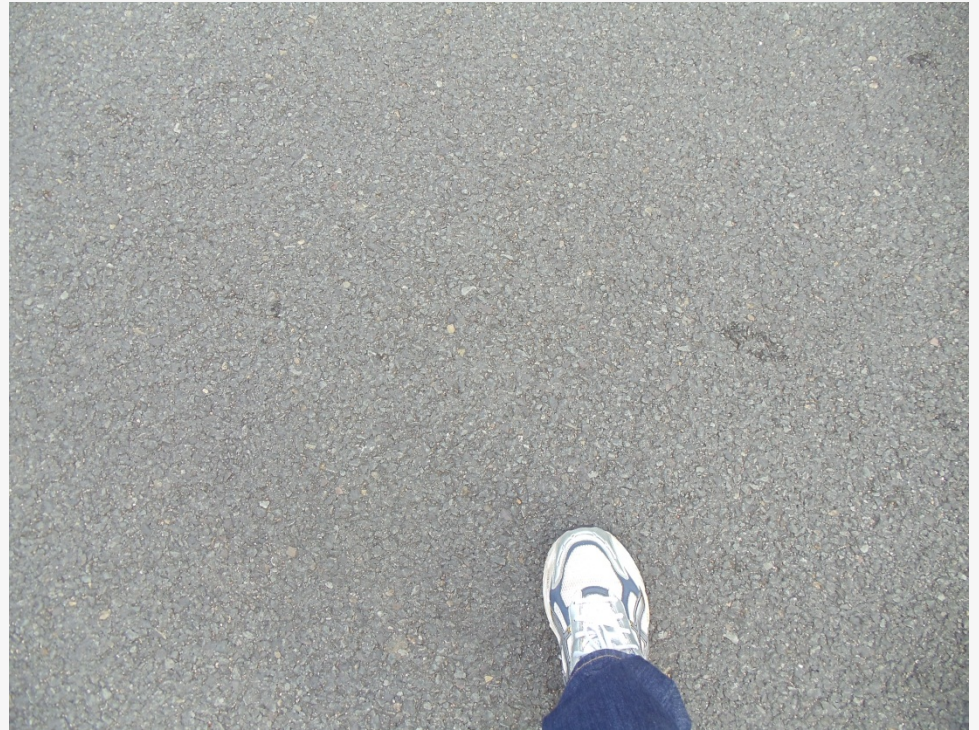
San Carlos St., San Diego

**Result:** The Engineer from the County said that if they did not use TruPave on this street that they would have expected to see most of the cracking reflect back through in six months.

**3 years later, not one crack in the failed areas.**

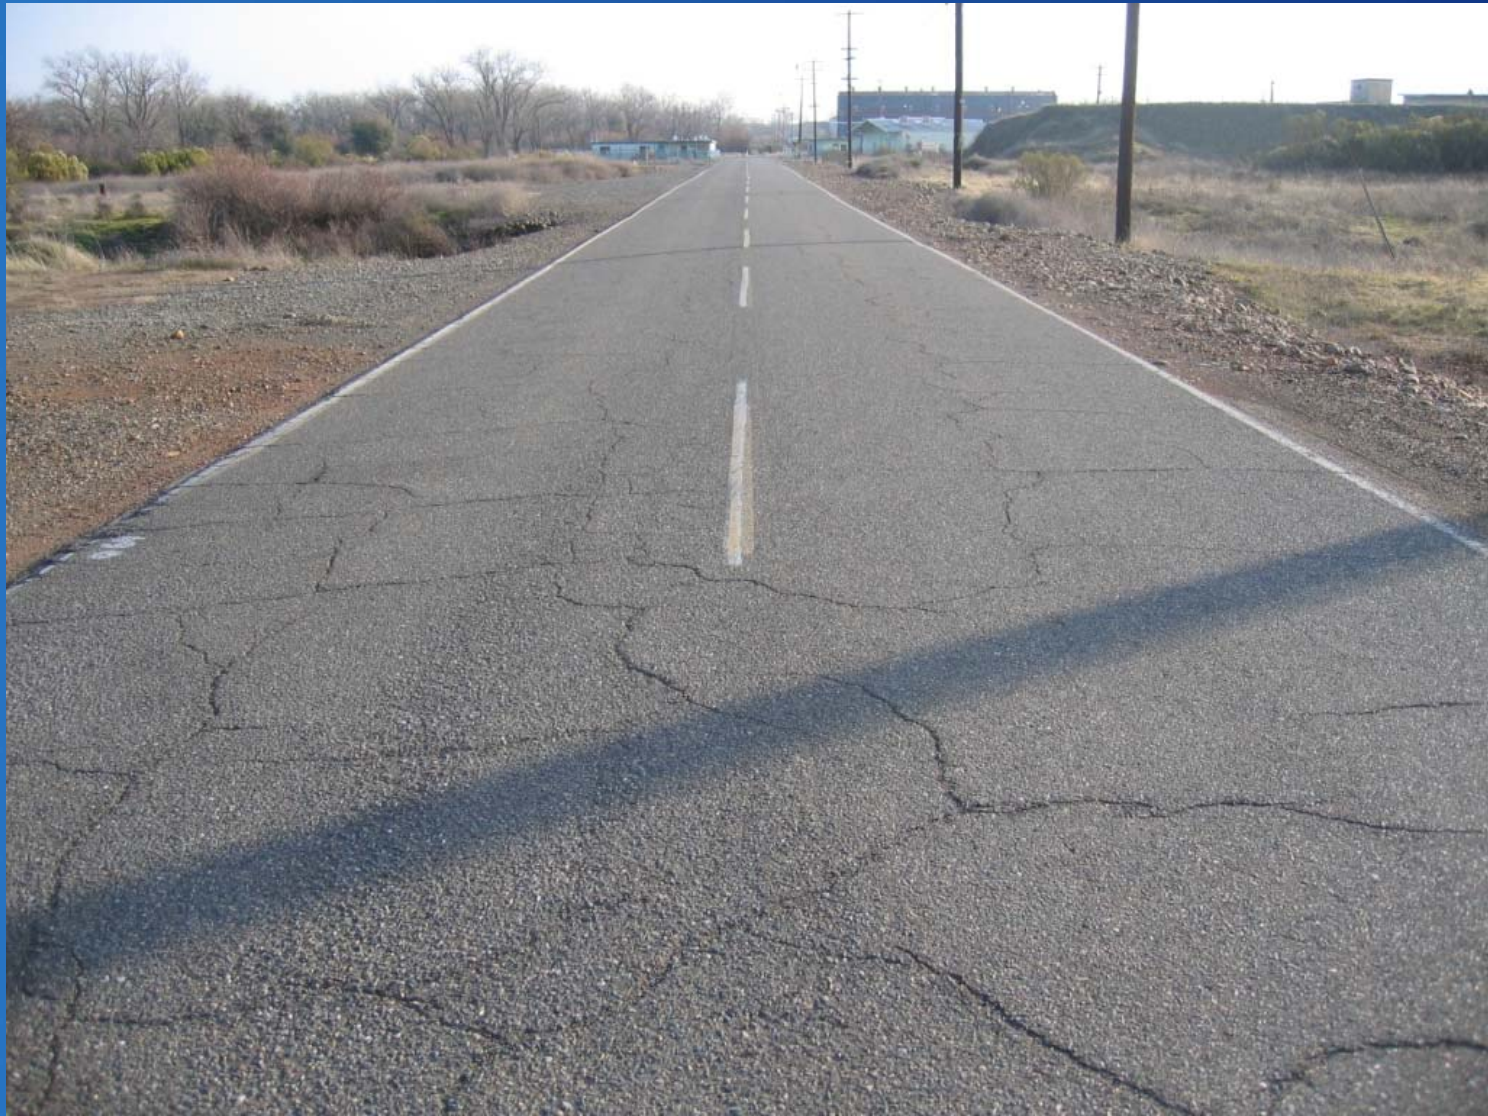
## AC Overlay on Fabric – Installed 1982
