# Geosynthetic In Construction

# Geosynthetic Pavement Interlayers

# **Geosynthetic Reinforced Chip Seal (GRCS)**

**Unmatched Value - Chip Sealing over Fabrics**

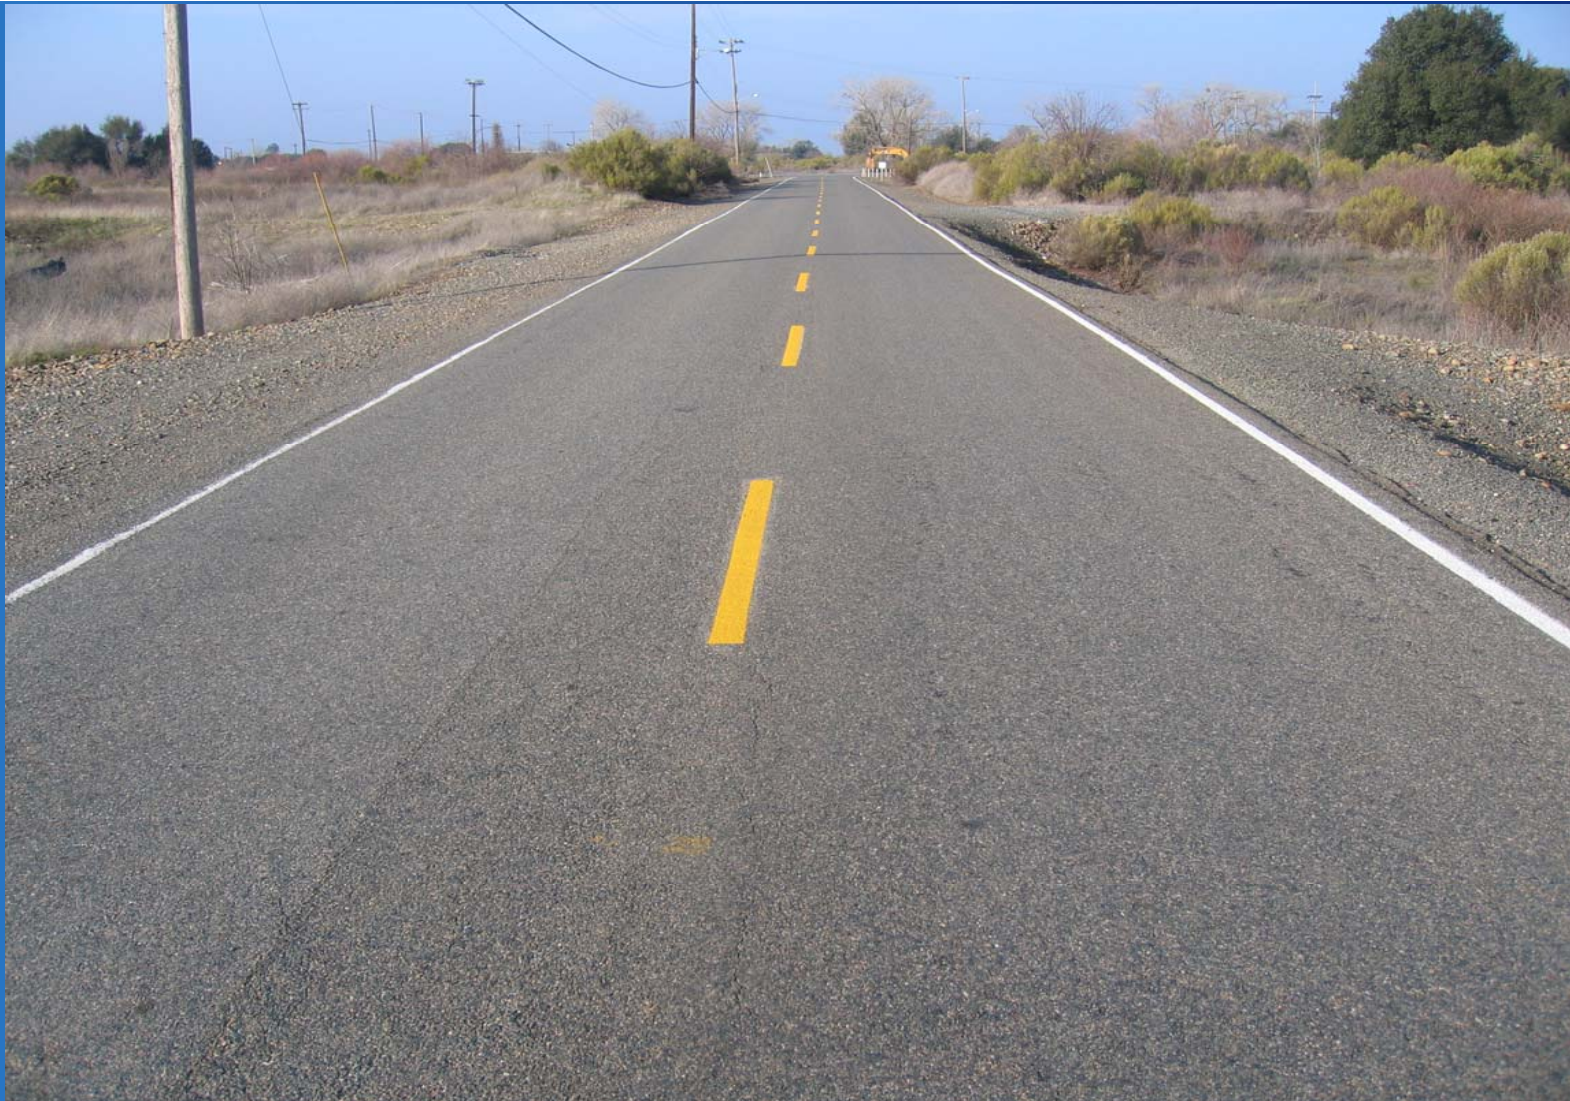
# Geosynthetic Reinforced Chip Seal (GRCS) Installed 1983

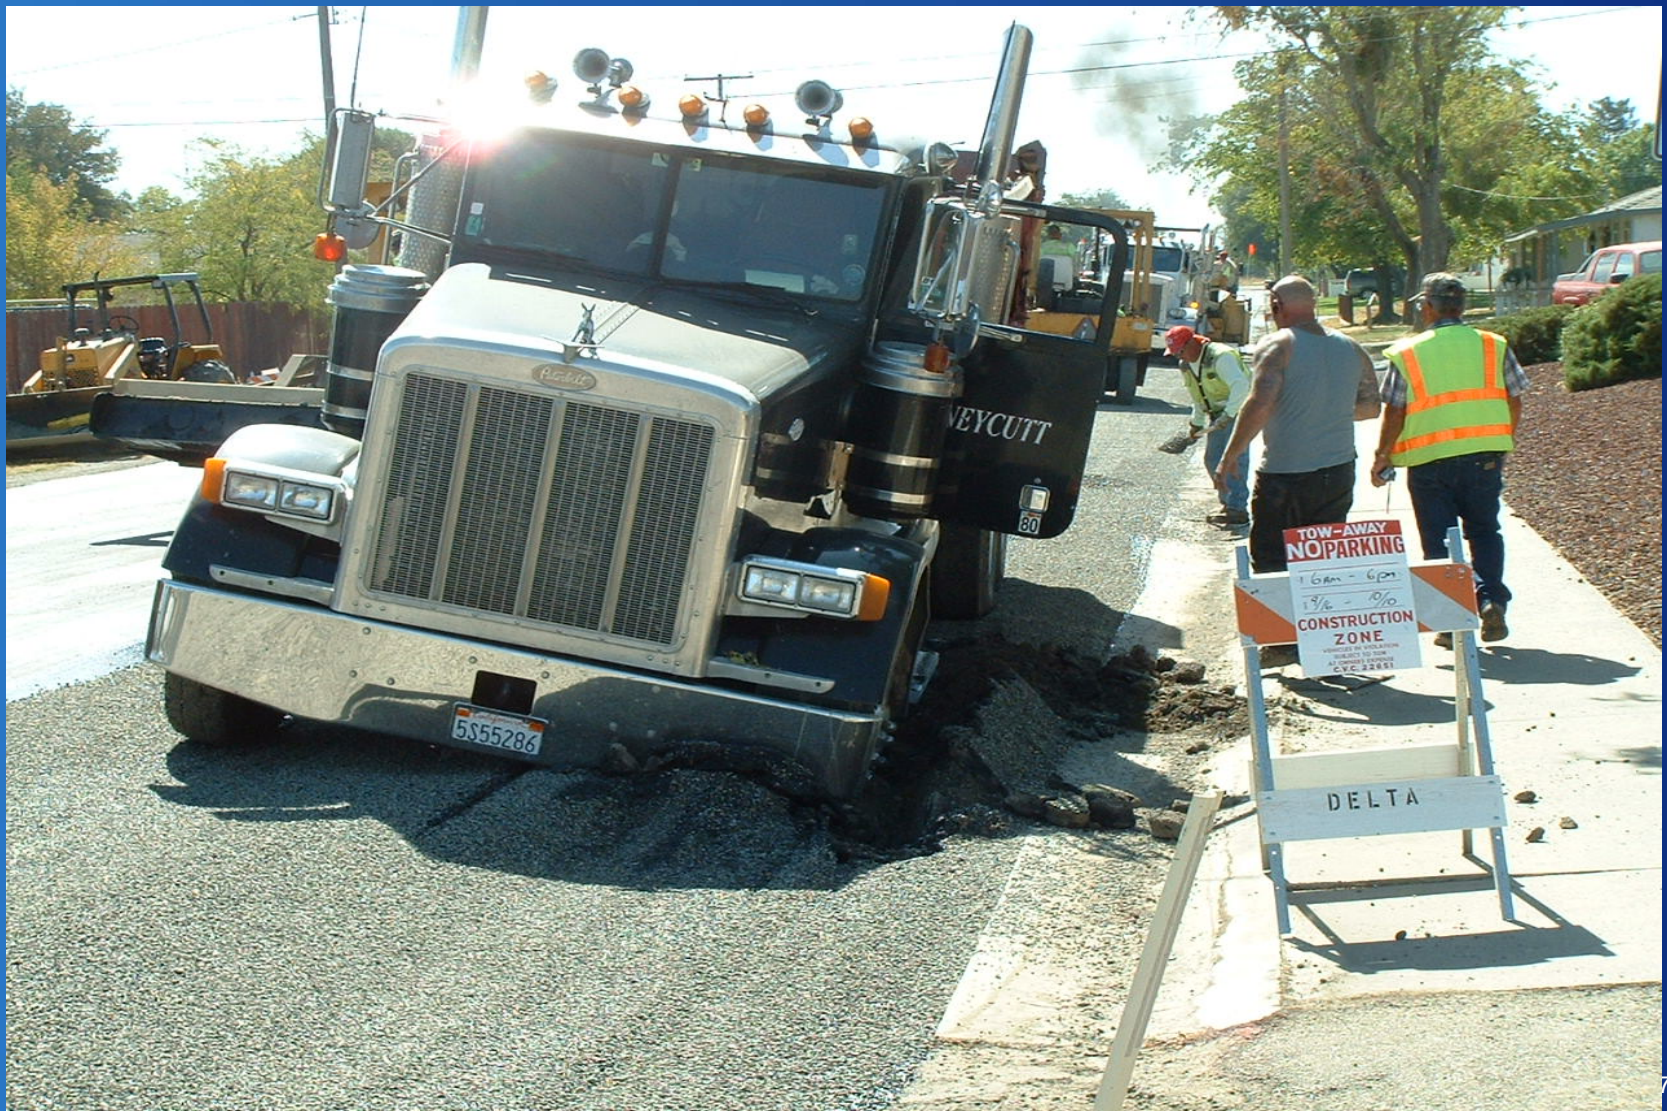
# Soft Subgrade!!!!!!

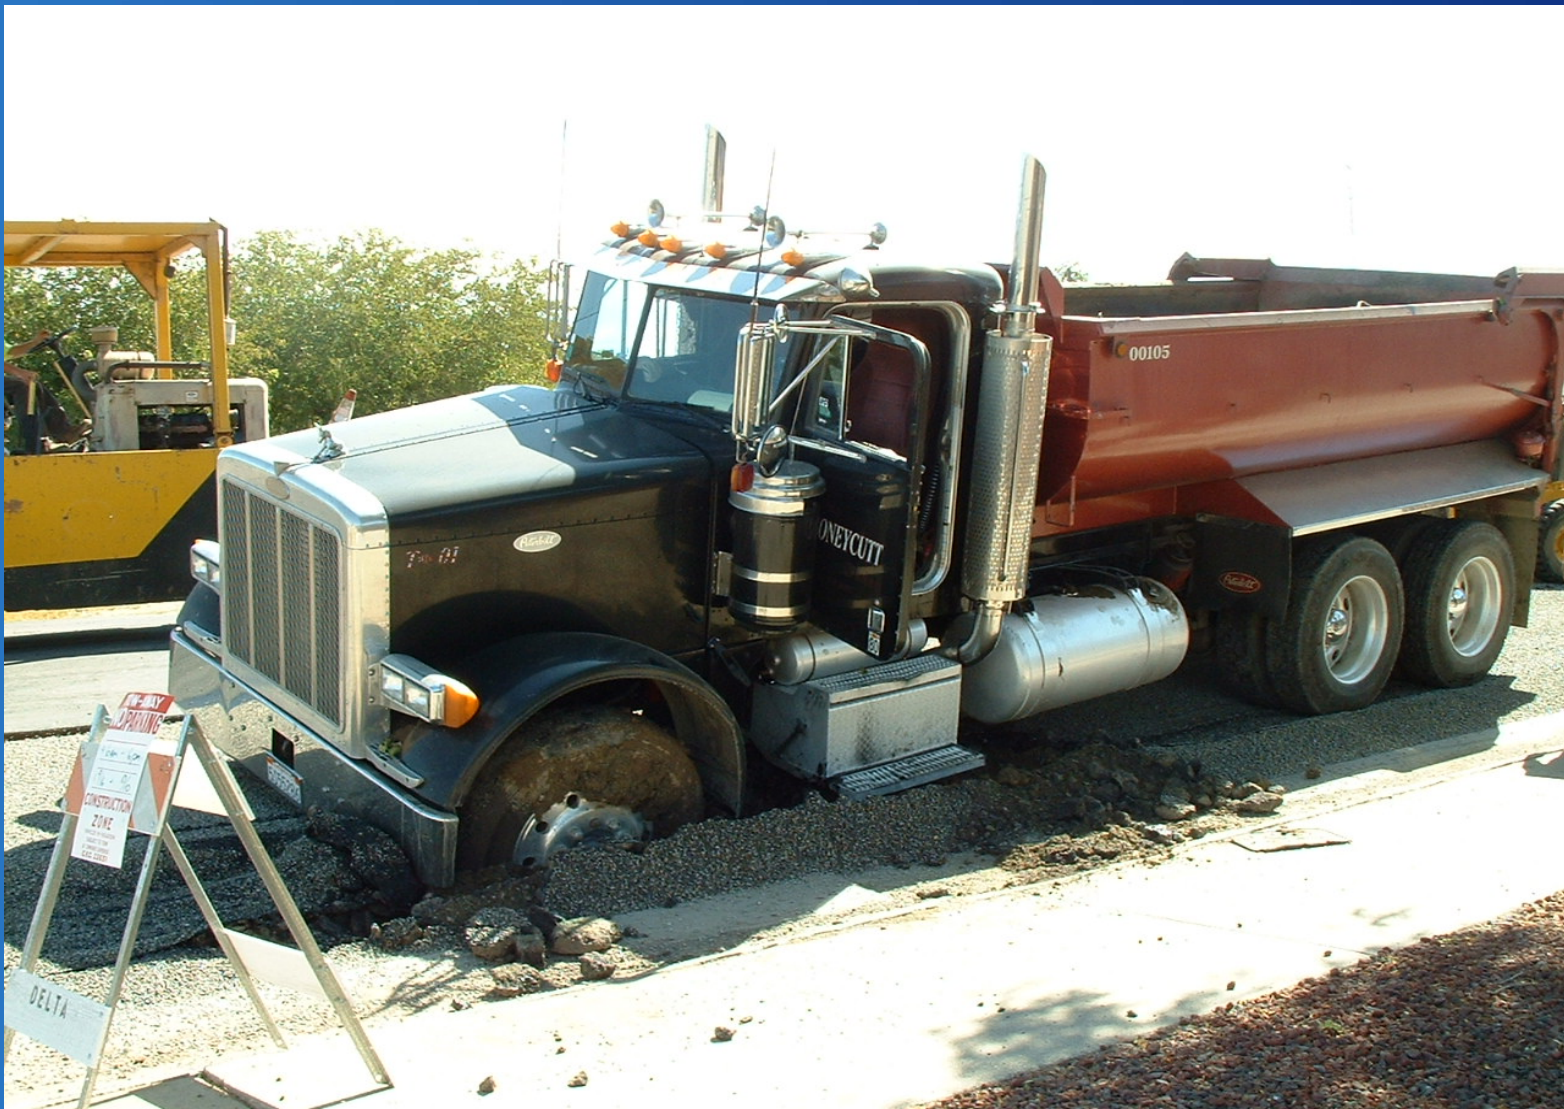
# One Too Many Heavy Axle Trips

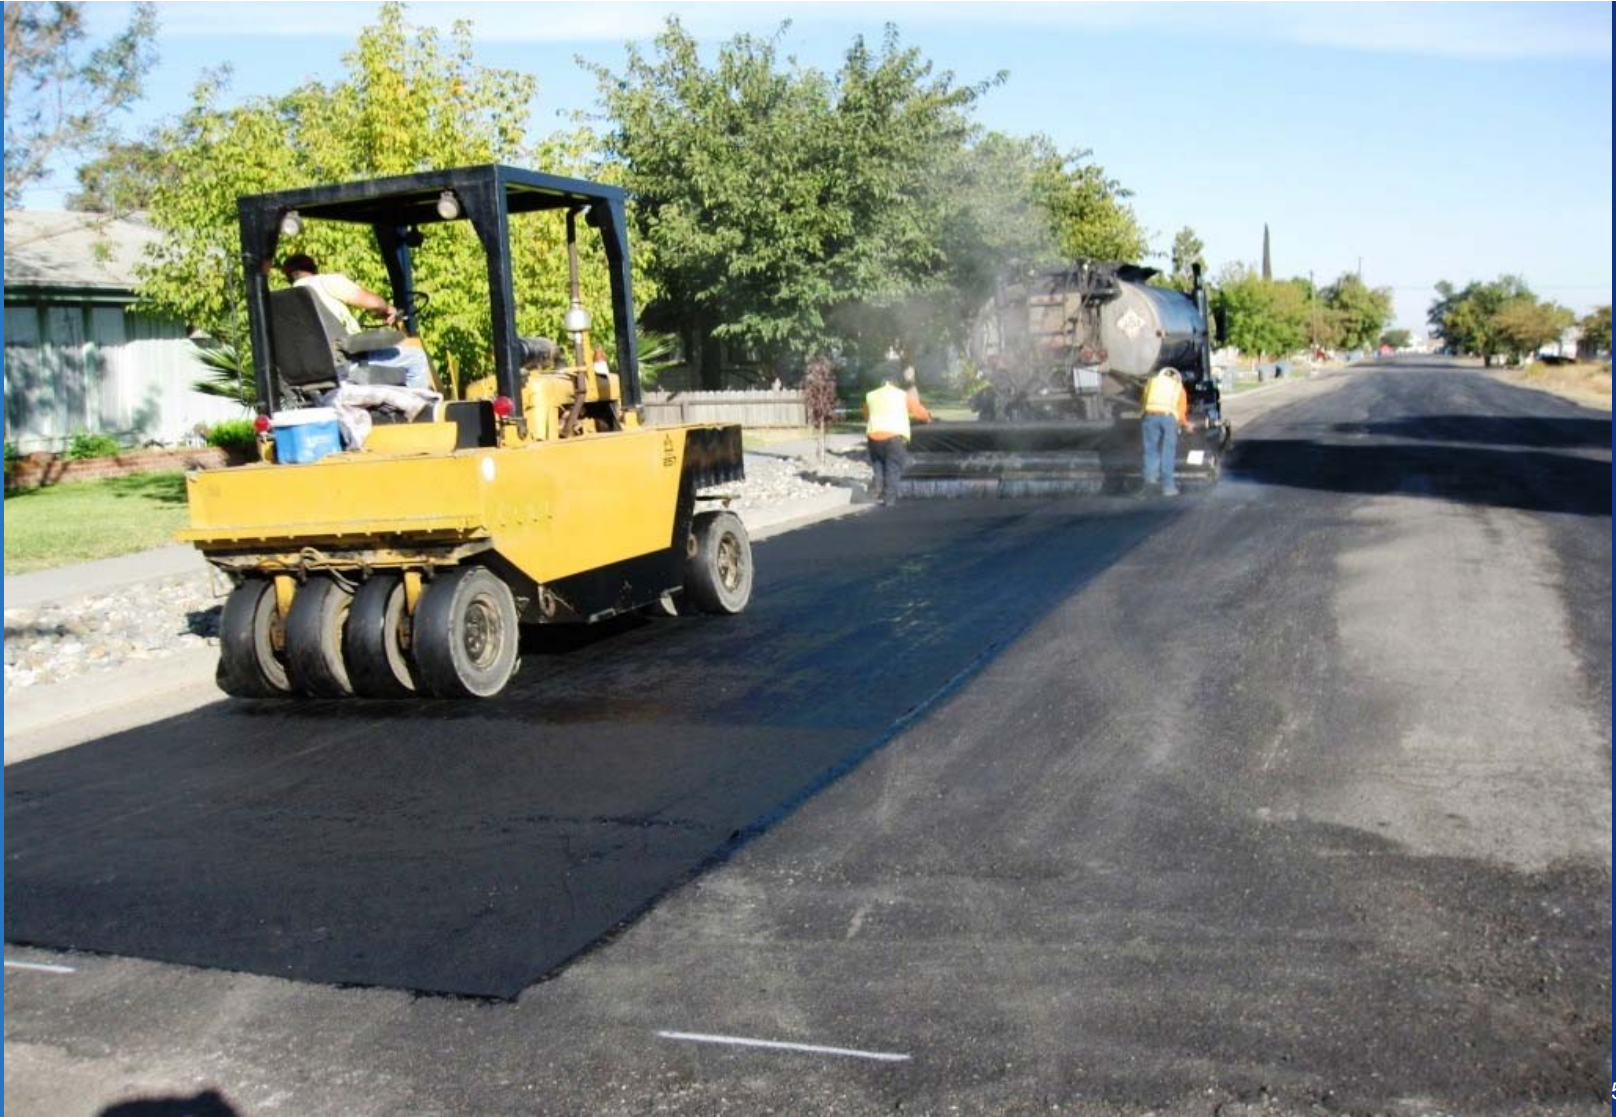
# Place and Immediately Roll Fabric

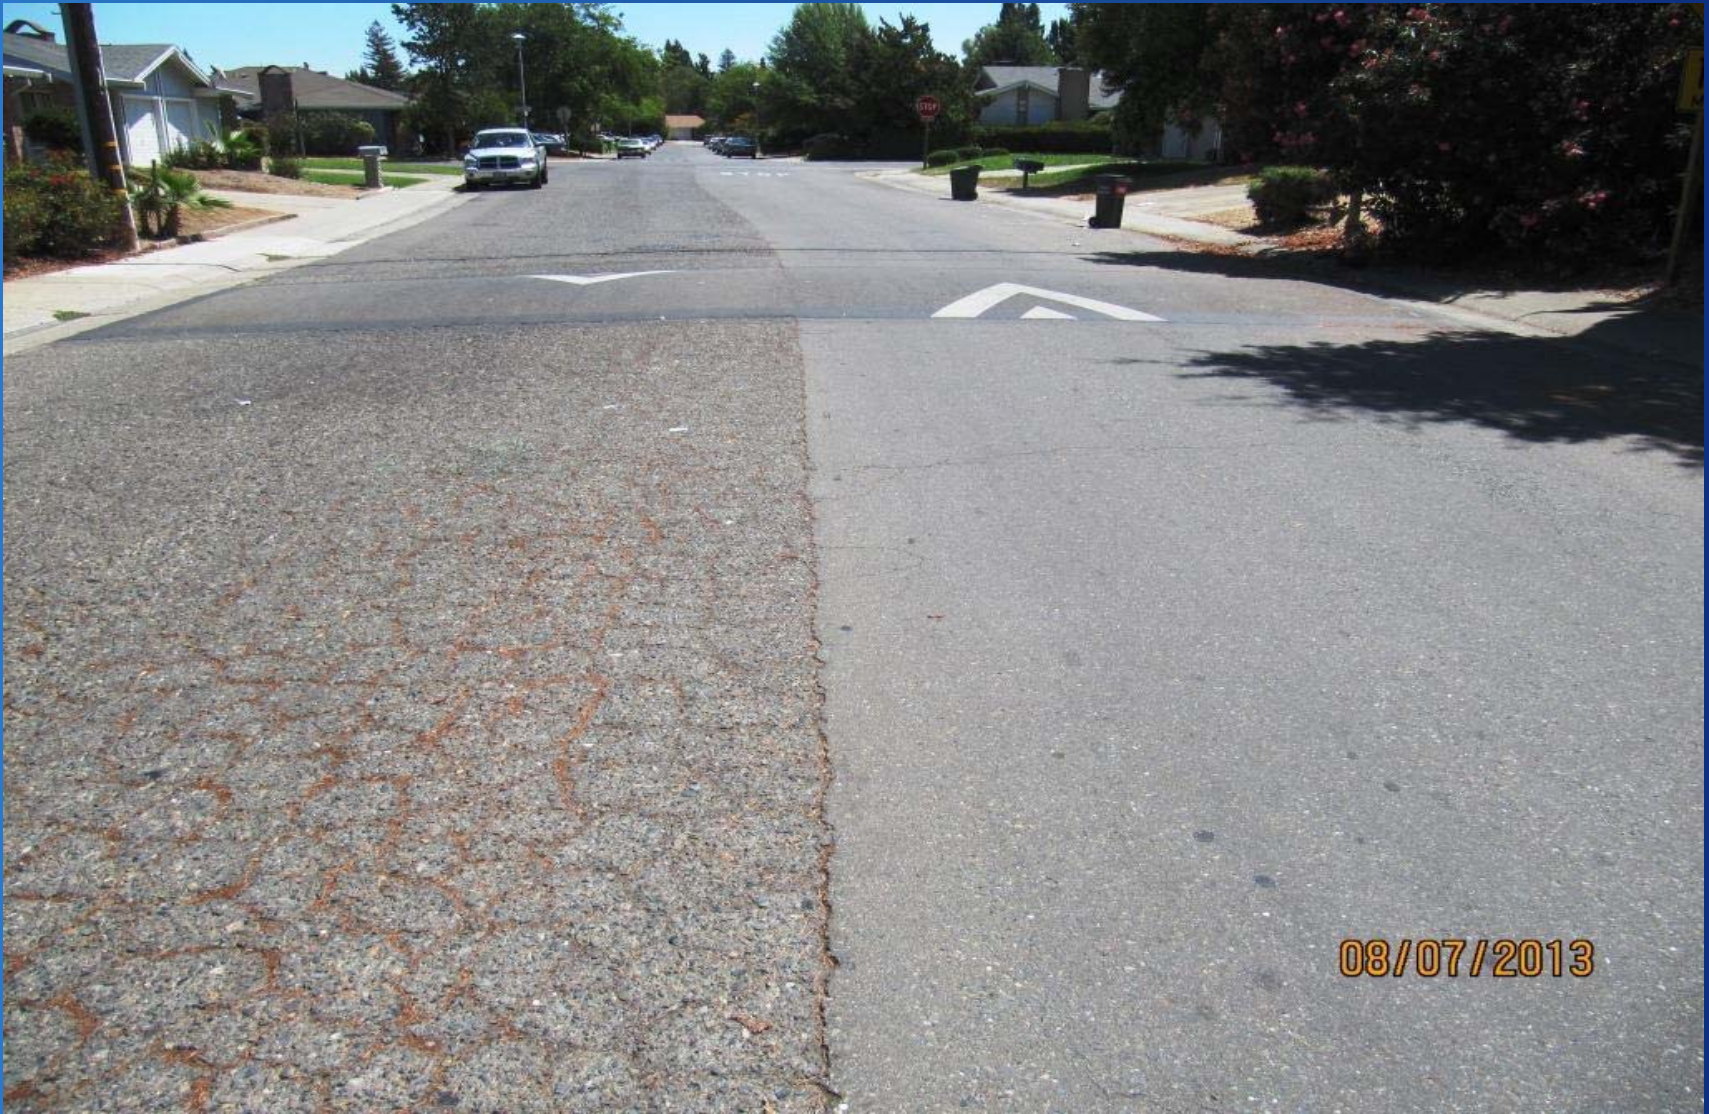
# What is the Proper Application Rate to Saturate Fabric

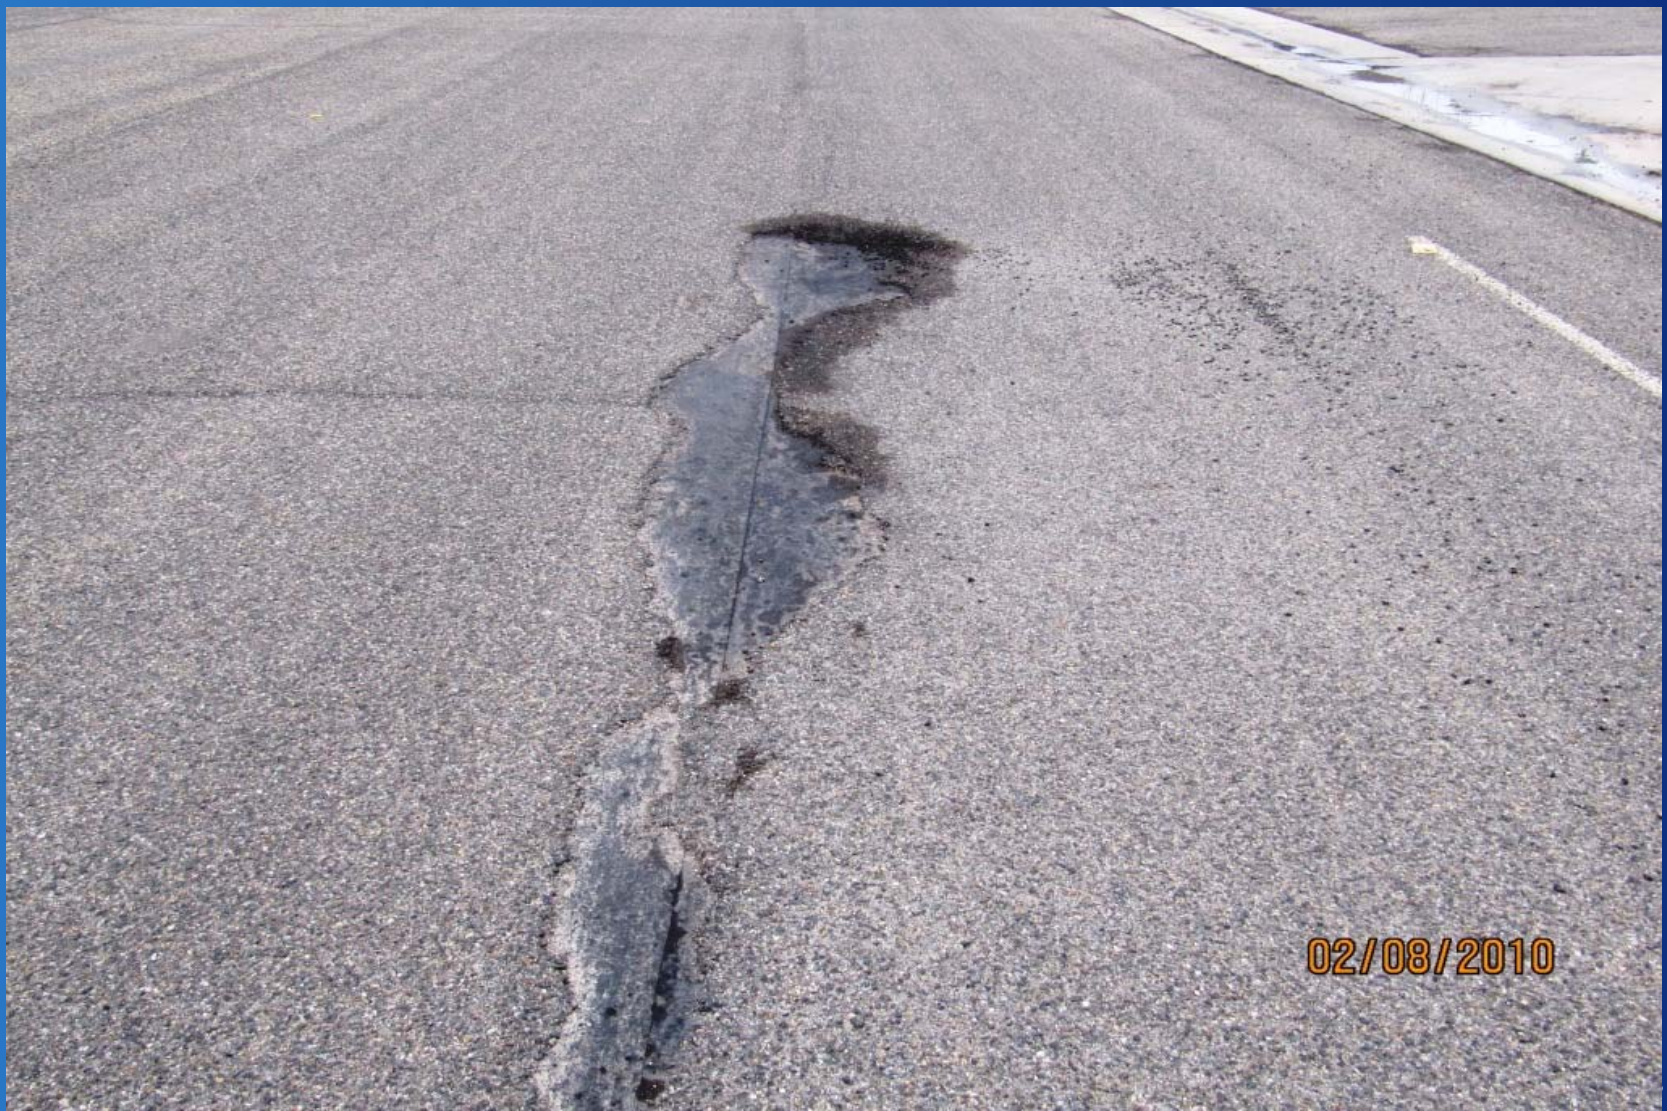
# Separation due to lack of good fabric saturation

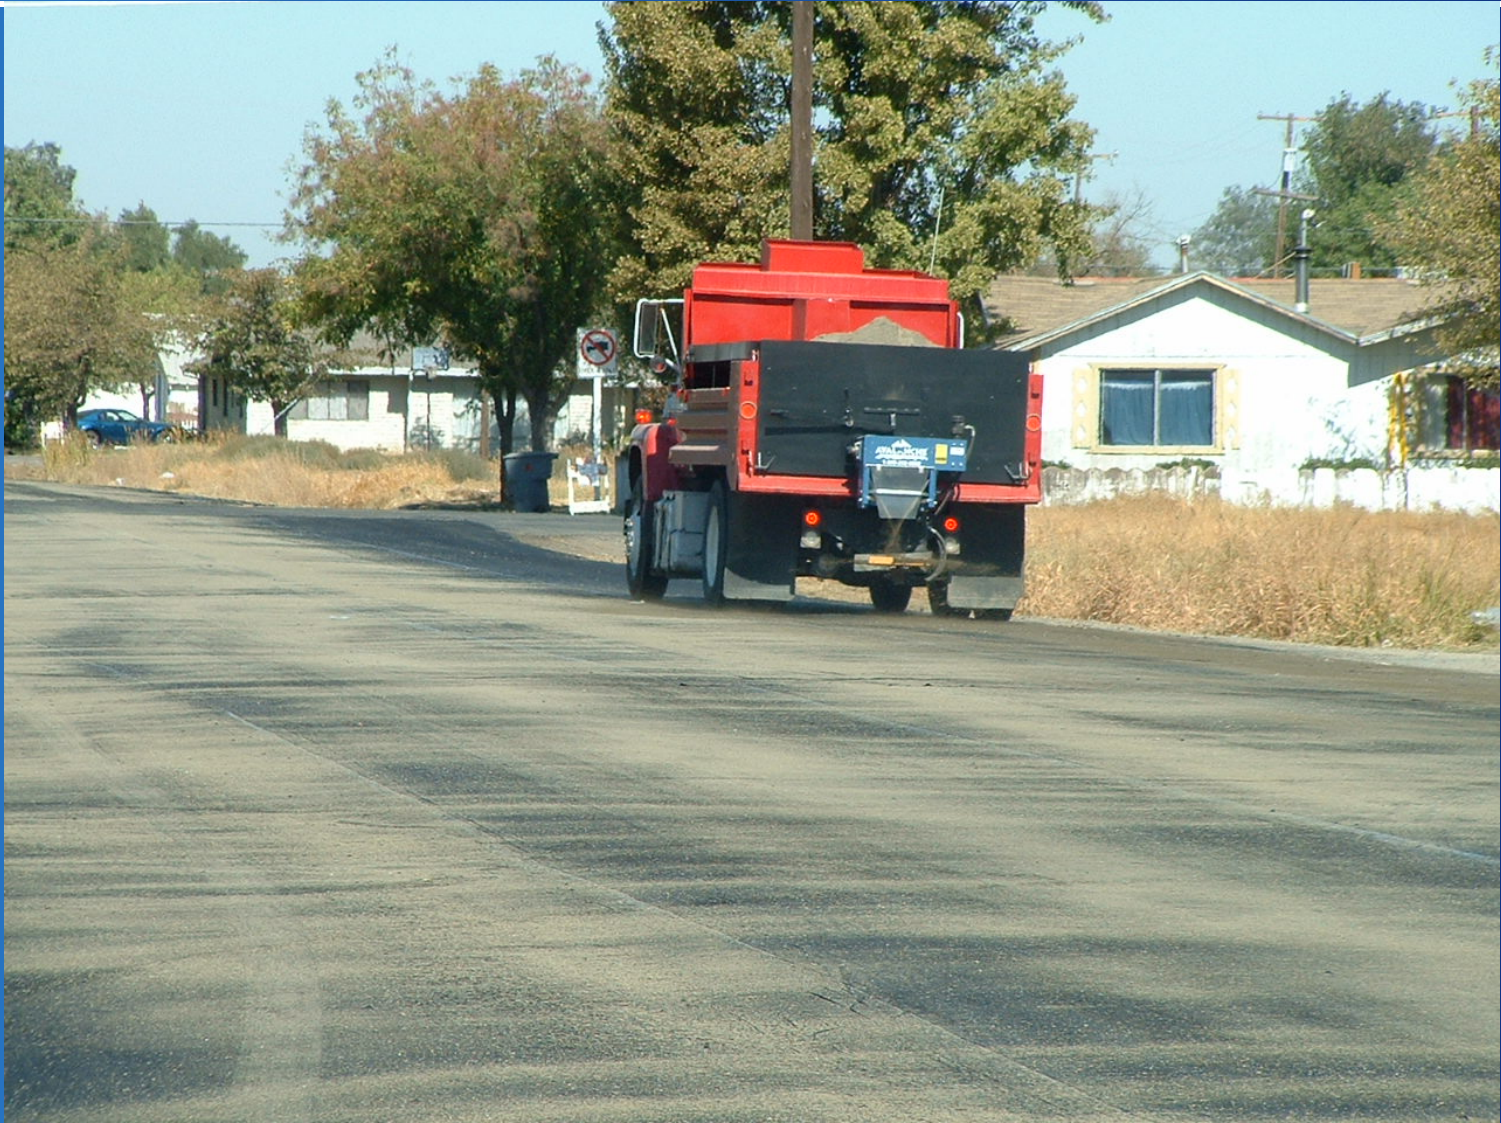
# Sanding the Fabric for Traffic

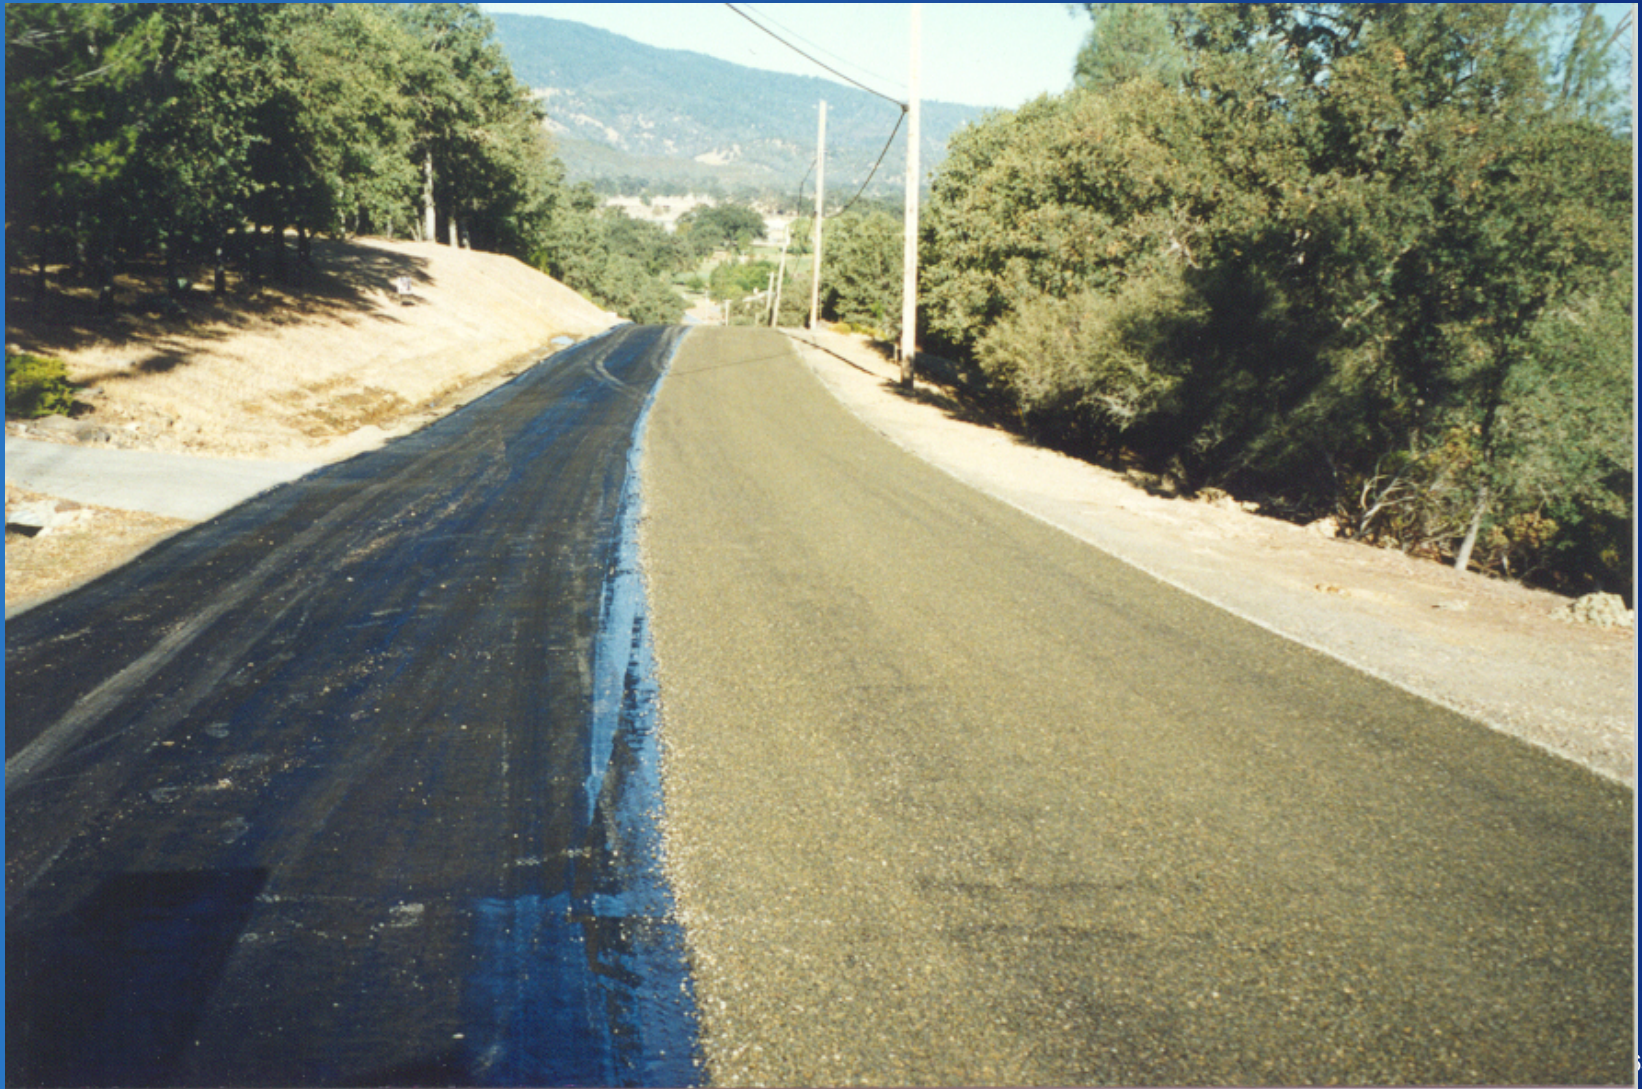
# First Course Chips – Clear Lake, California

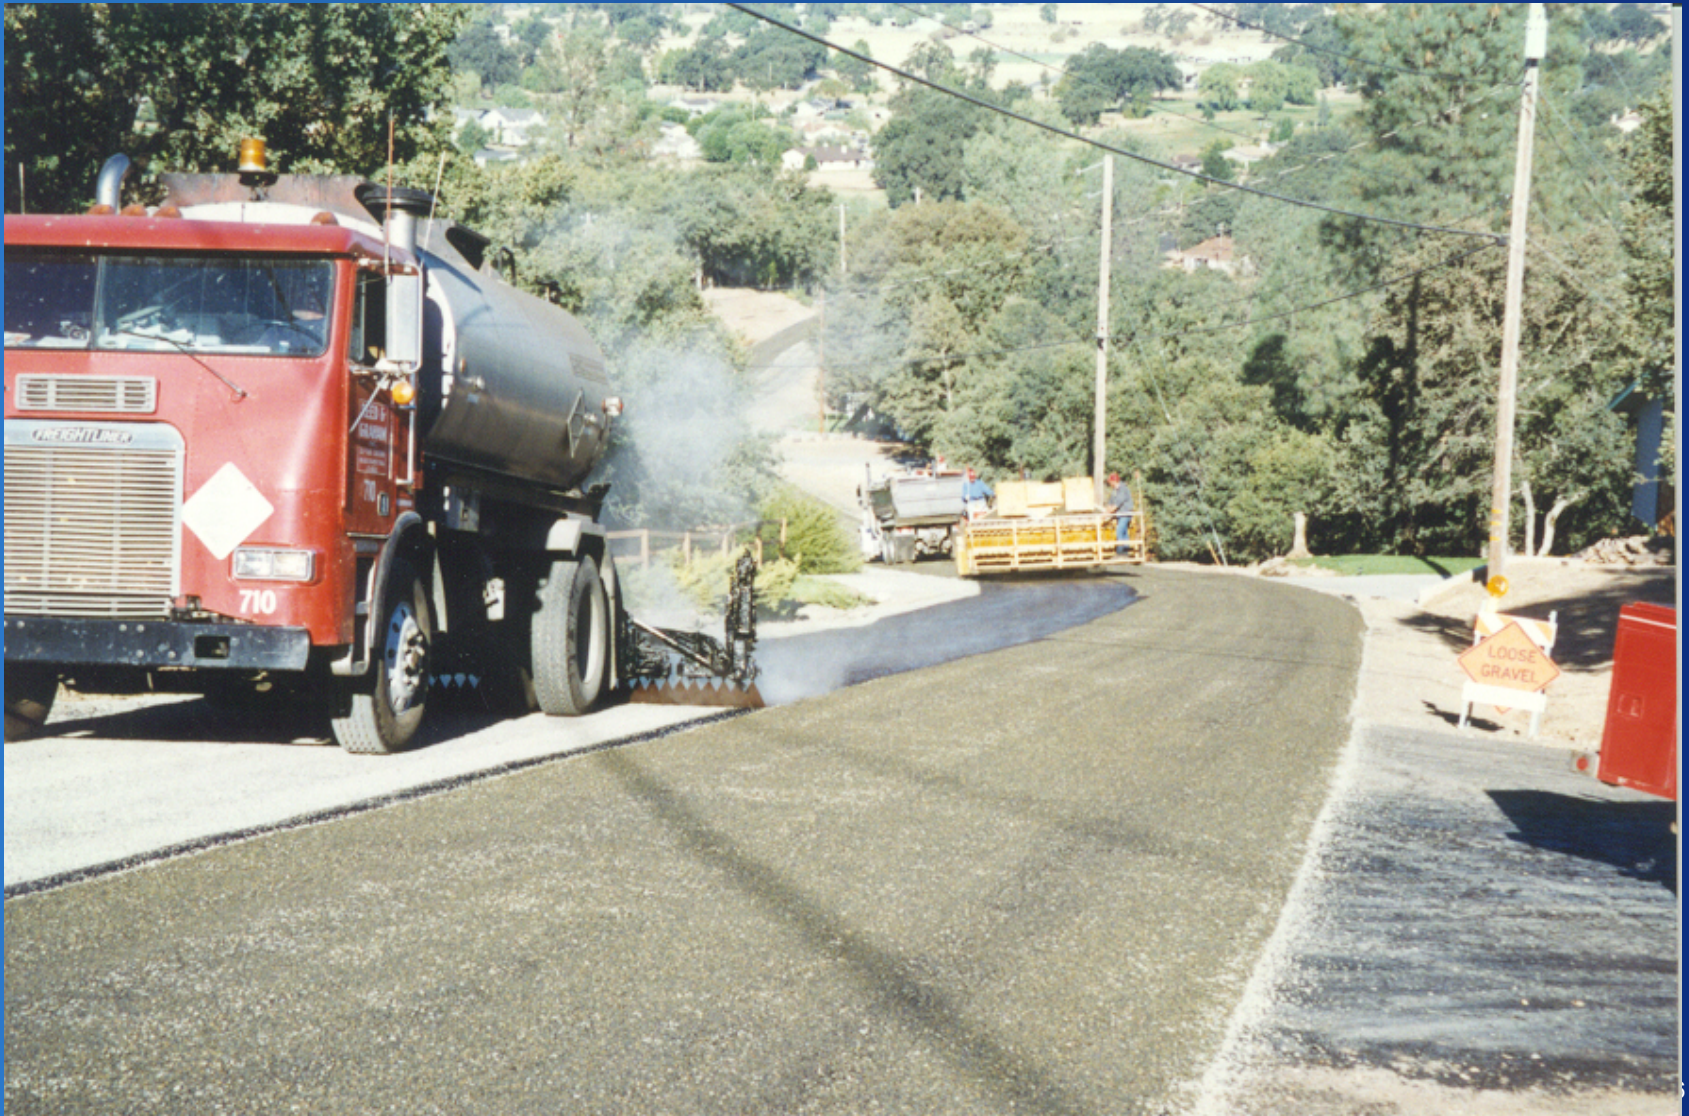
## Second Course Chips – Clear Lake, California

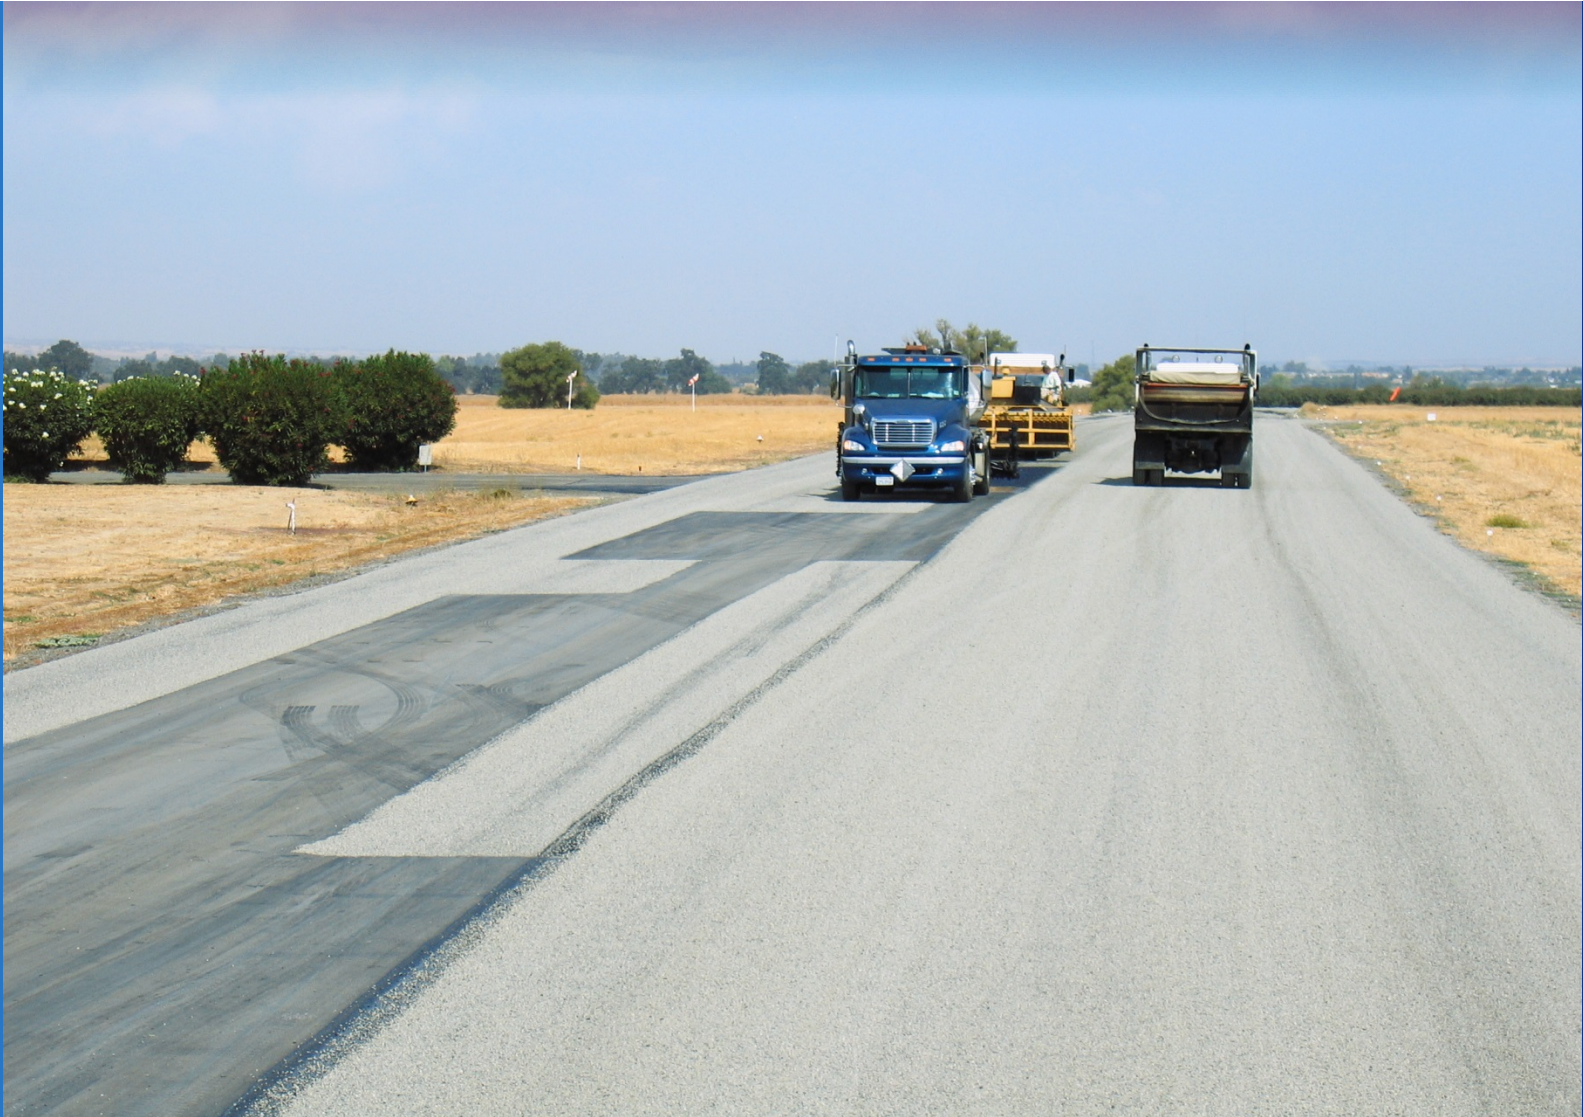
# Double Chip on Fabric, Single over Balance

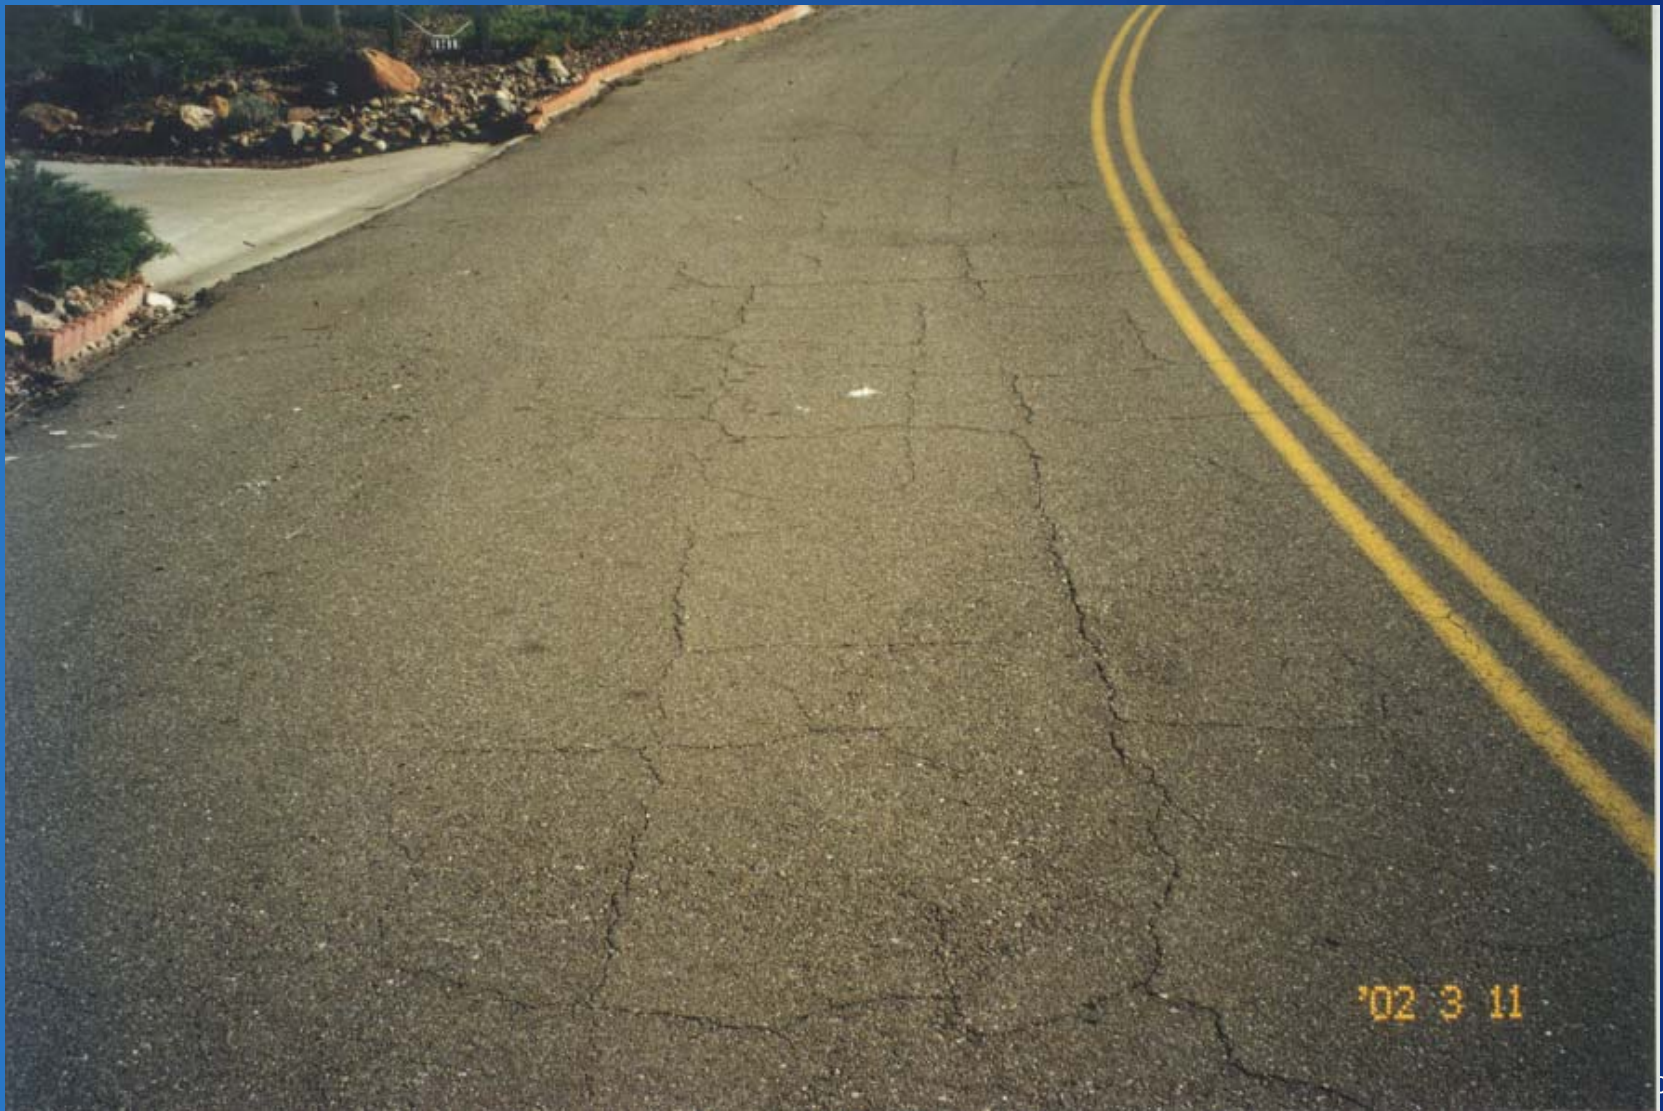
# AC Overlay on Cracked Pavement After Six Years

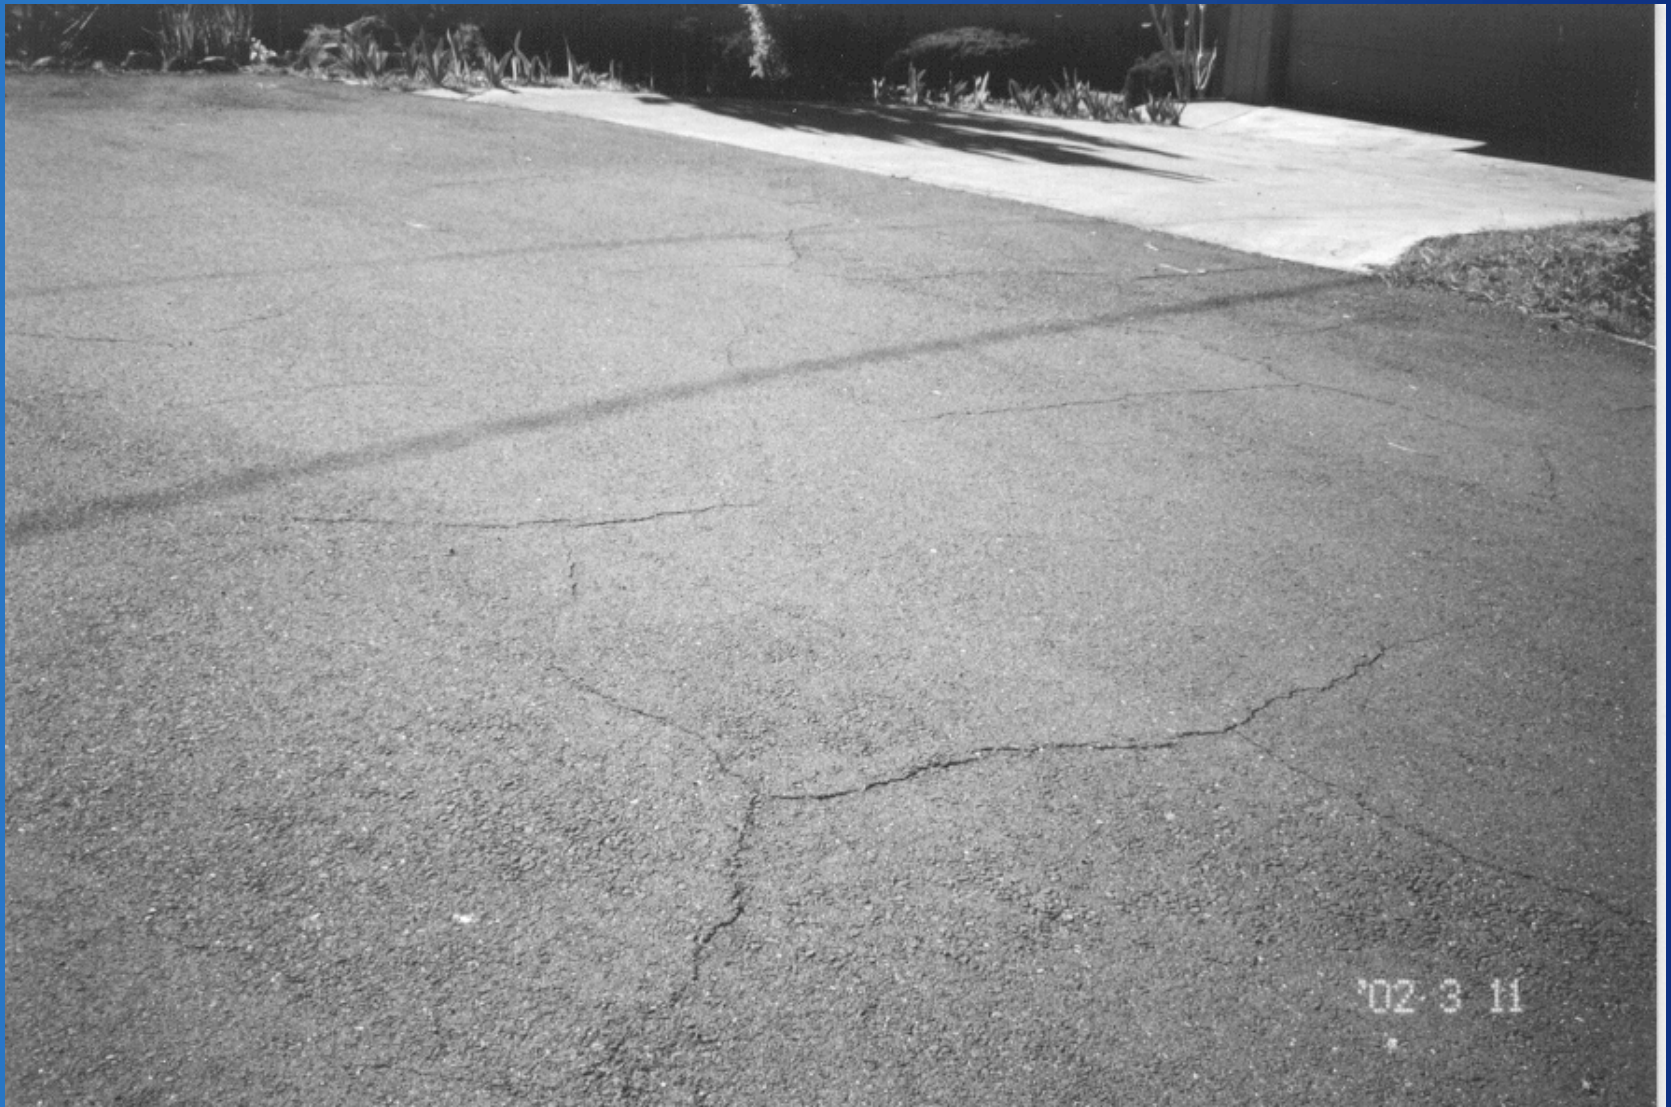
# Asphalt Overlay on Paving Fabric After 4 Years
