# Geosynthetic In Construction

# Geosynthetic Pavement Interlayers

# **Geosynthetic Reinforced Chip Seal (GRCS)**

**Unmatched Value - Chip Sealing over Fabrics**

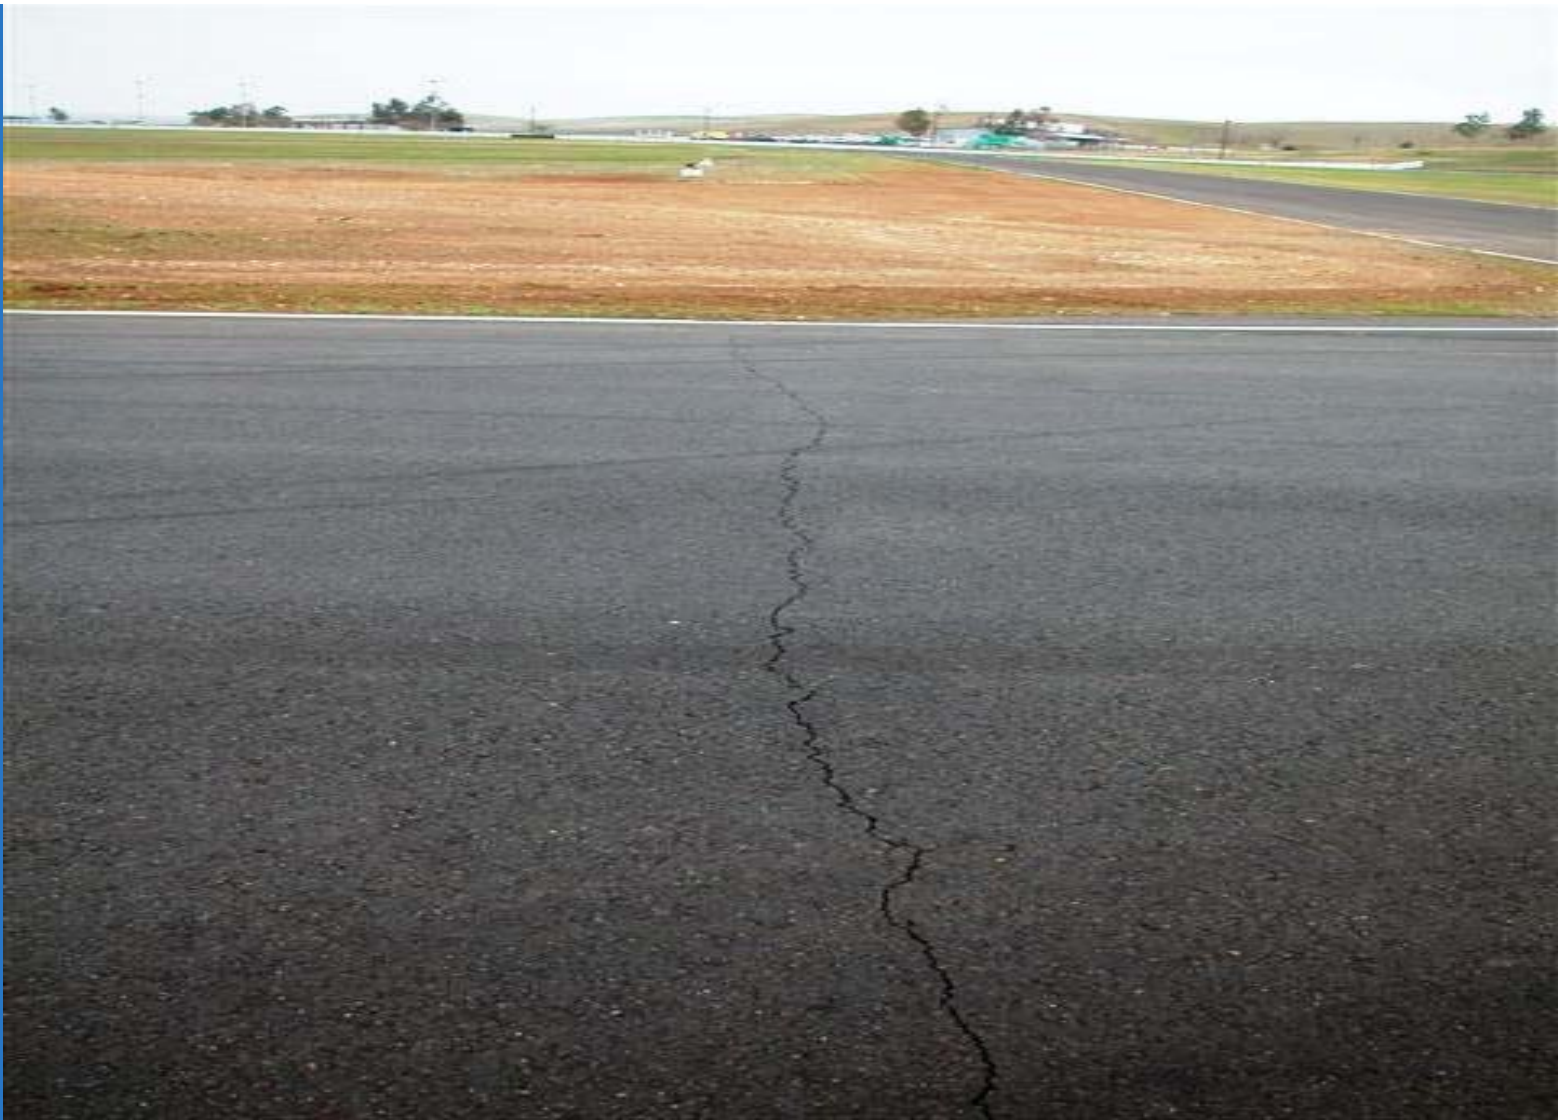
# Asphalt Overlay Without Fabric After 5 Months

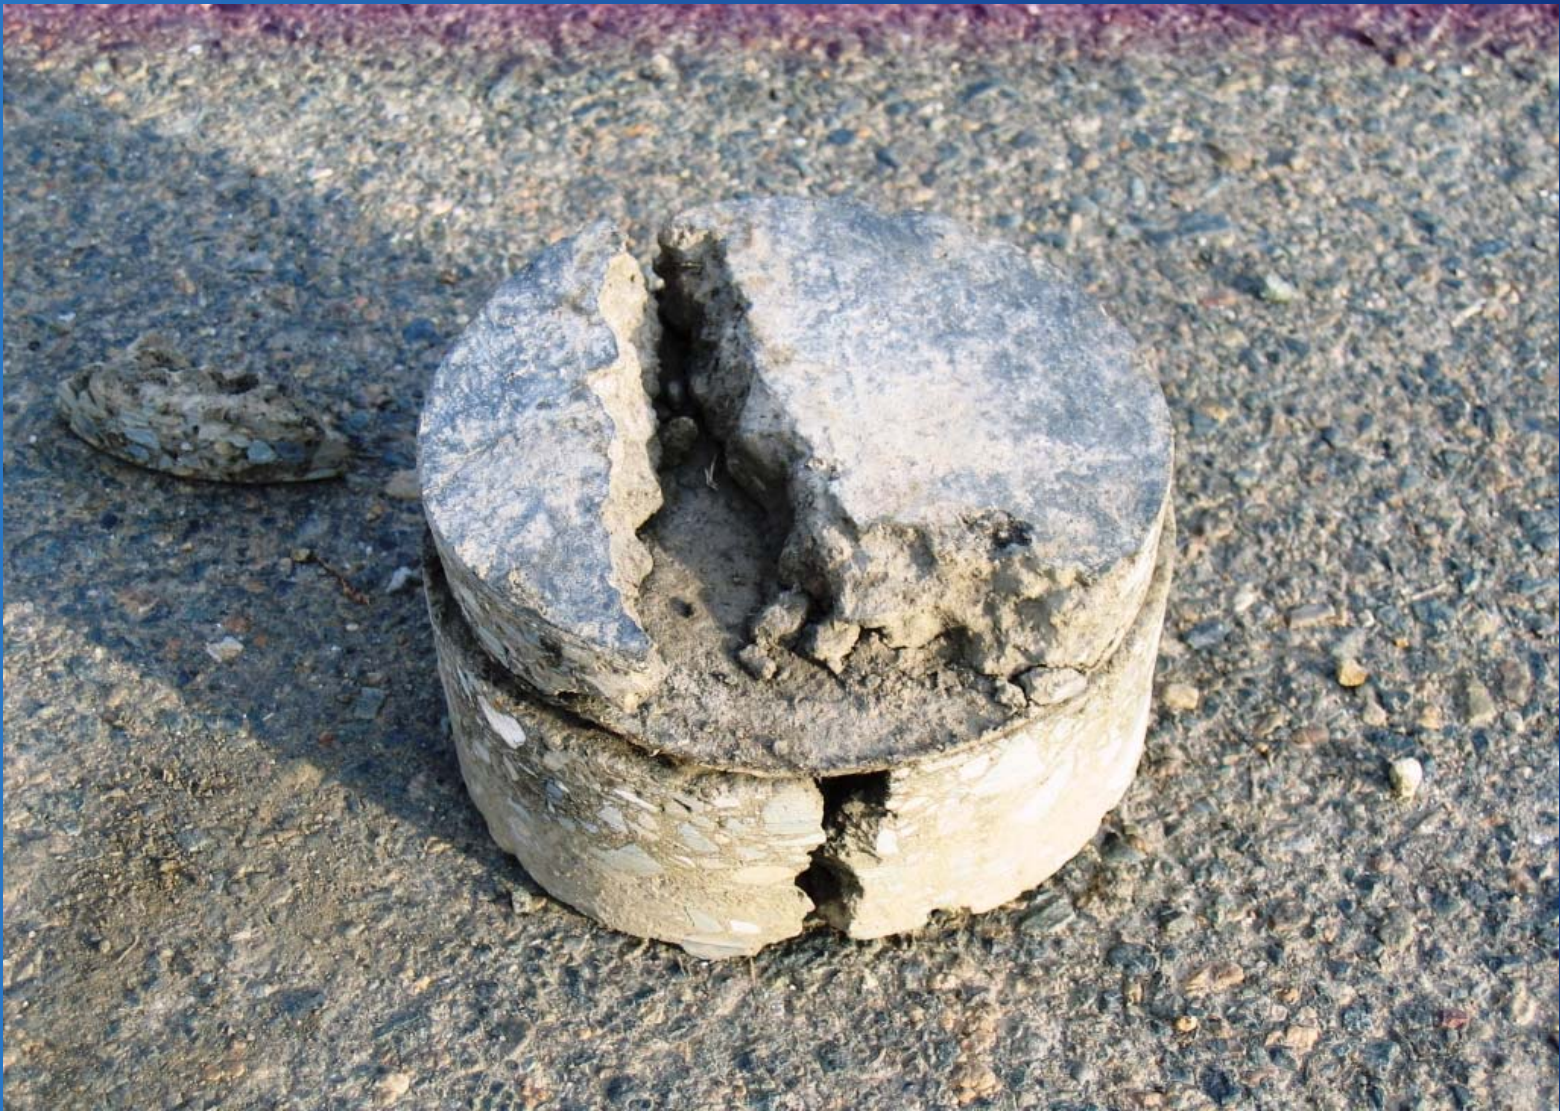
## Overlay on Fabric after 8 years

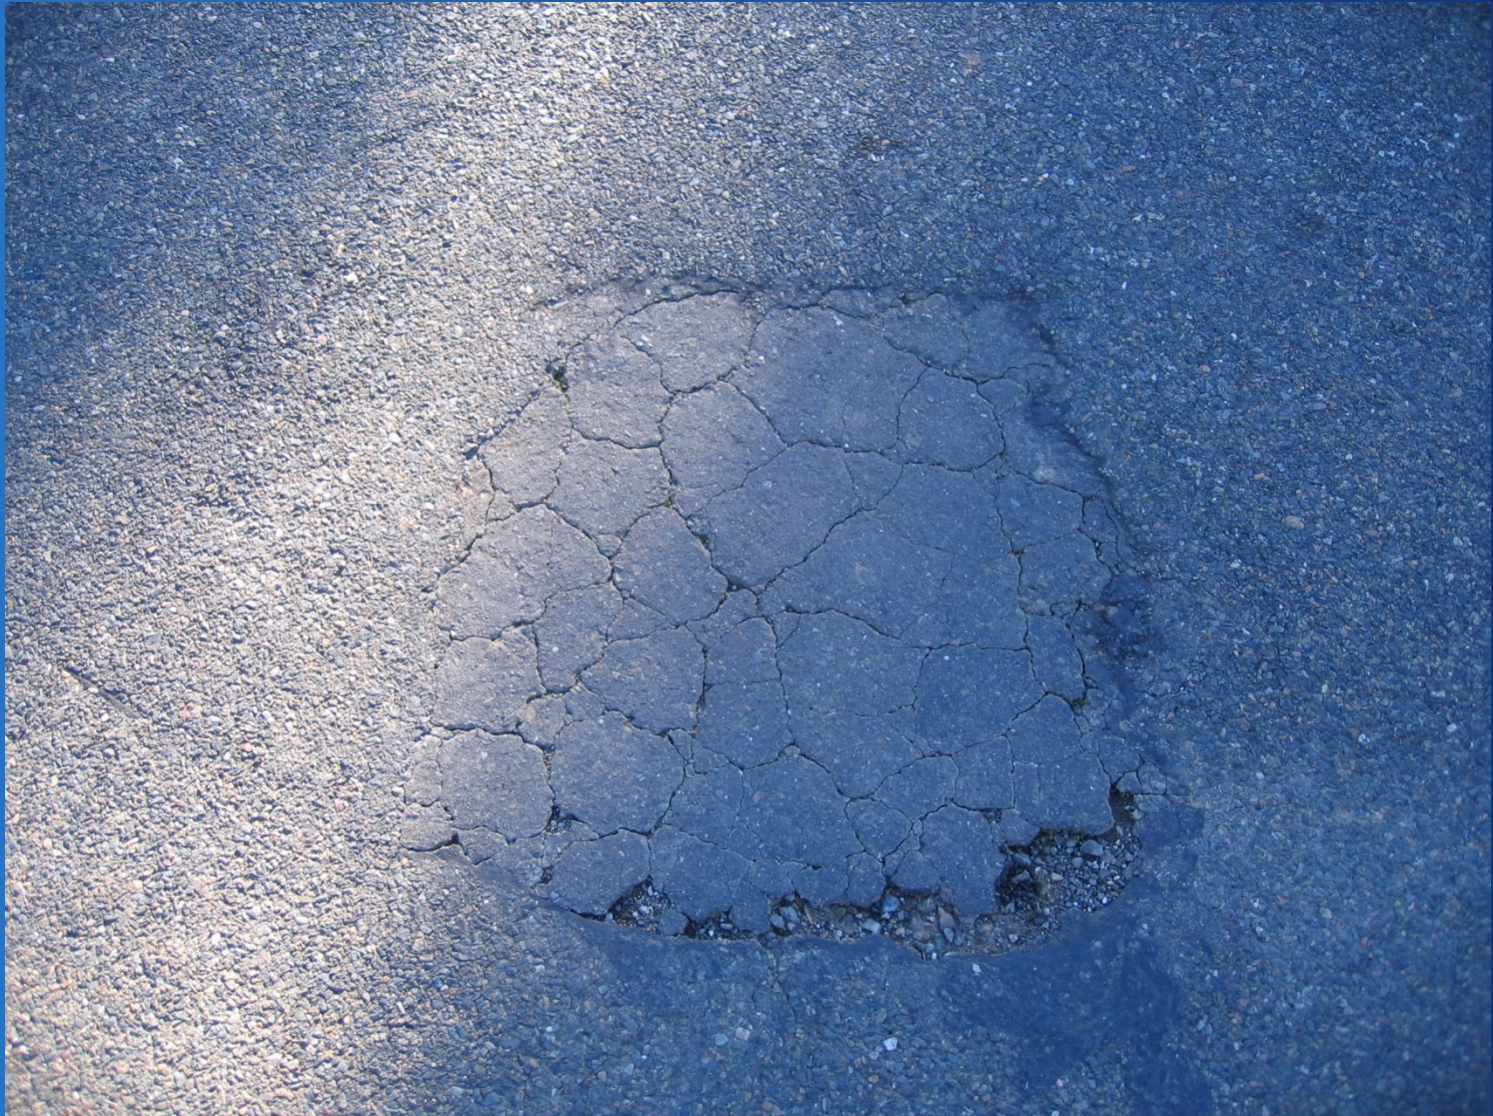
# Underground Spring after 10 Years

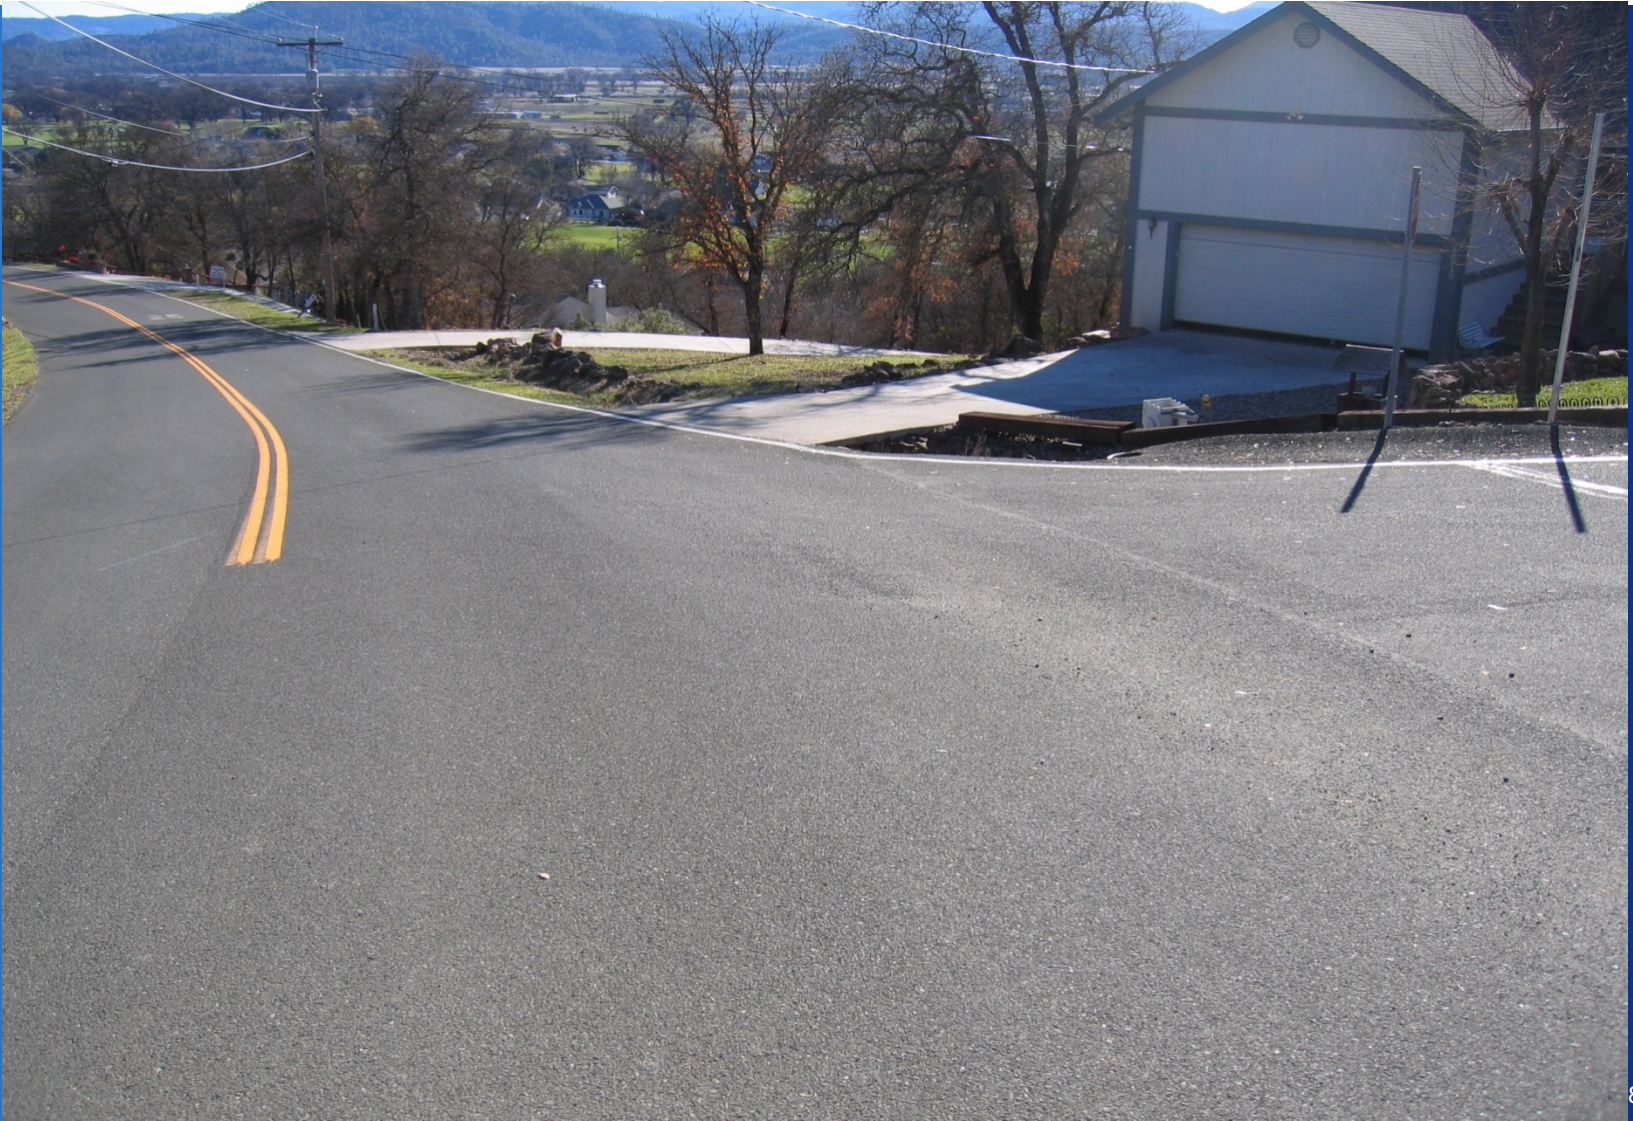
# AC Overlay on GRCS 10 years

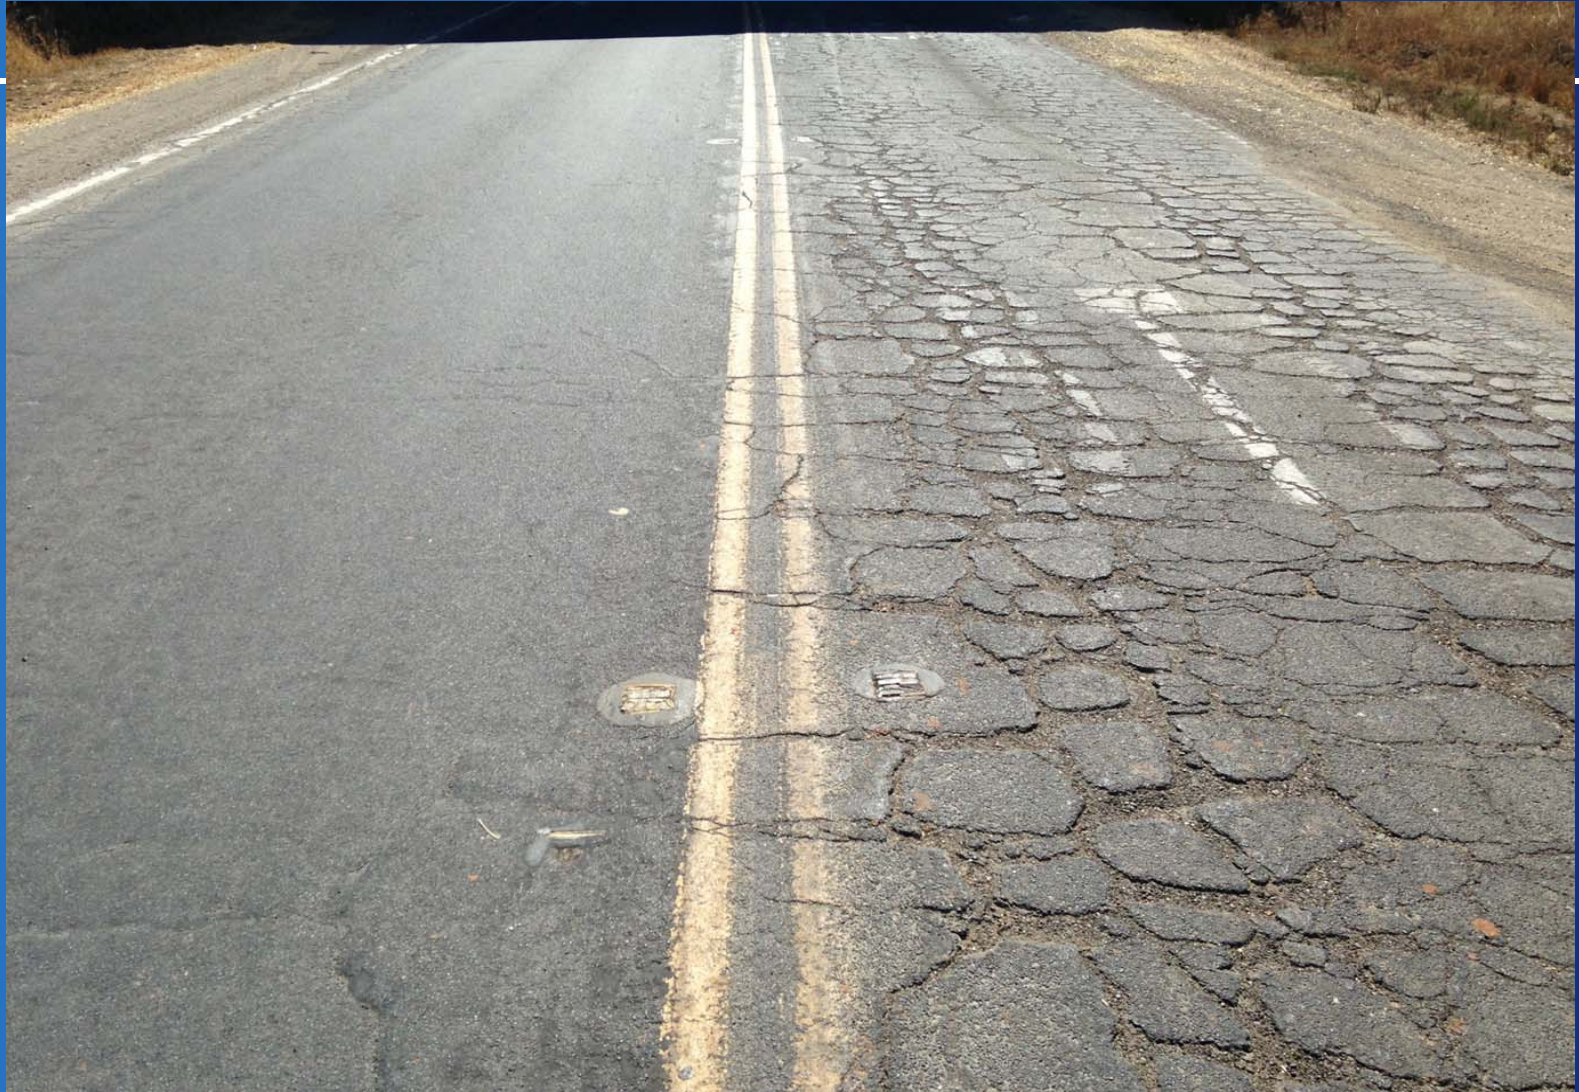
# GRCS-Chip Seal/Fabric – Woodbridge Rd/5 Fwy

Chip with and without Fabric 2005 - 2013 - 8 Yrs.

With Fabric

Without Fabric

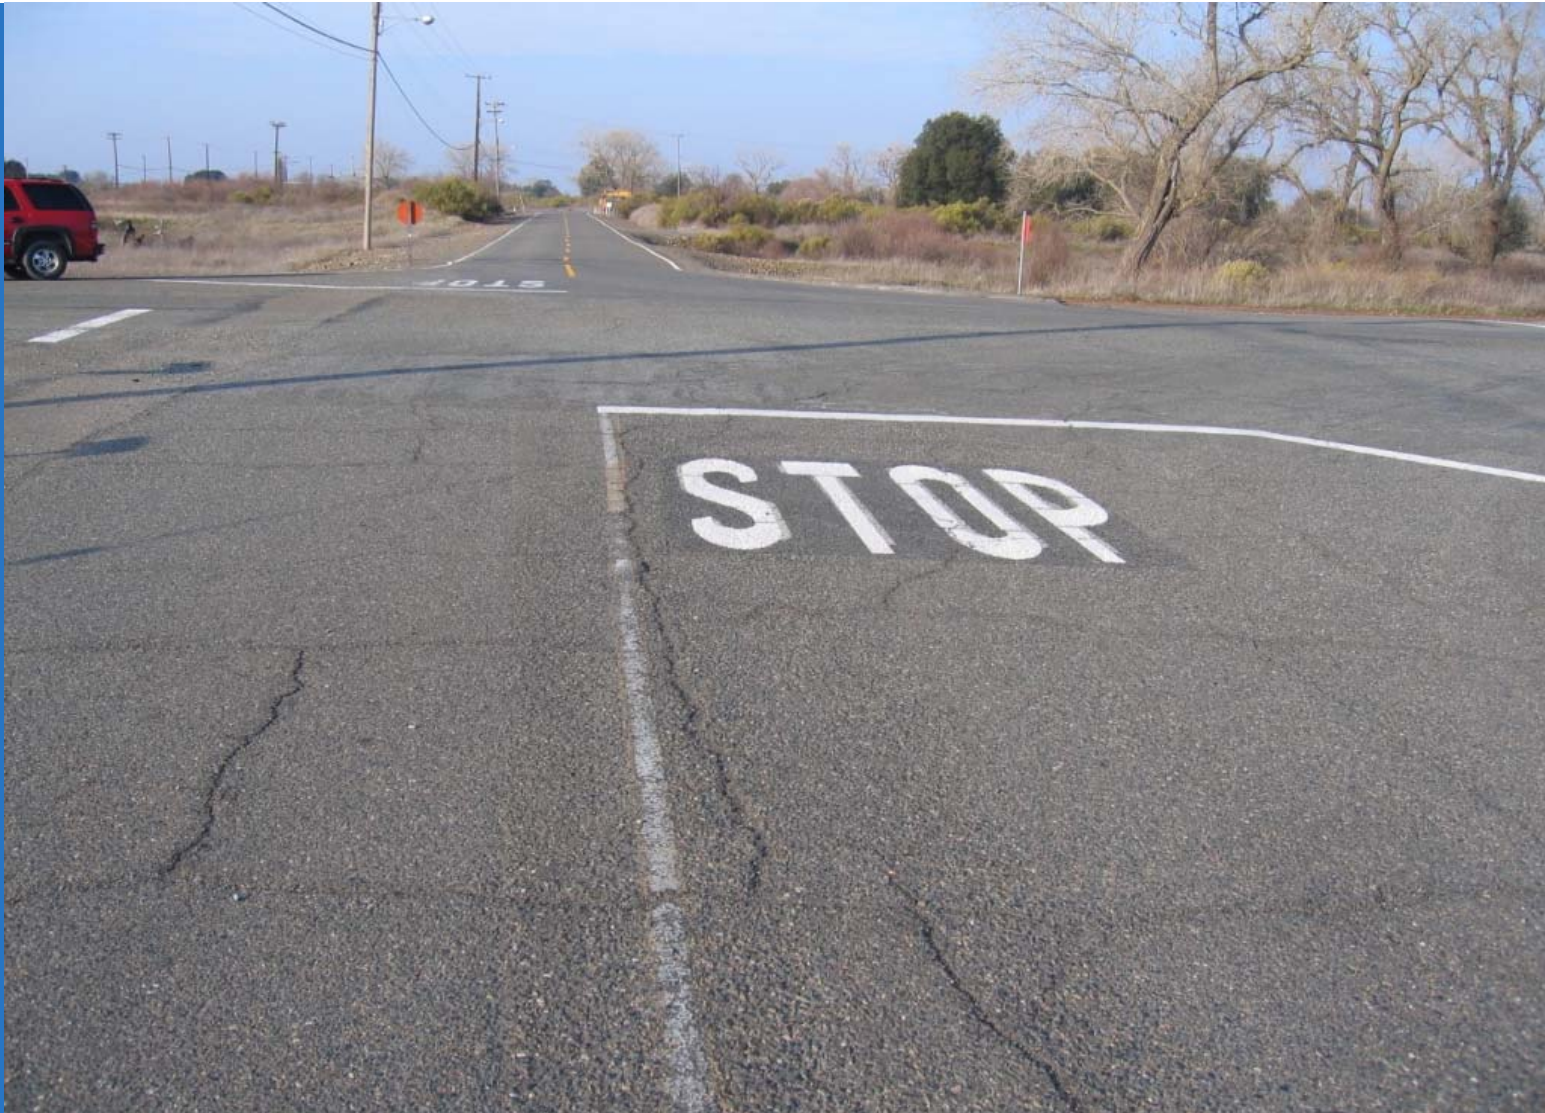
# Aerojet Intersection, GRCS Process Meets AC over Fabric after 20 years

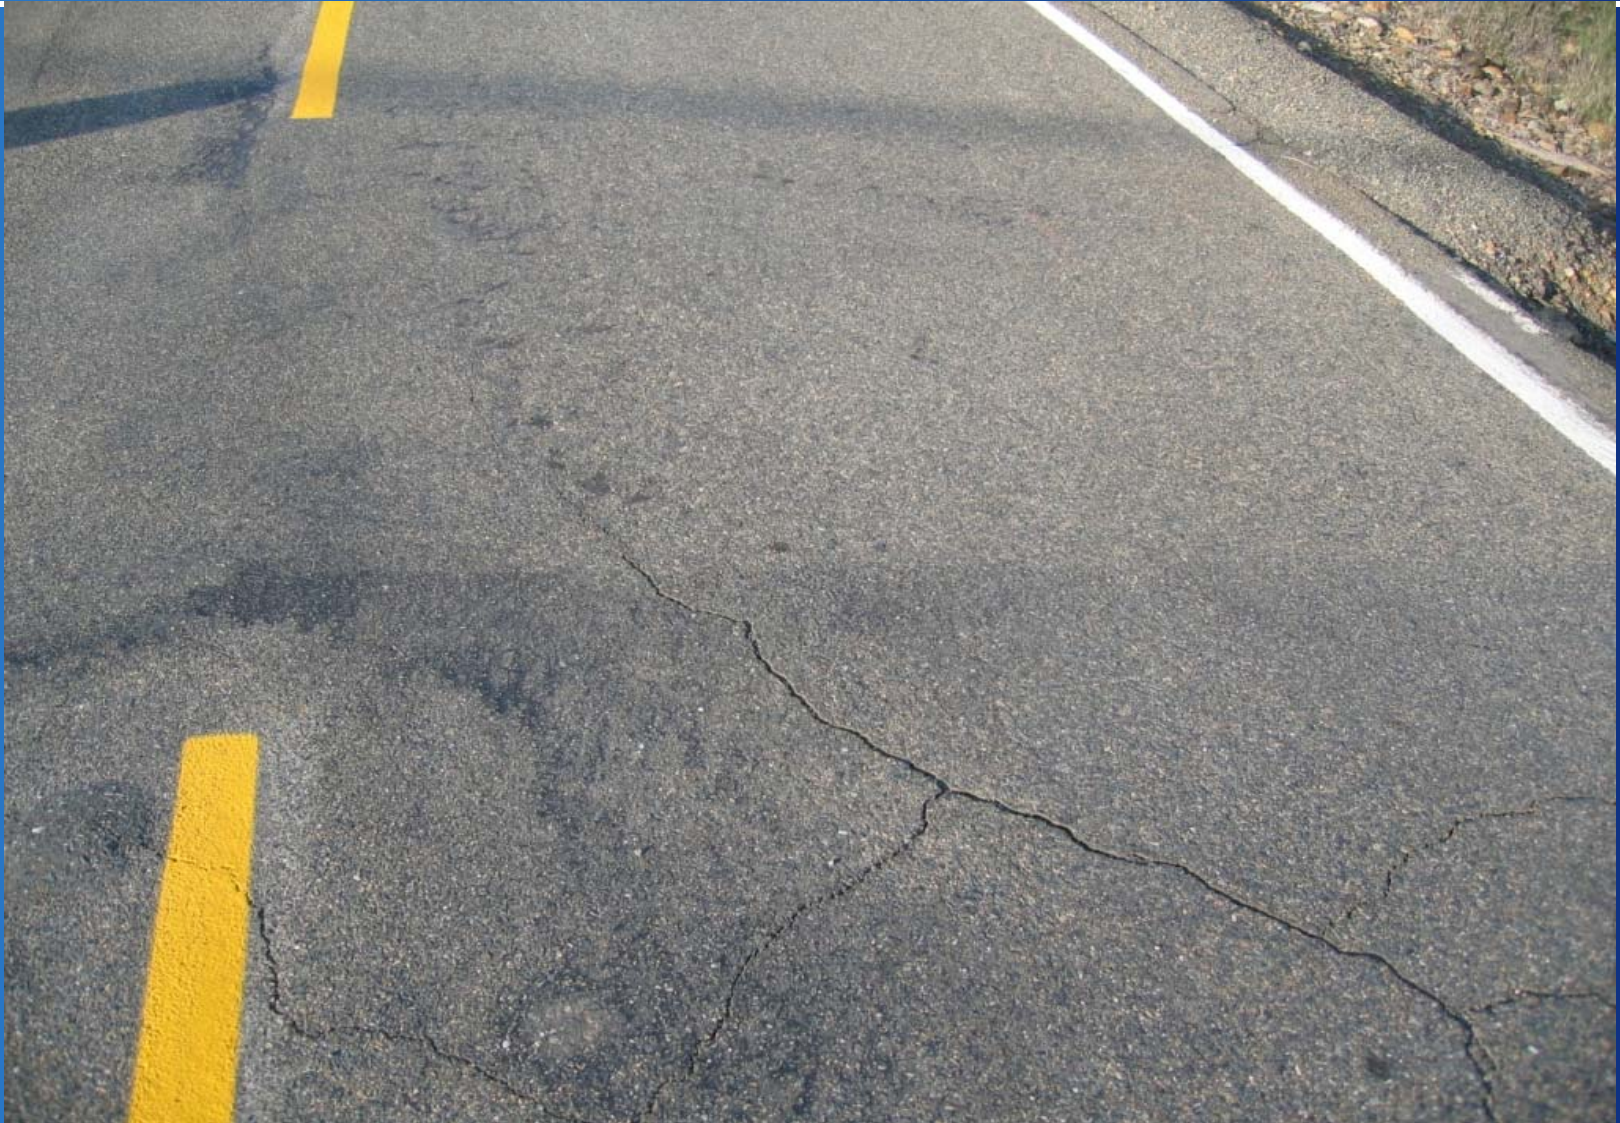
## Where GRCS Stops, 25 years later
