High Friction Surface Treatment (HFST)

The use of High Friction Surface Treatments to Improve Safety on Horizontal Curves

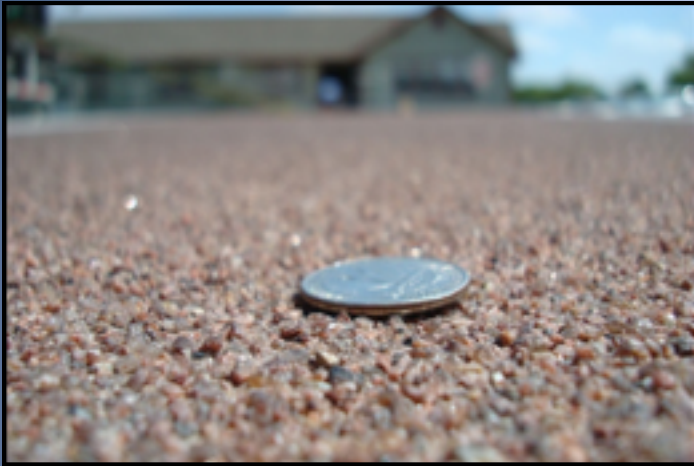
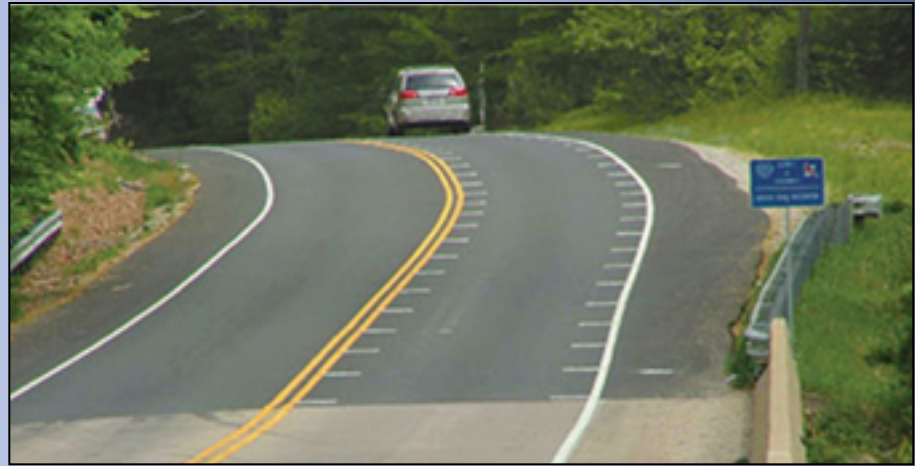
What is a High Friction Surface Treatment?

These are pavement surface treatment systems that are composed of "tough" polish-resistant, abrasion-resistant aggregates bonded to the pavement surface using a resin.

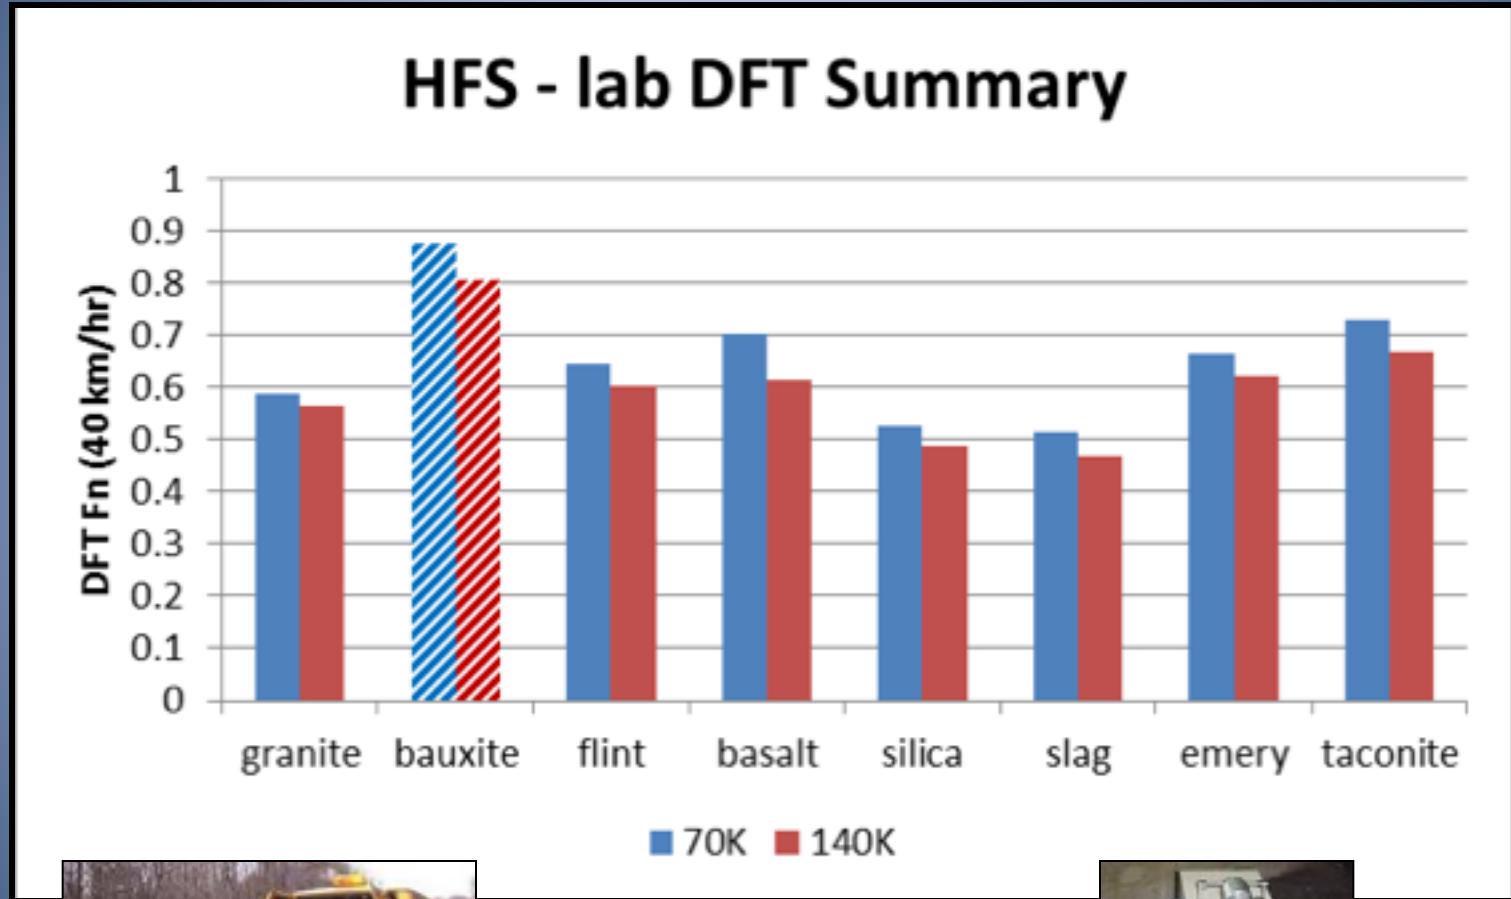
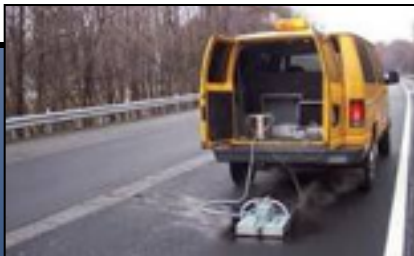
Early NCAT Testing of HFST Aggregates

Dynamic Friction Tester
ASTM E-1911

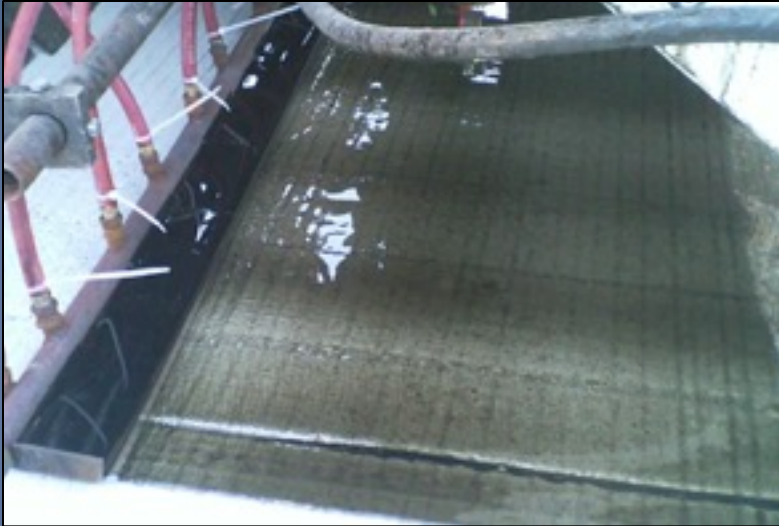
A high friction surface treatment installed with automated application equipment

- Does not require any manual work
- Mixes, monitors and installs an exact volume of polymer resin and cover aggregate enclosed in one mobile unit
- Installs at 12 foot full lane widths at 26 linear feet per minute
- Will install up to 2600 sy² per hour before requiring to be refilled

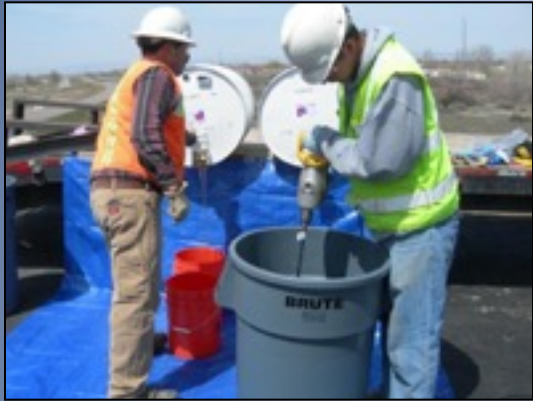
Hand Mixing

- Ratio - Visual
- Time - Timer
- Temperature - Viscosity
- Mixer – Jiffy Style

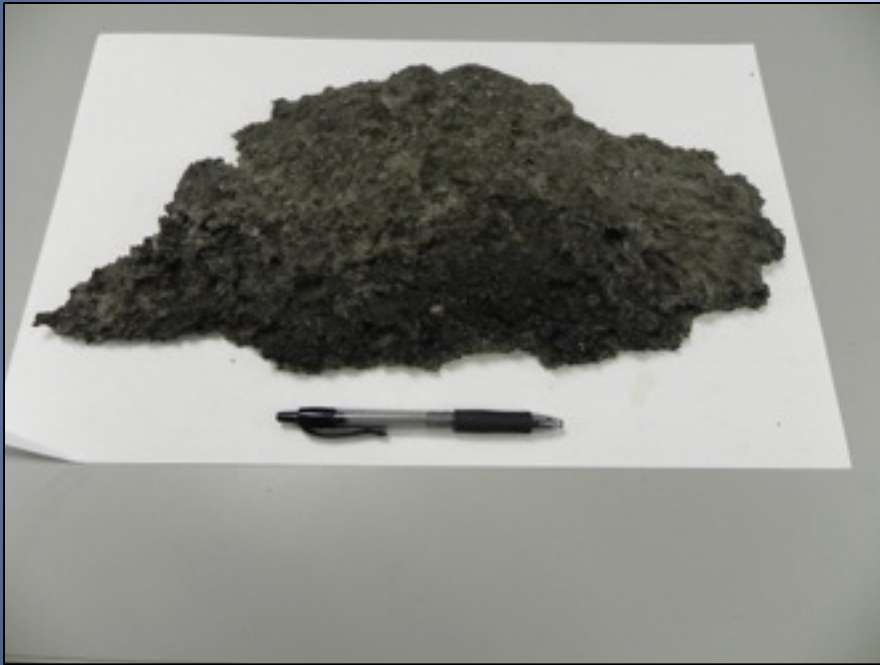
Stresses induced in a weak asphalt pavement may result in this type of delamination

Why is a sound substrate important?
