Performance of Recycled Asphalt Pavement (RAP) in Gravel Roads

2015 Northwest Pavement Management Association Conference

Josh Jones

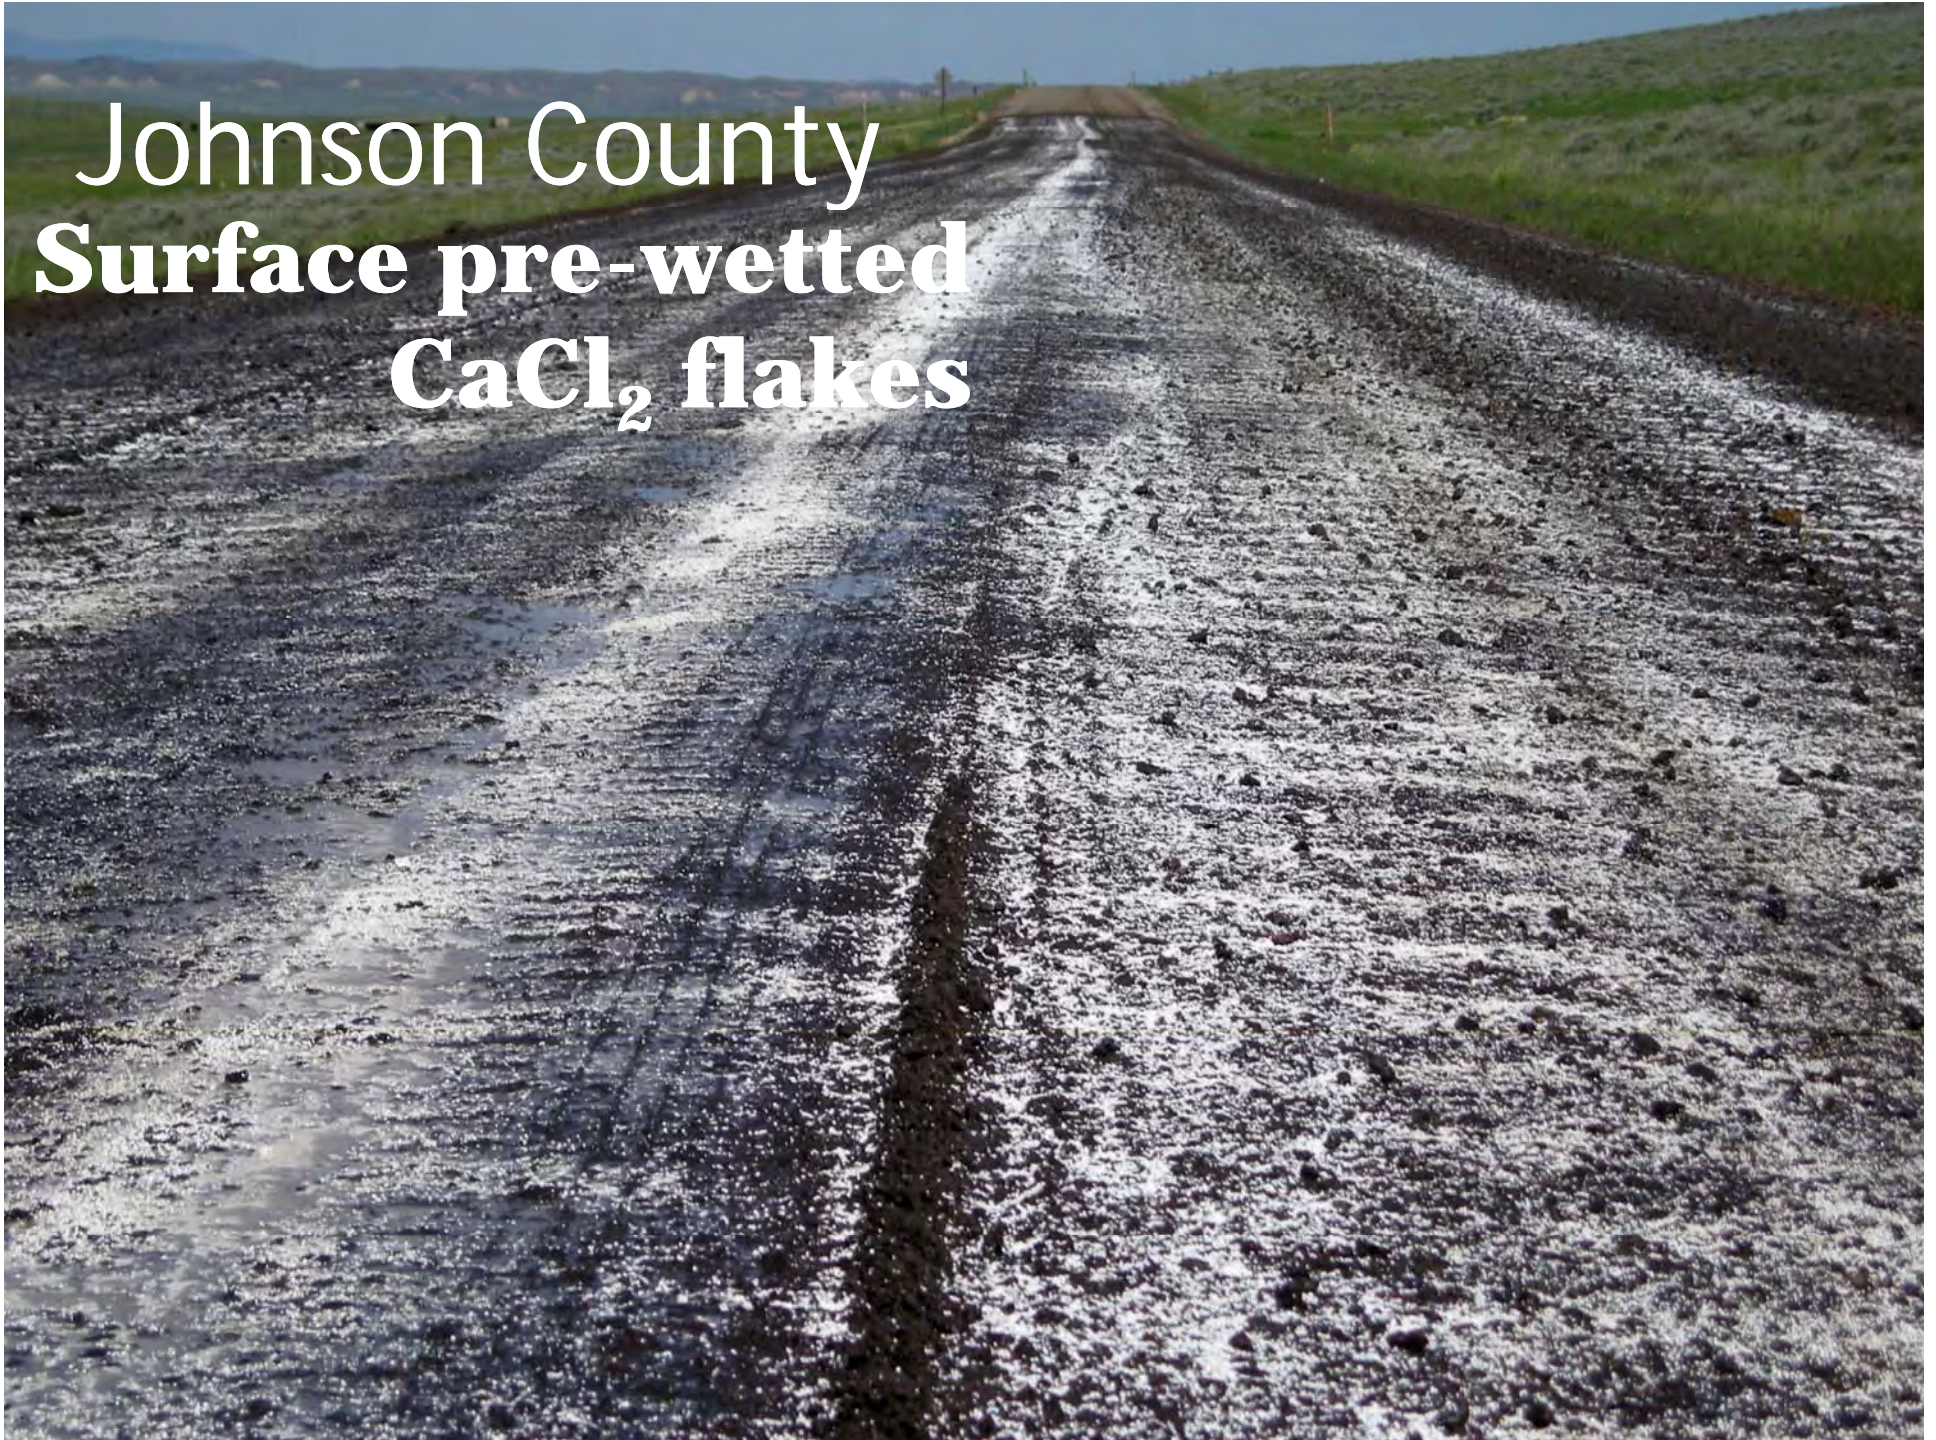
**Surface pre-wetted
CaCl₂ flakes**

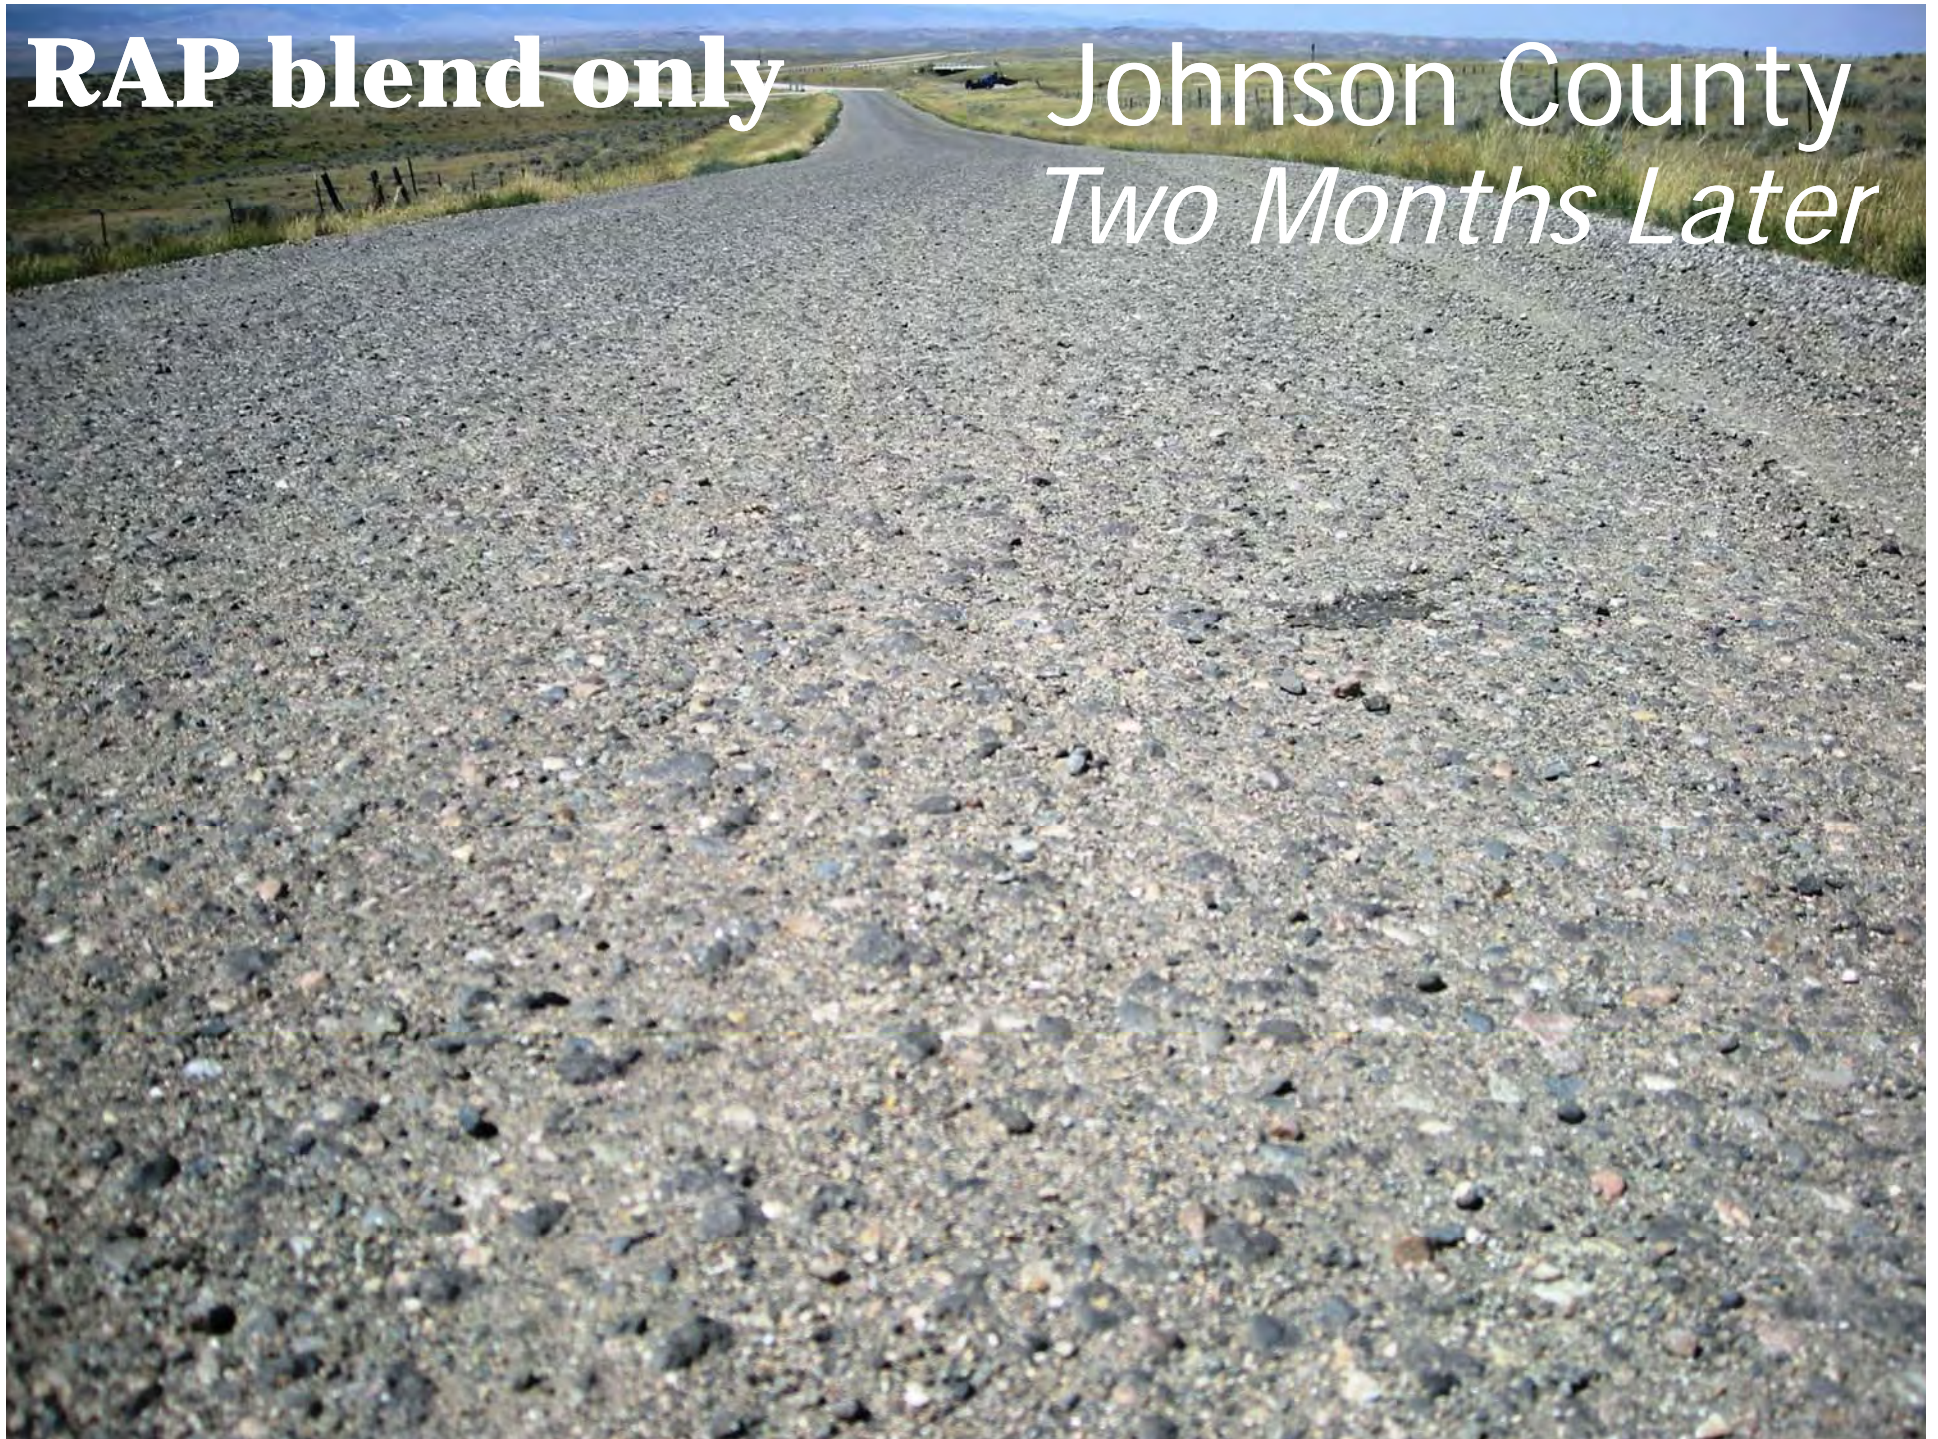
RAP blend with CaCl_2

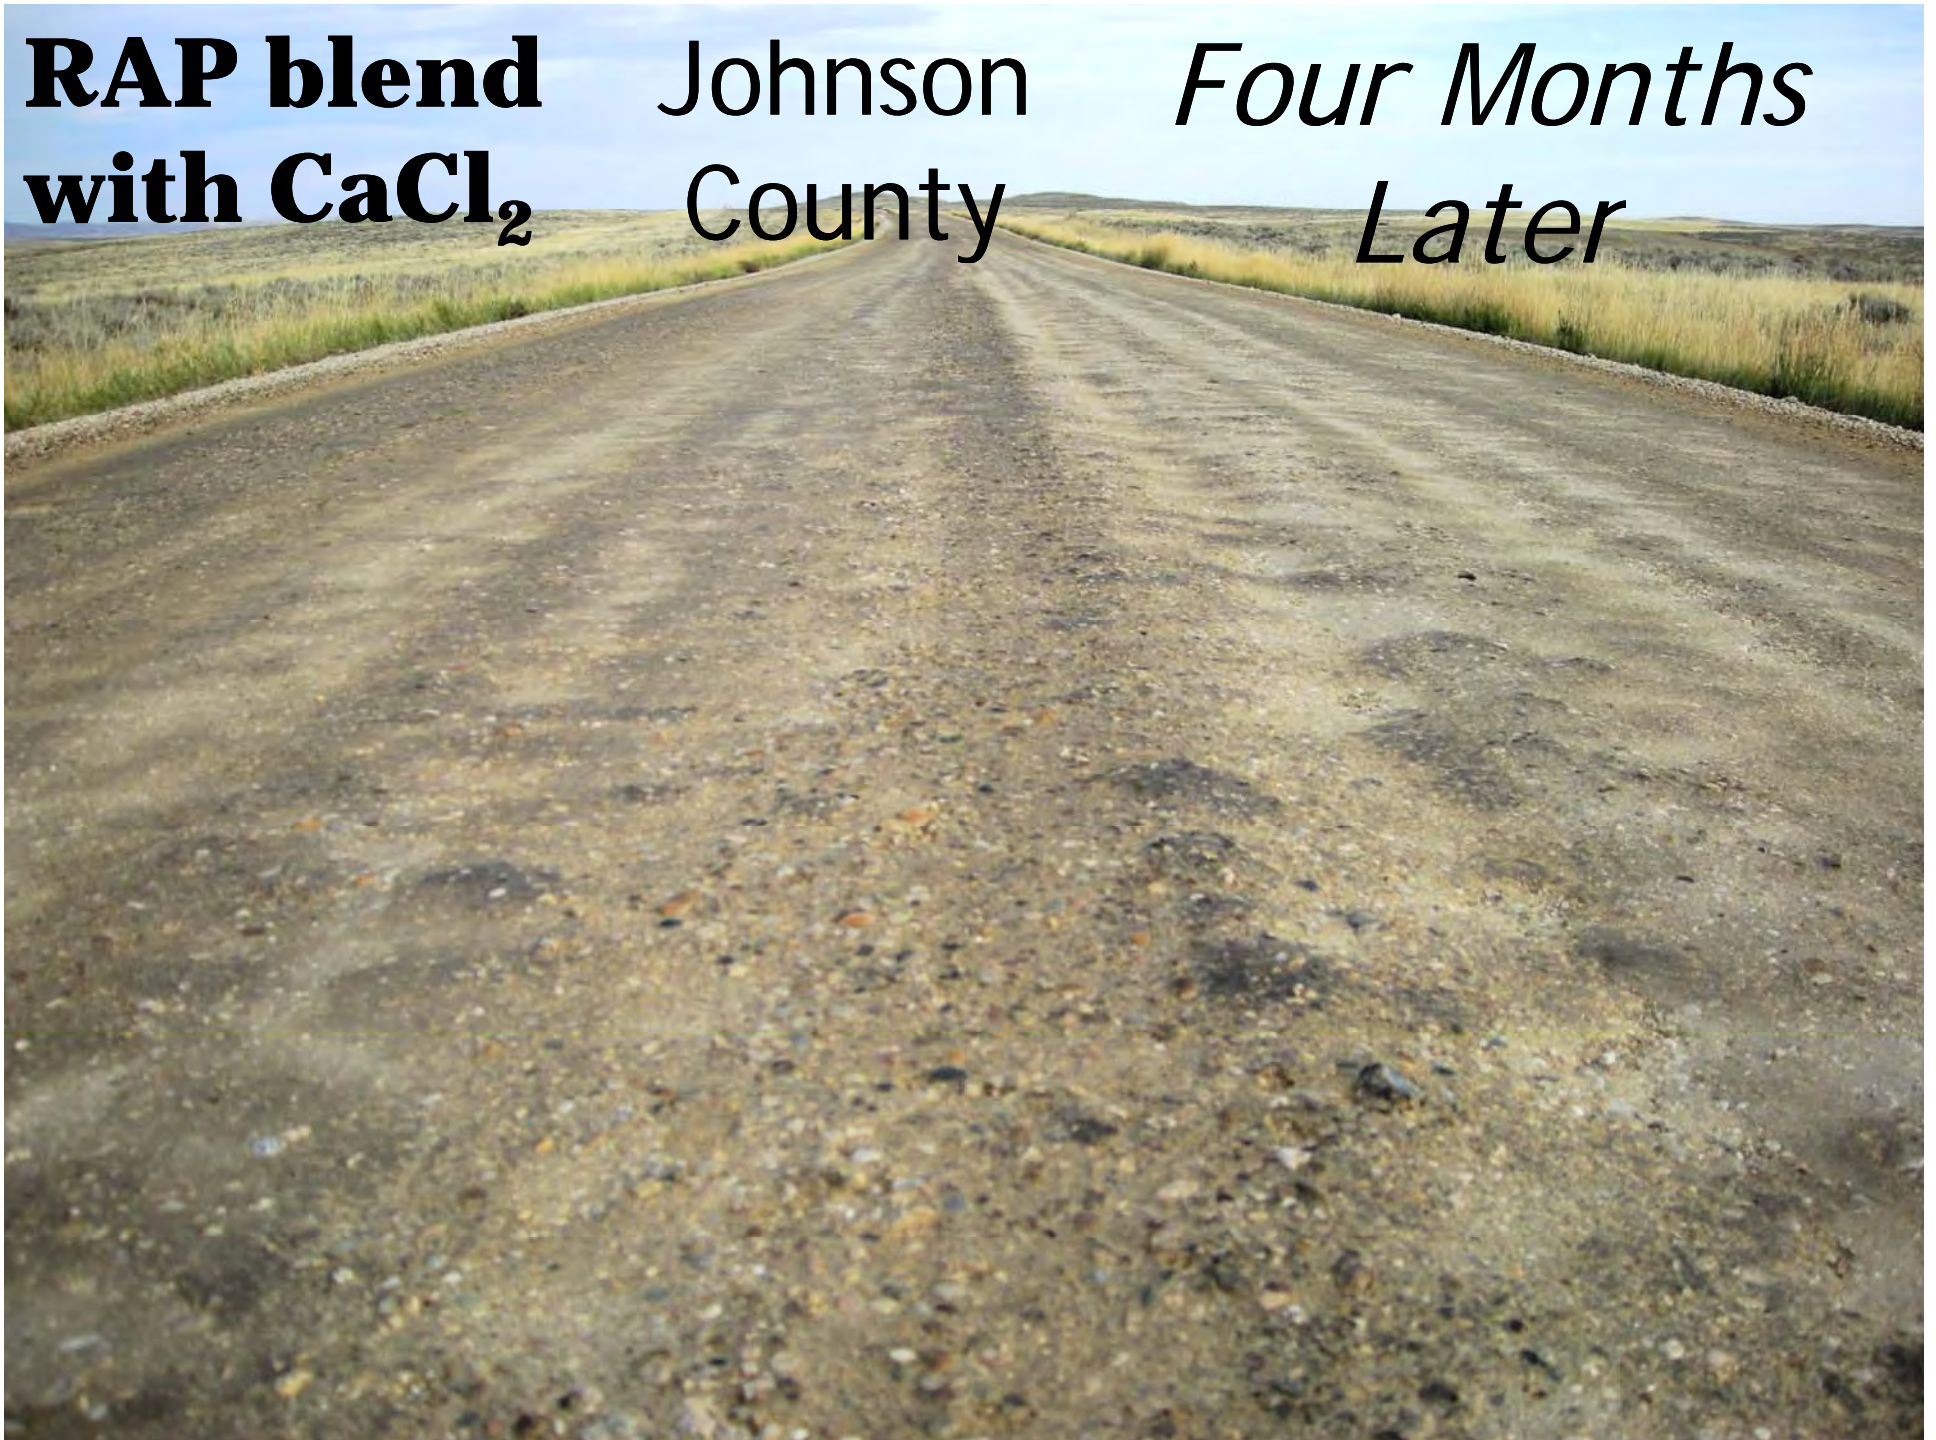
RAP blend only

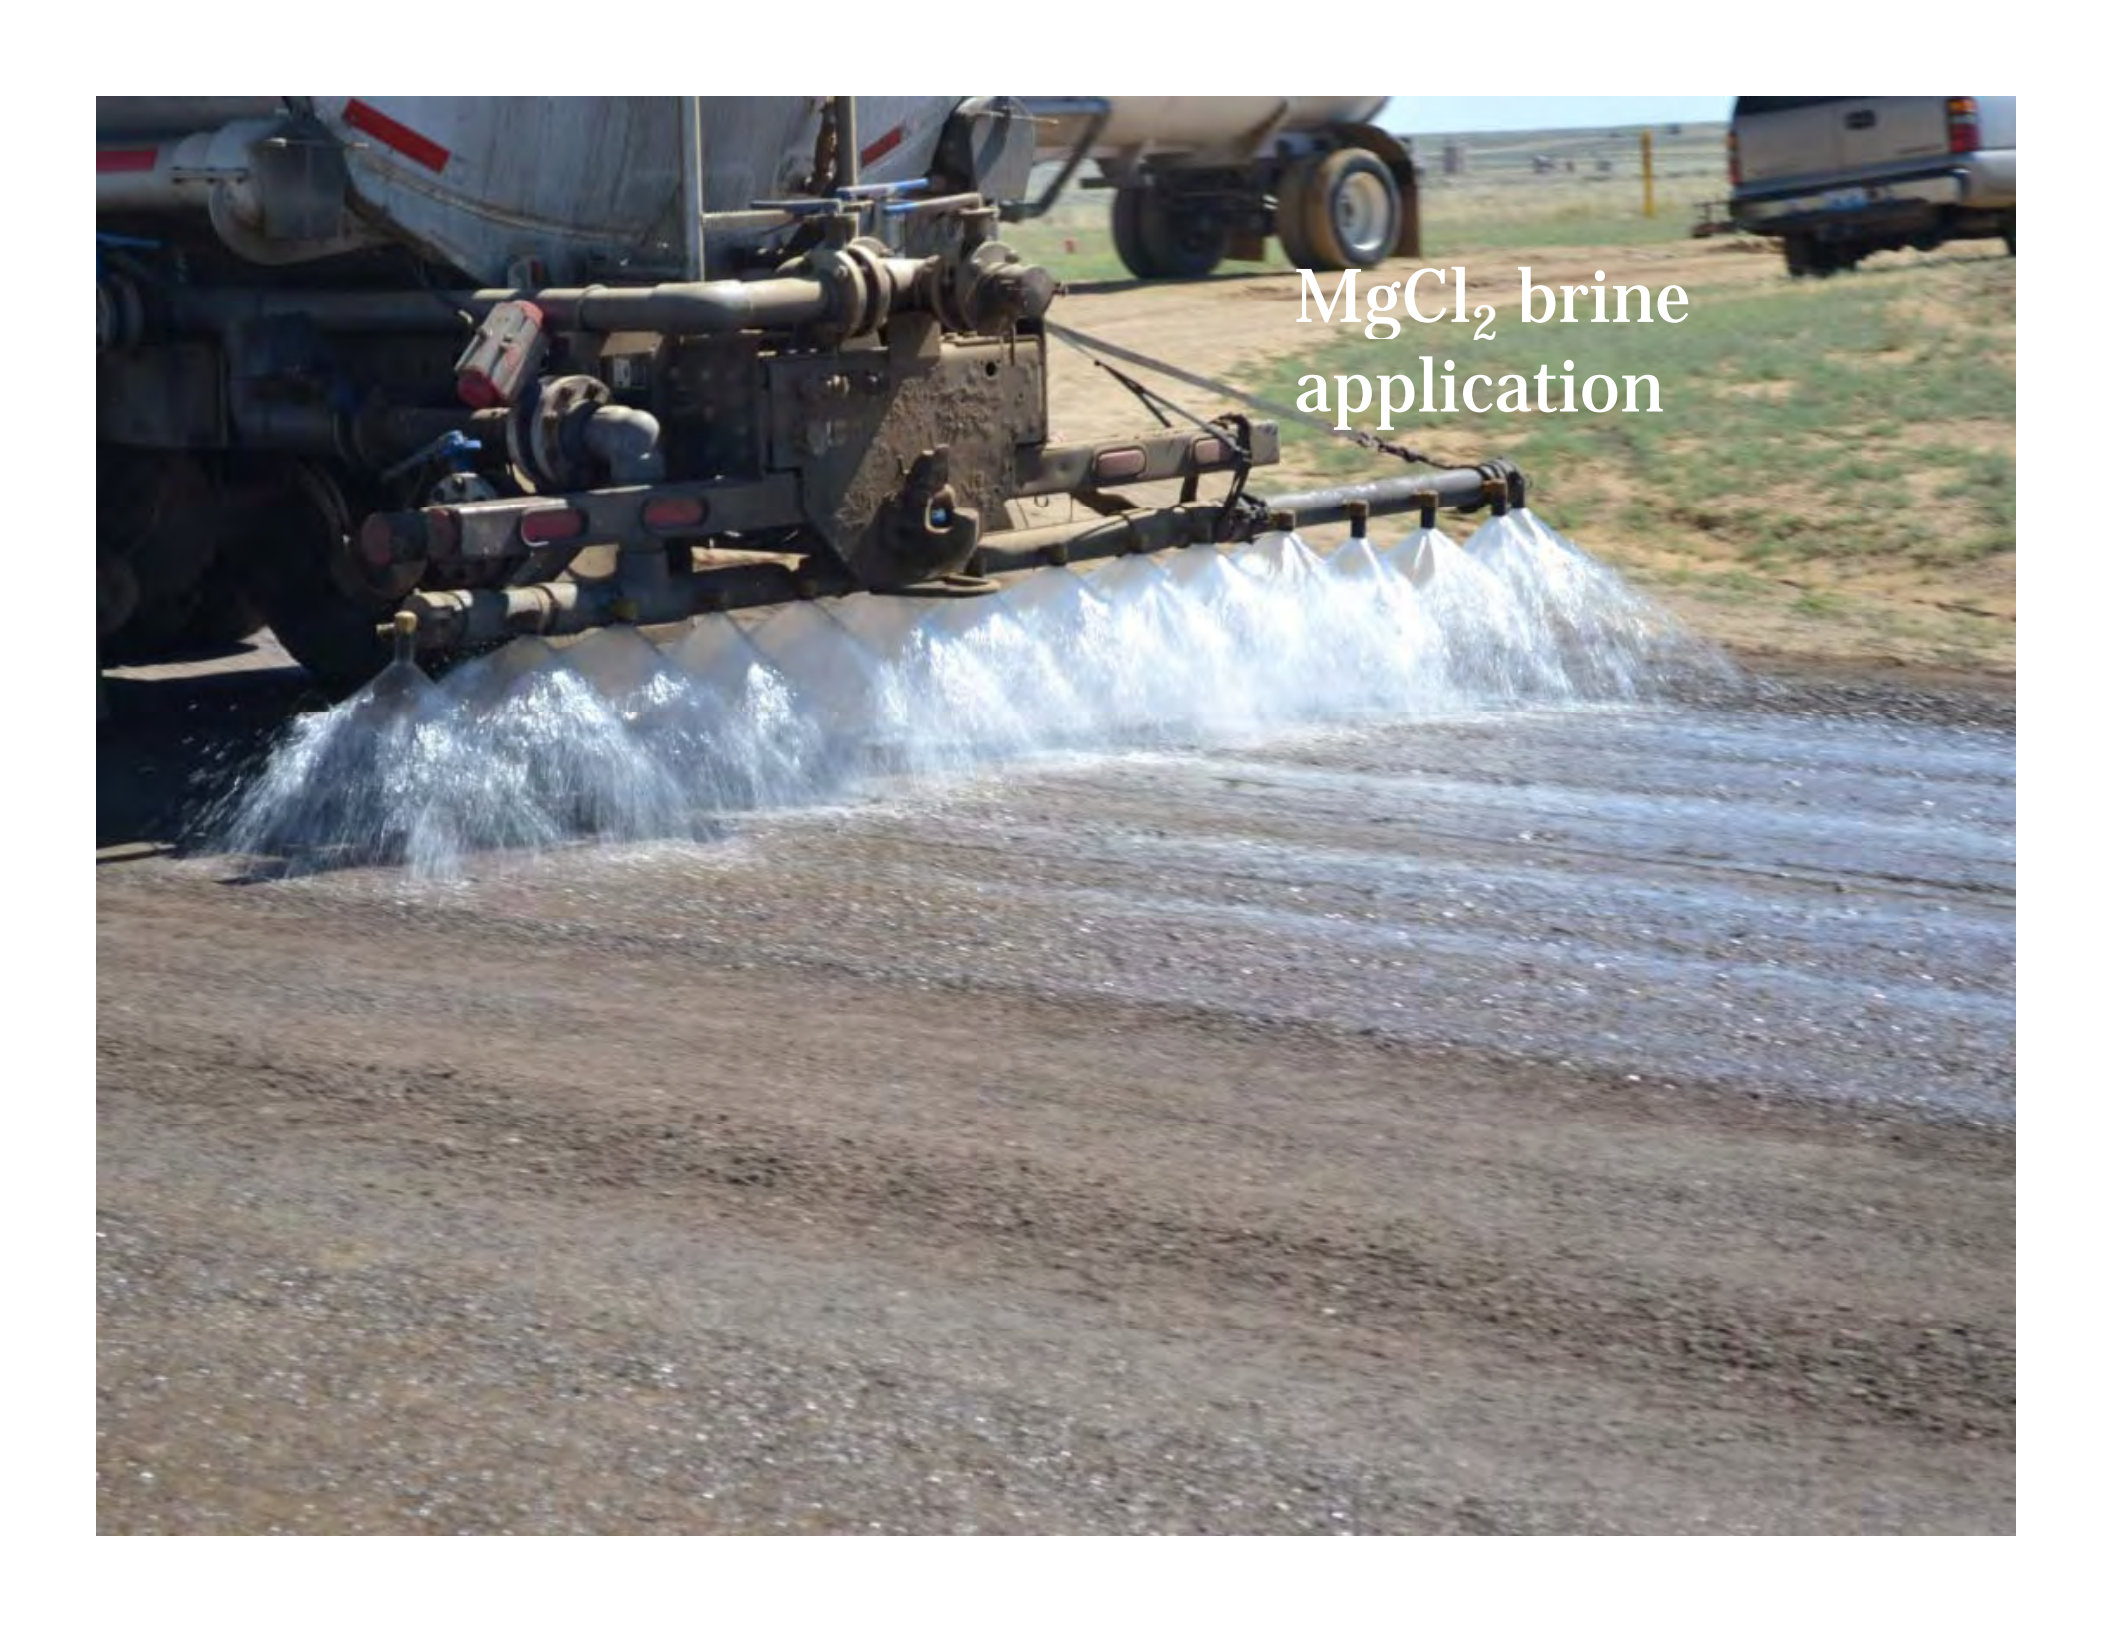
A large truck is shown from a side-rear perspective, equipped with a long spray bar. Multiple nozzles along the bar are spraying a white, foamy liquid onto a dark gravel surface. The truck's body is white with red reflective stripes. In the background, another white truck is parked on a dirt area, and the landscape is a flat, open field under a clear sky. The text "MgCl2 brine application" is overlaid in white on the right side of the image.

MgCl₂ brine
application

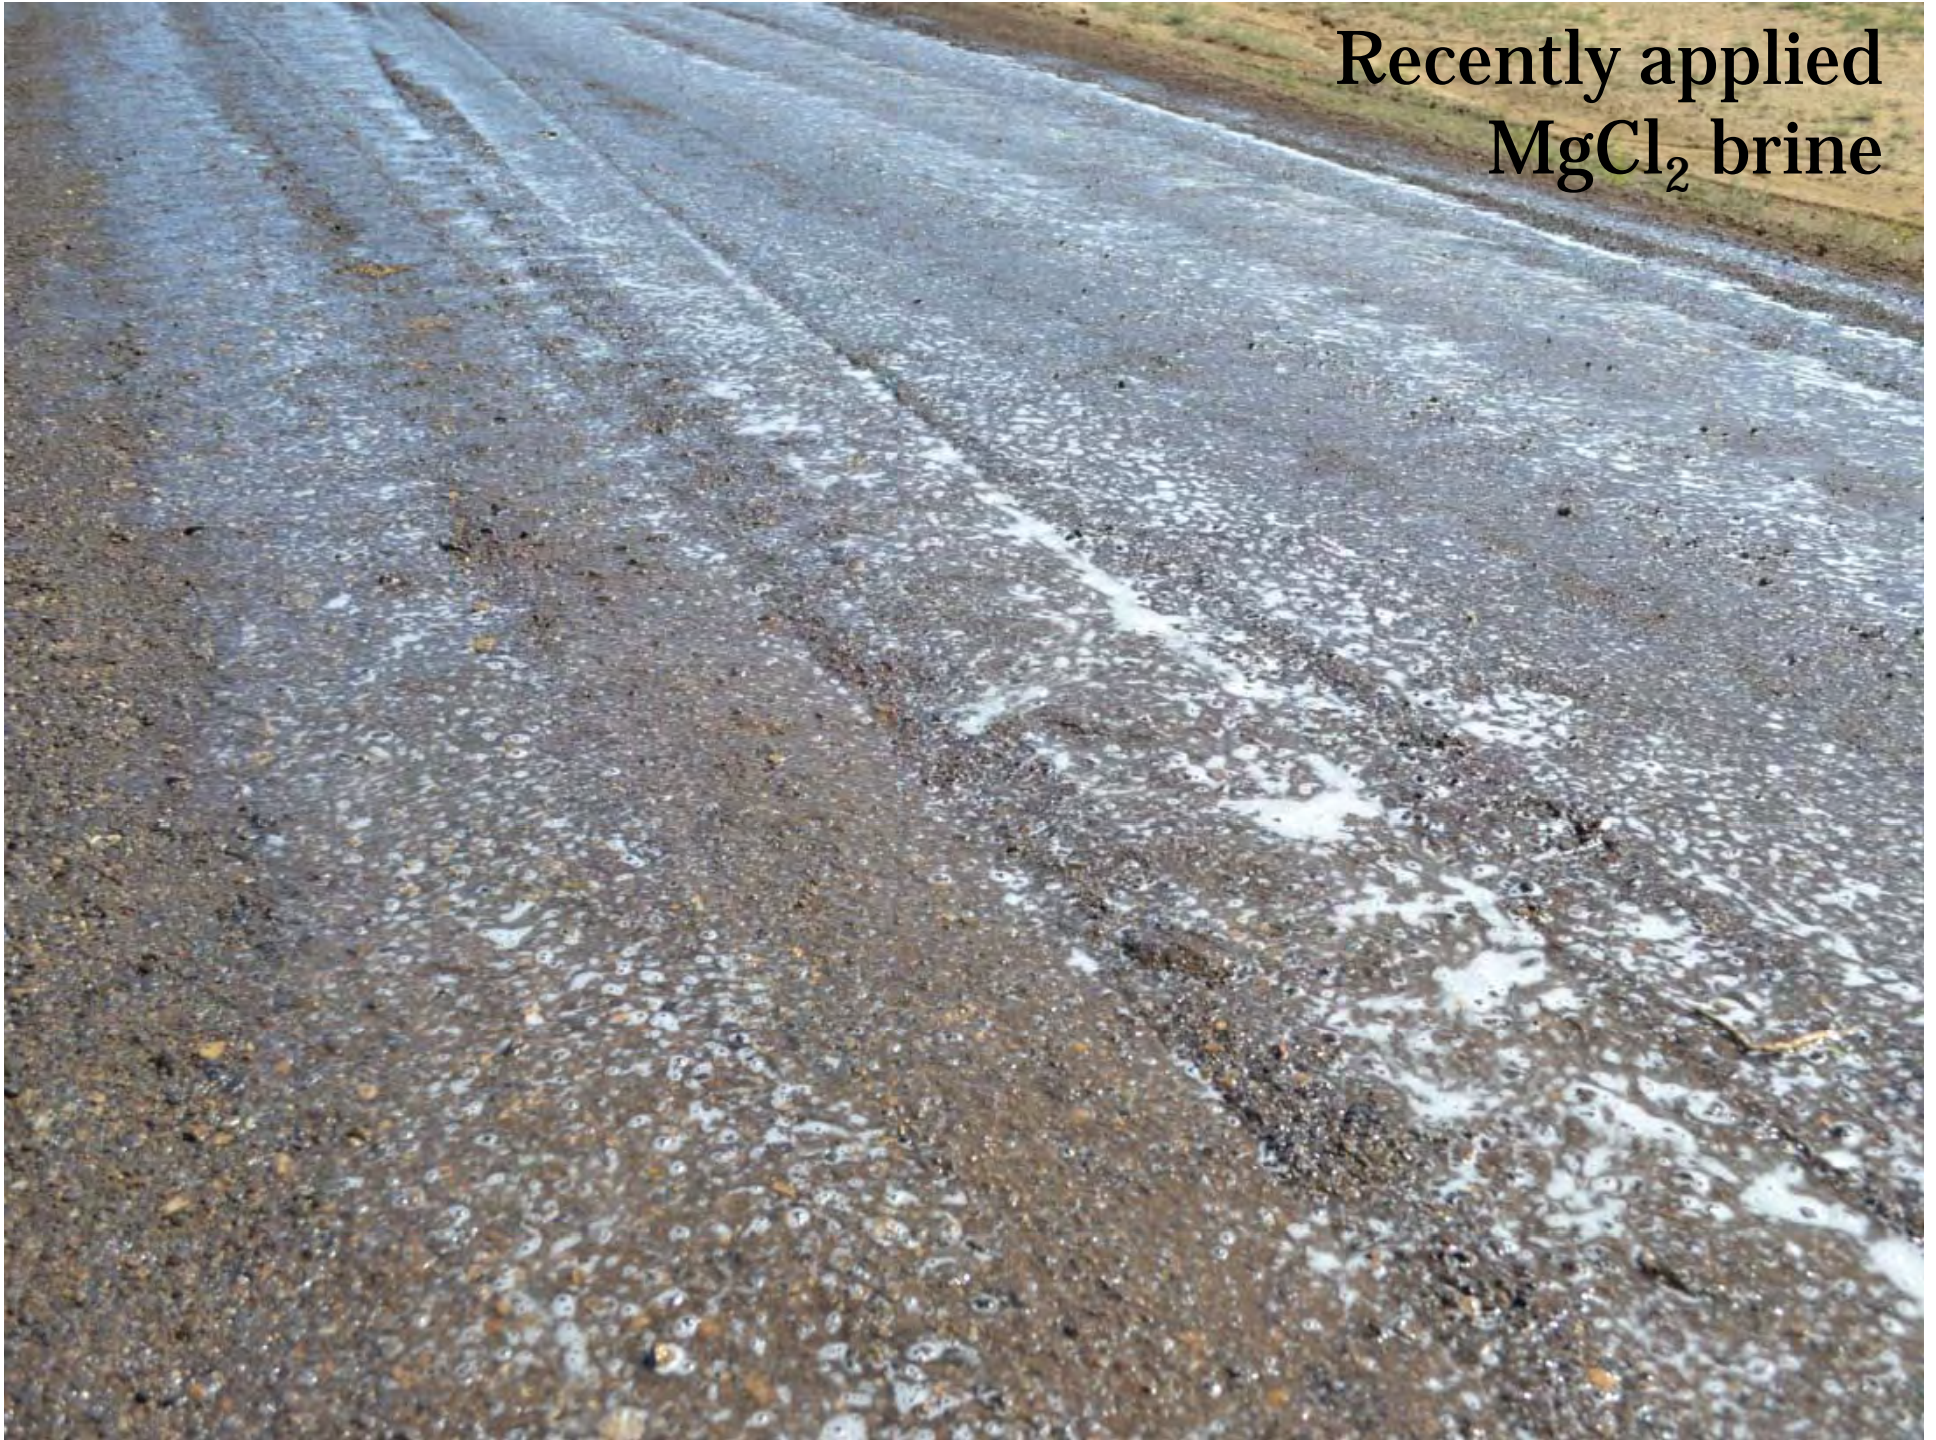
Recently applied
 MgCl_2 brine

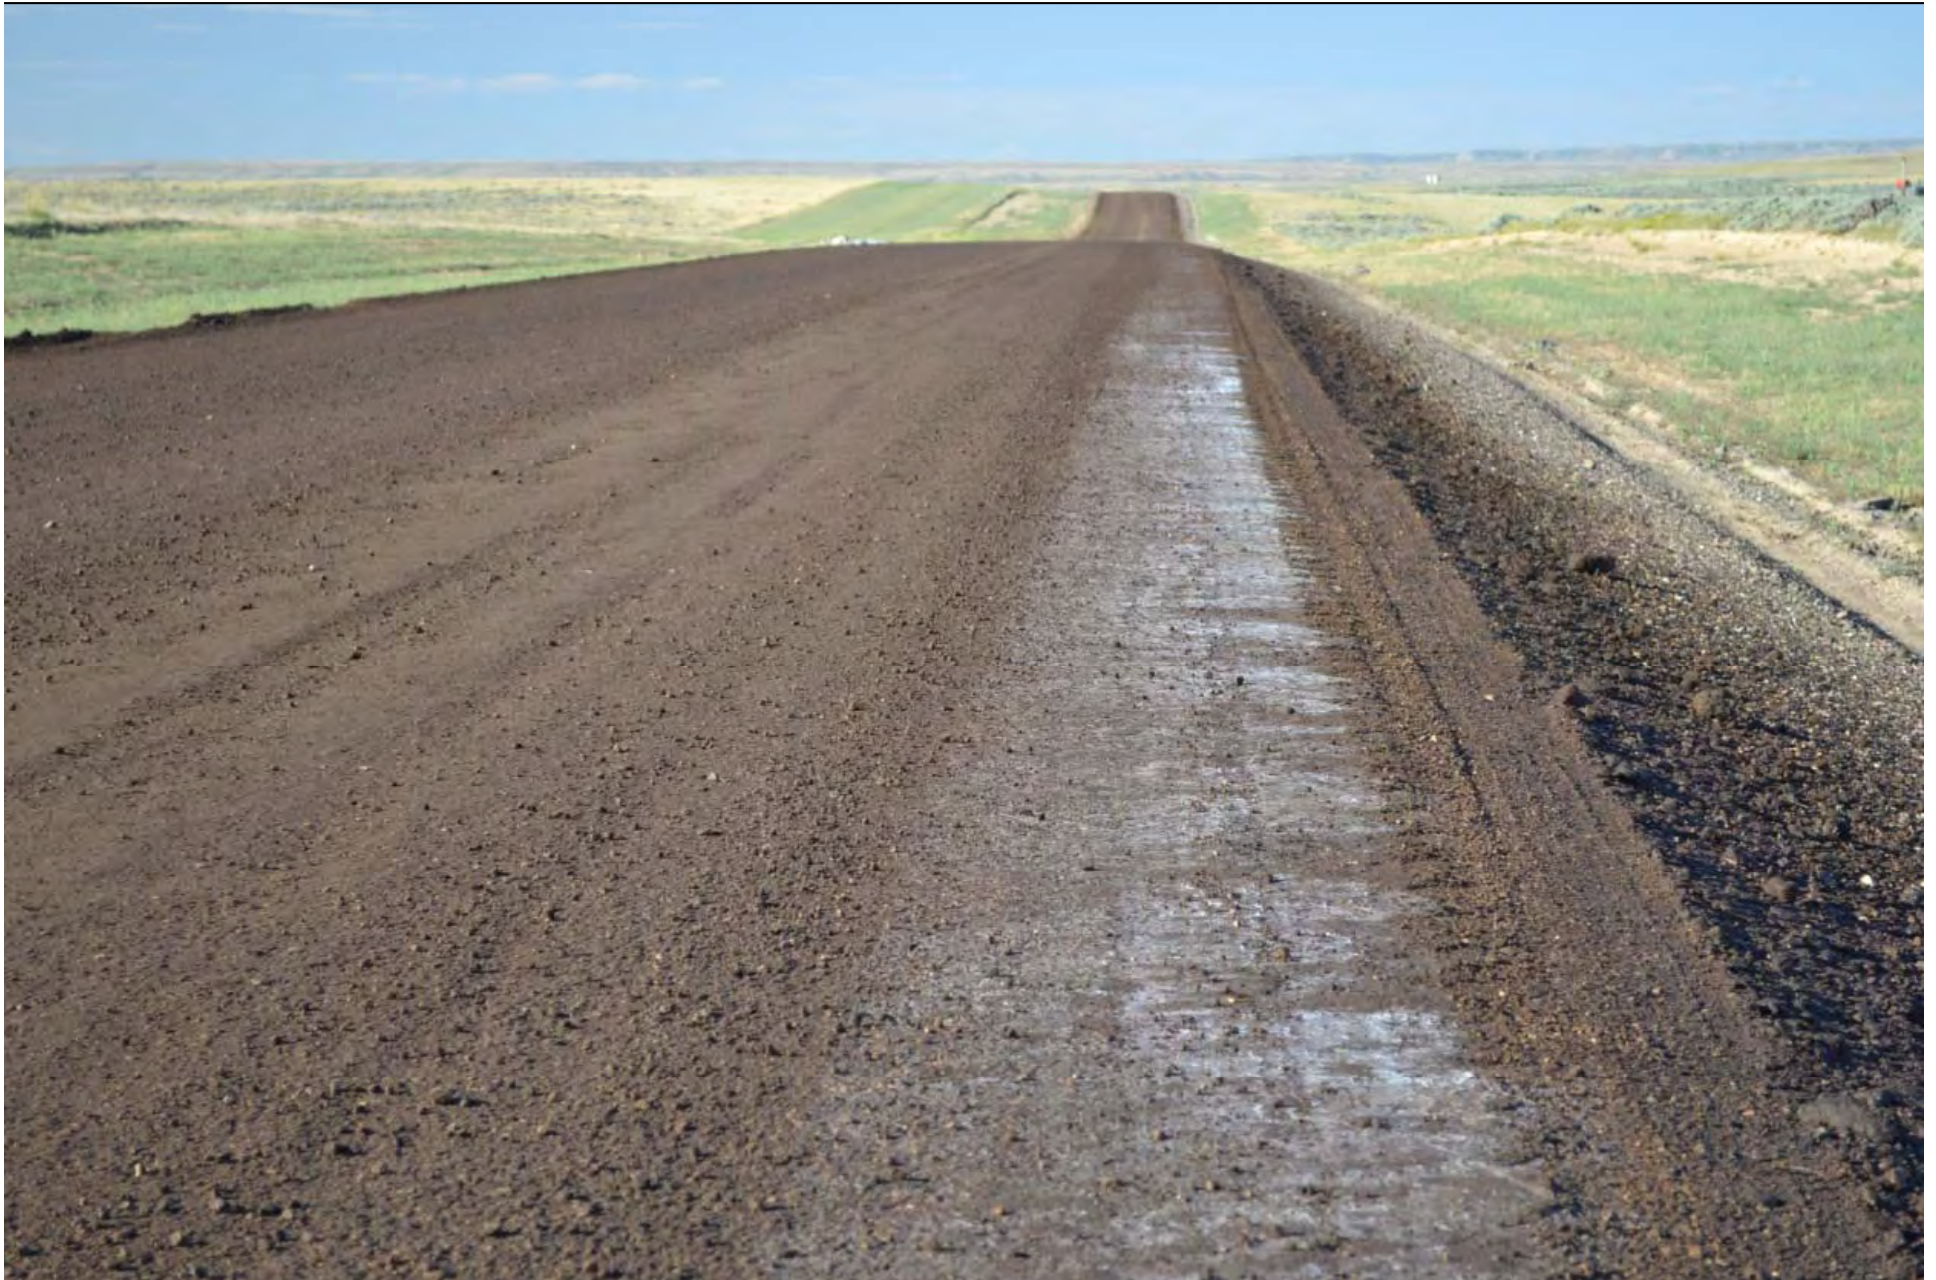
MgCl_2 brine about one hour after application

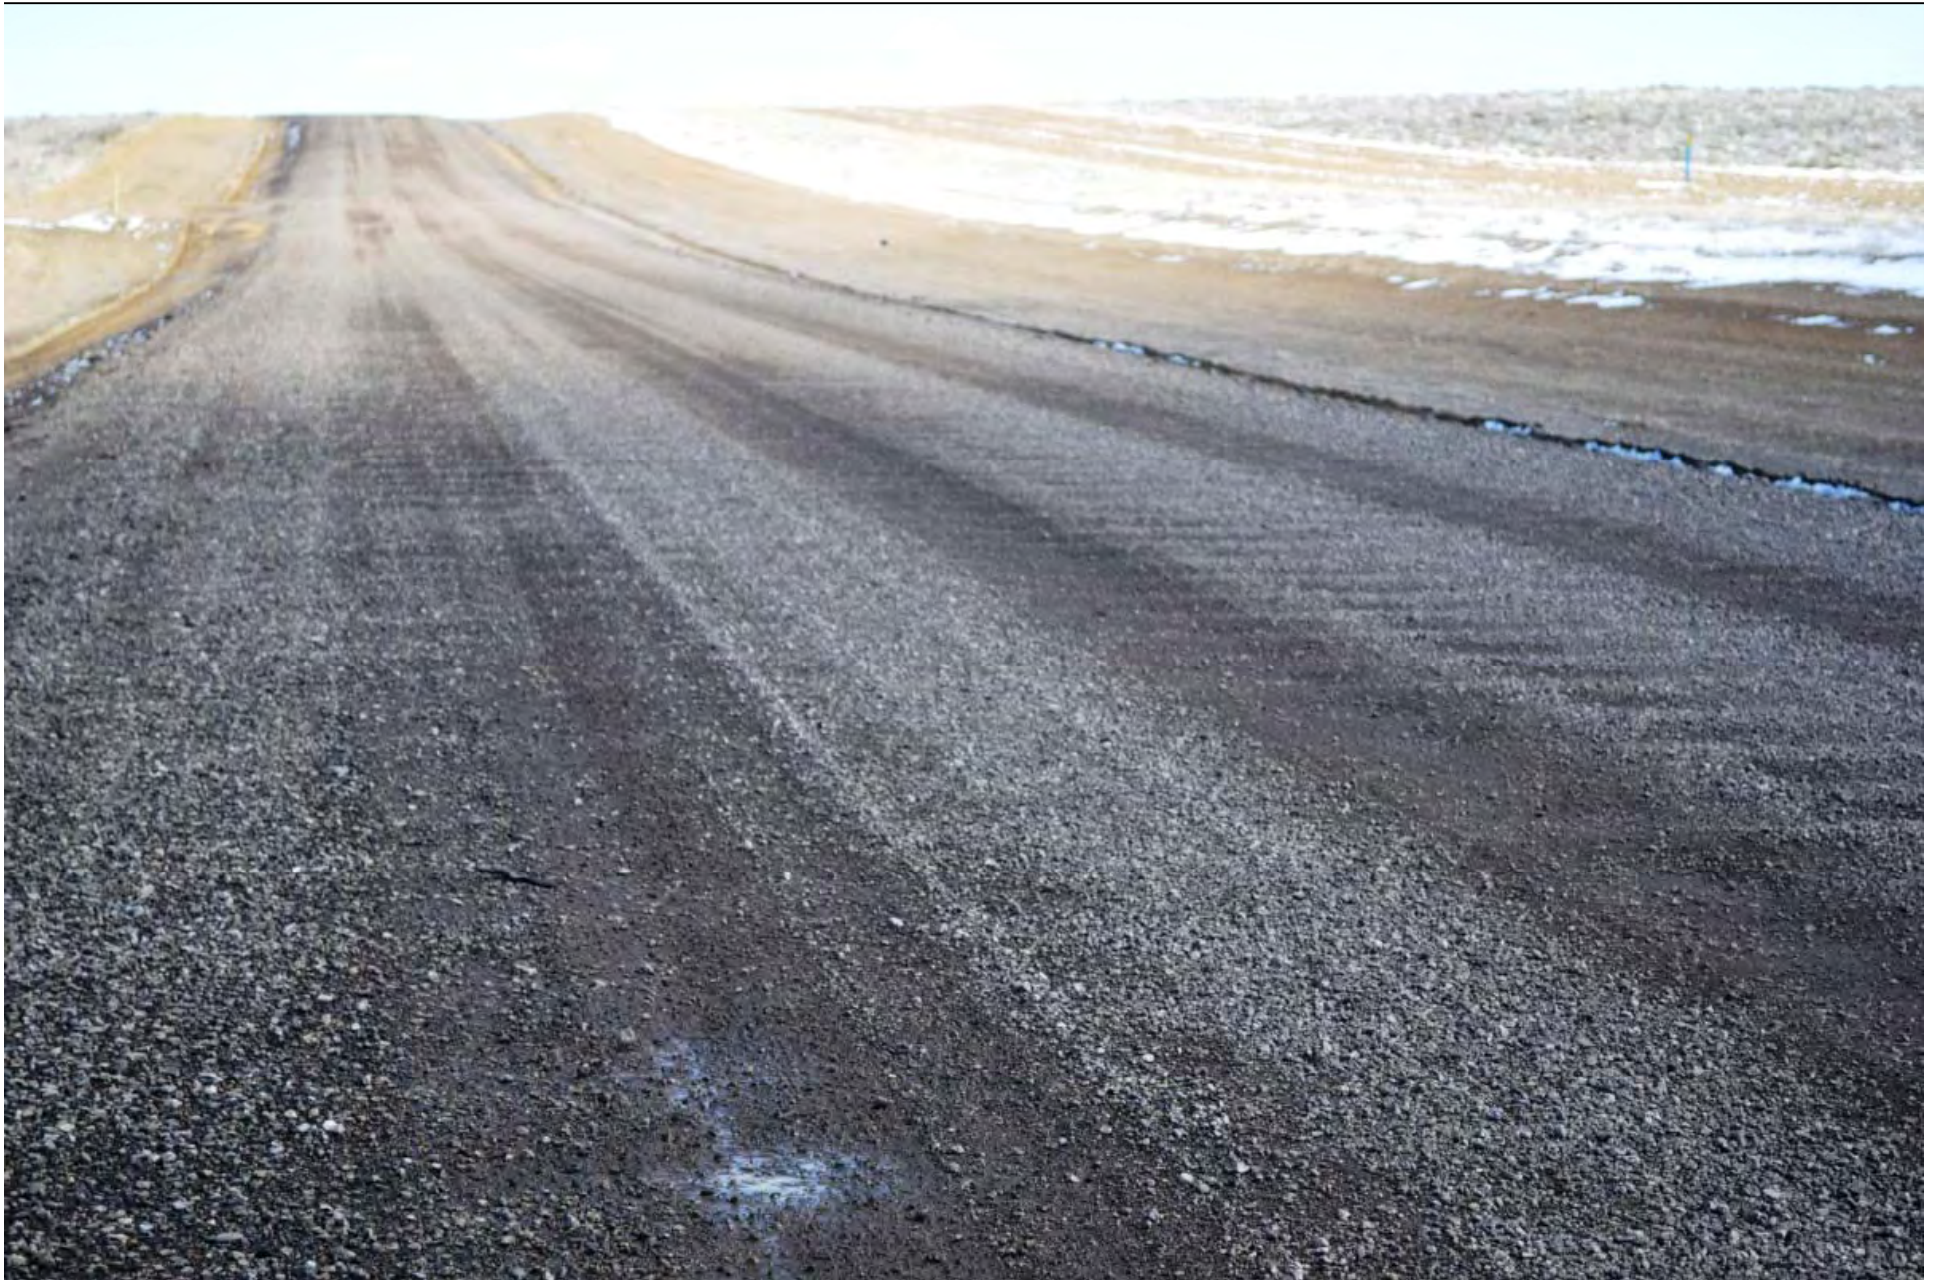
Untreated RAP blend Initial Construction

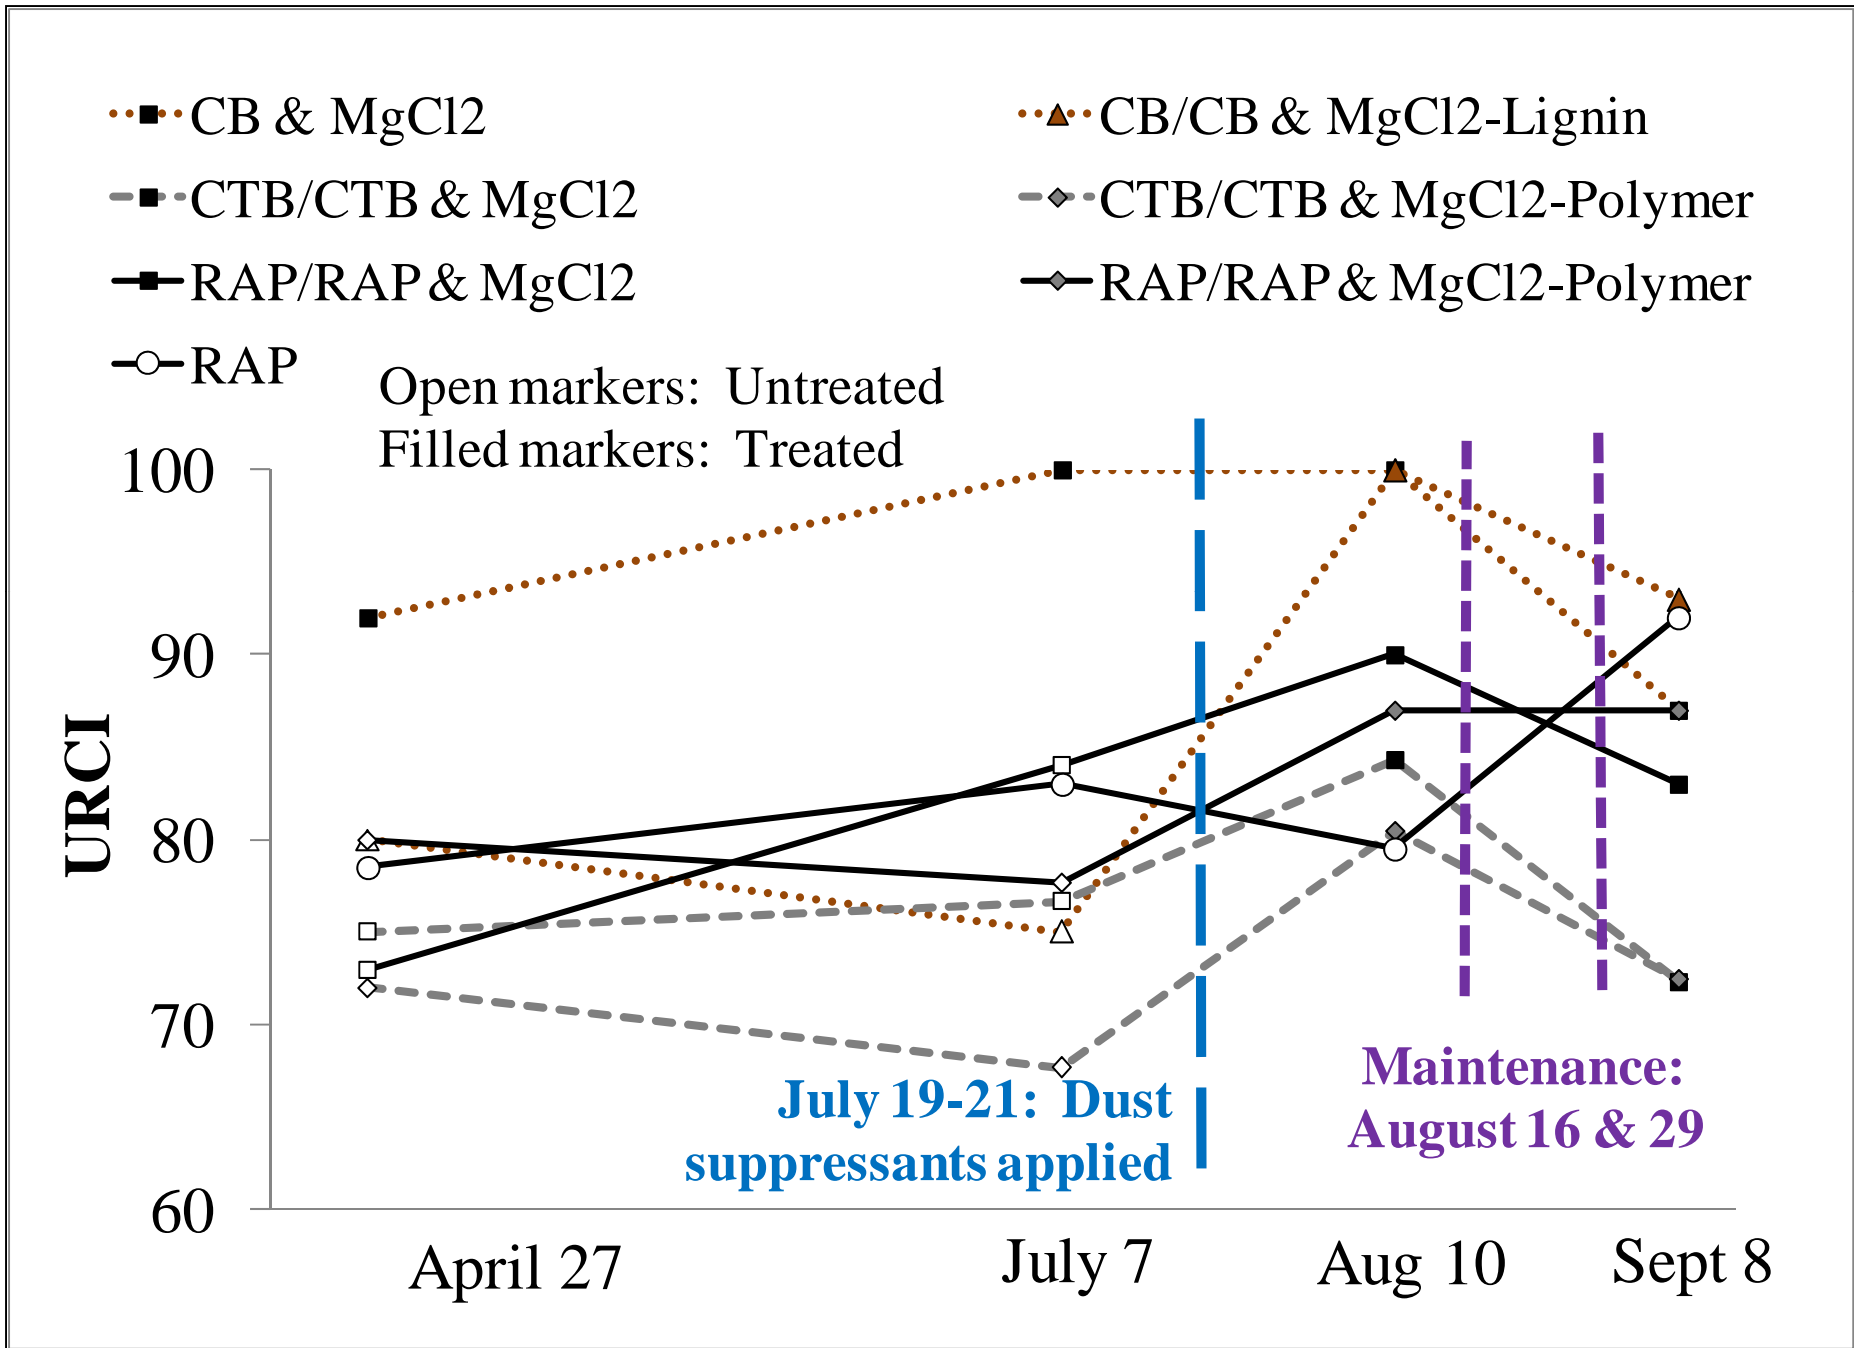
- CB & MgCl₂
- CTB/CTB & MgCl₂
- RAP/RAP & MgCl₂
- RAP
- ▲● CB/CB & MgCl₂-Lignin
- ◆ CTB/CTB & MgCl₂-Polymer
- ◆ RAP/RAP & MgCl₂-Polymer

Open markers: Untreated
 Filled markers: Treated

Washboards/Corrugations

Deduct Values

July 19-21: Dust suppressants applied

Maintenance: August 16 & 29
