Performance of Recycled Asphalt Pavement (RAP) in Gravel Roads

2015 Northwest Pavement Management Association Conference

Josh Jones

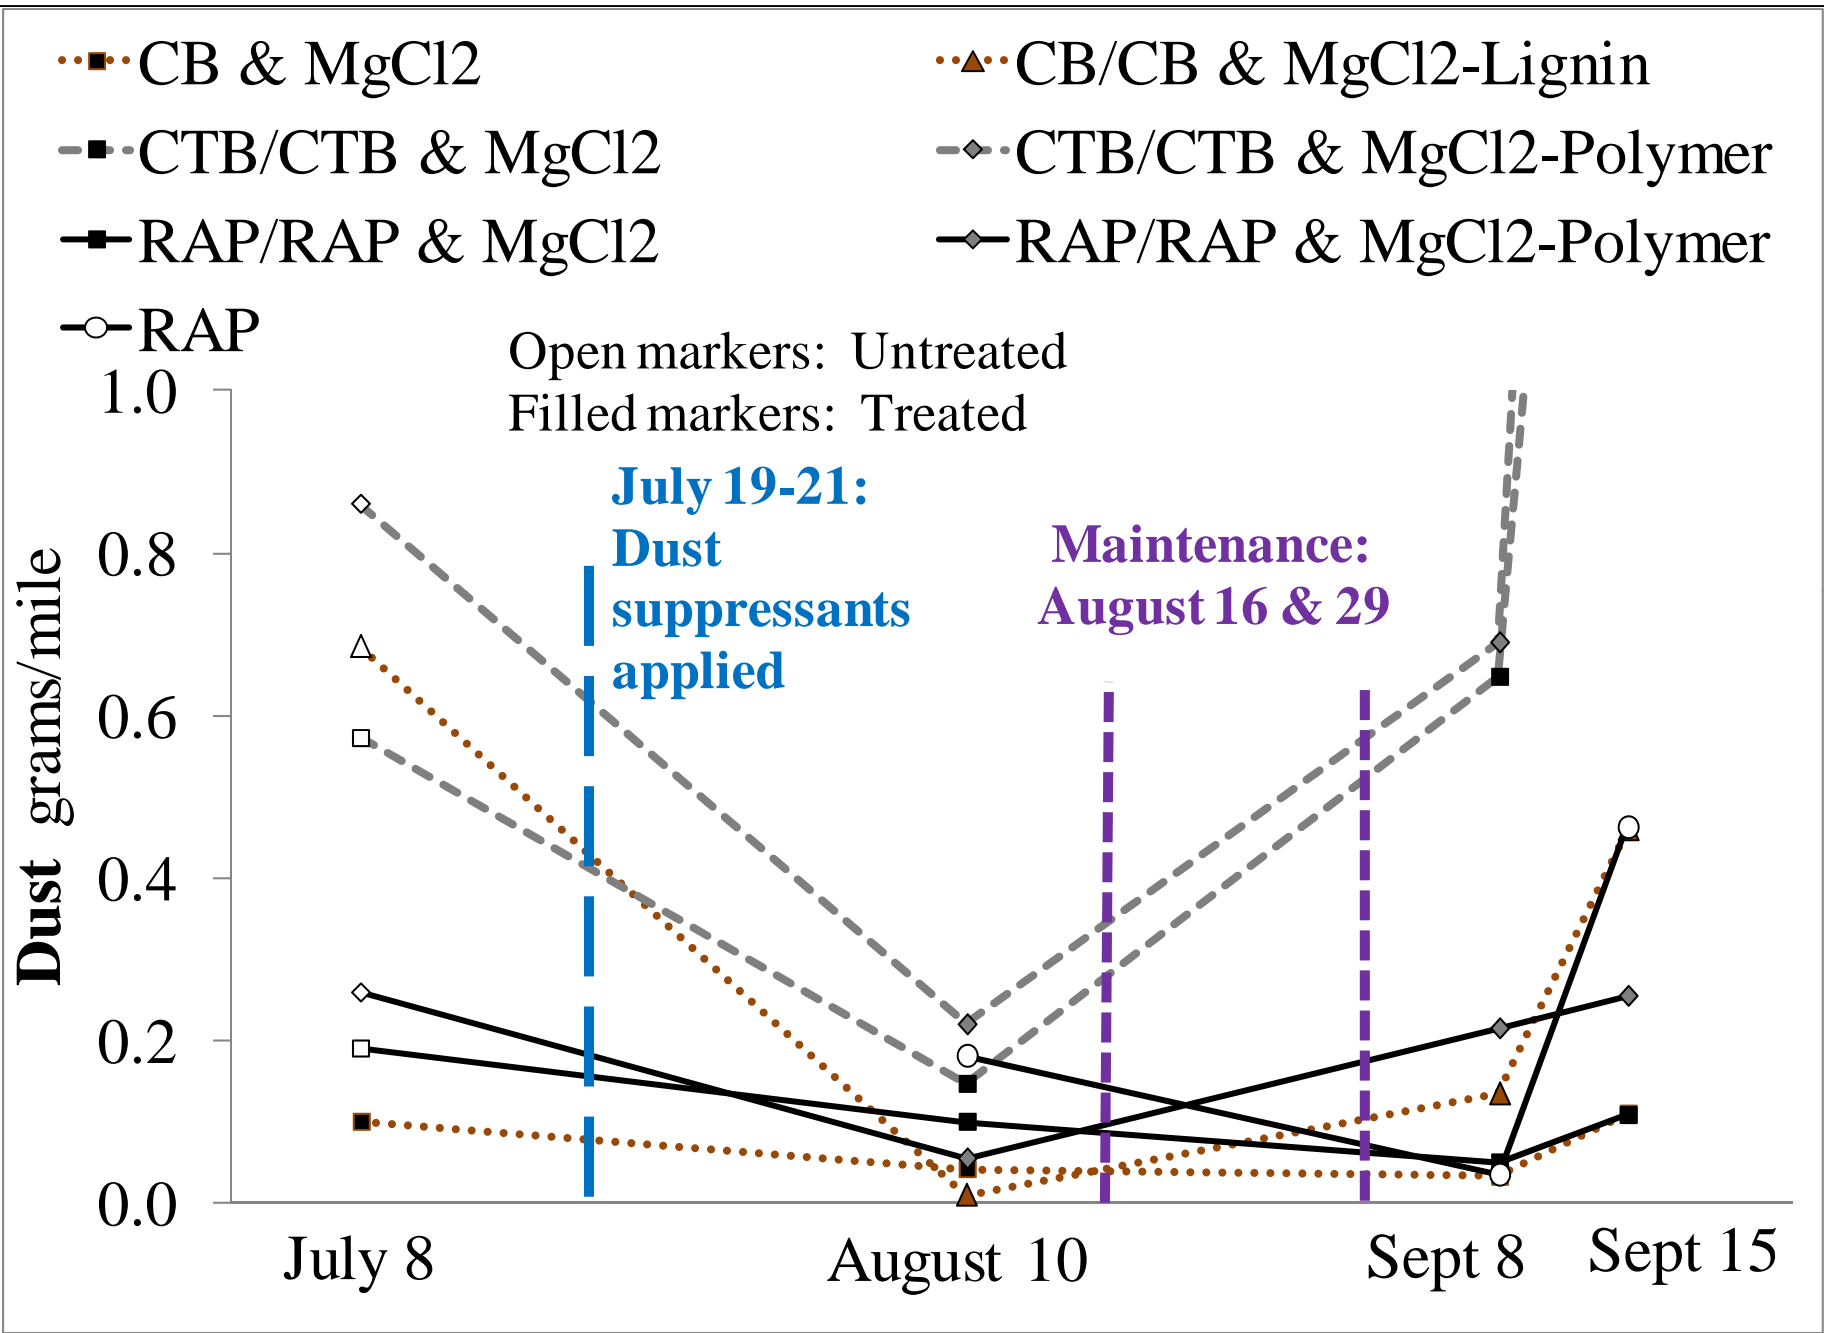
- CB & MgCl2
- CTB/CTB & MgCl2
- RAP/RAP & MgCl2
- RAP
- ▲● CB/CB & MgCl2-Lignin
- ◇ CTB/CTB & MgCl2-Polymer
- ◇ RAP/RAP & MgCl2-Polymer

July 19-21: Dust suppressants applied

Maintenance: August 16 & 29

Potholes
Deduct Values

Open markers: Untreated
Filled markers: Treated
