PAVEMENT REHABILITATION TECHNIQUES: Applying Reasonableness & Avoiding Pitfalls

MIKE MALONEY, PE

LINDSI HAMMOND, PE

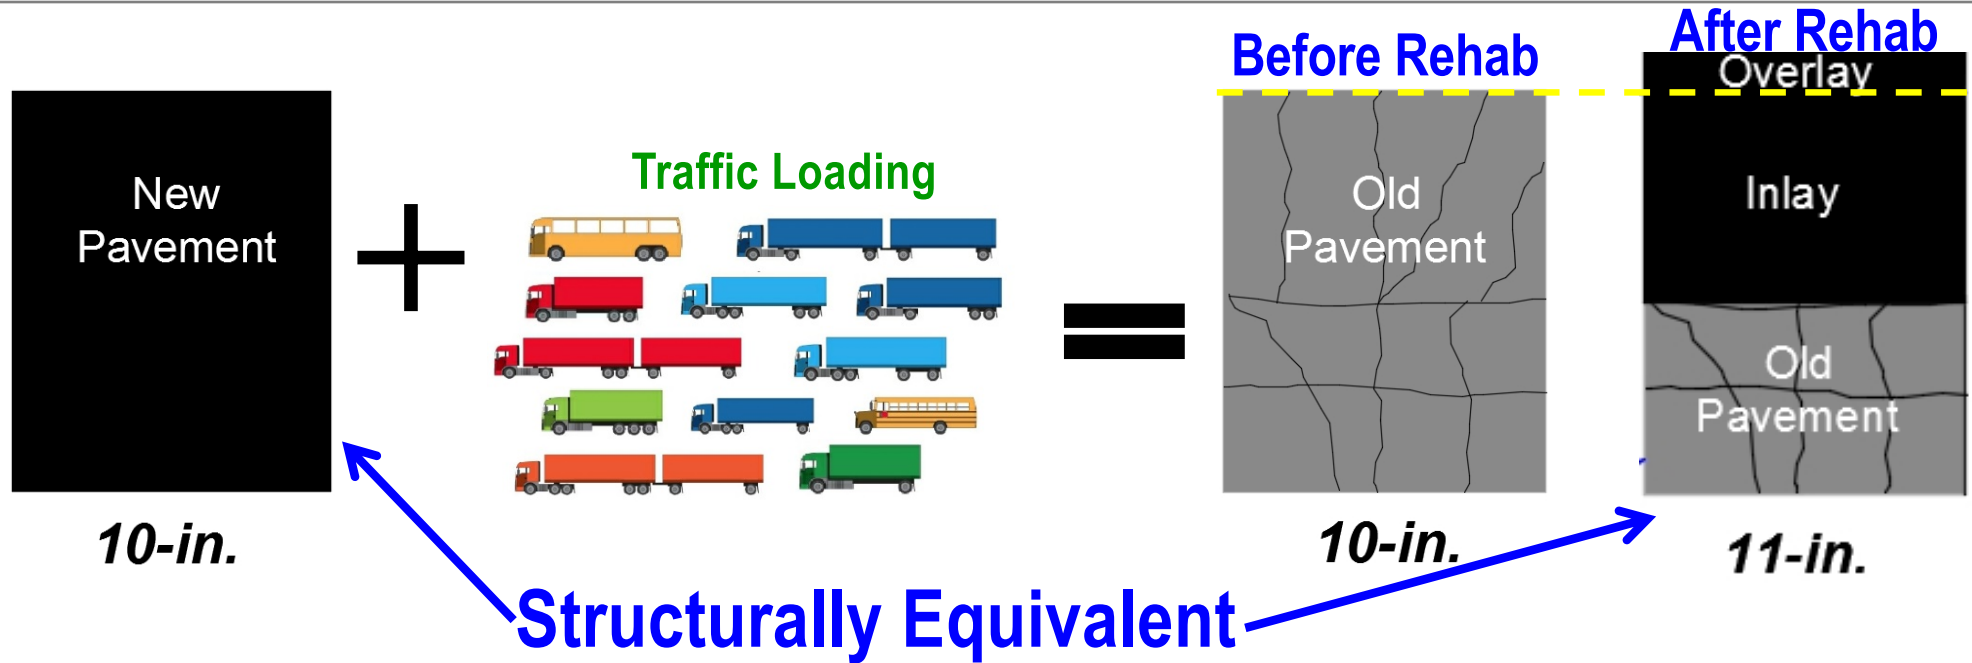
Structural Strengthening – Mill + Overlay

Mill and Overlay is removal of a portion of the existing asphalt concrete and placement of new asphalt concrete that results in an increase in grade.

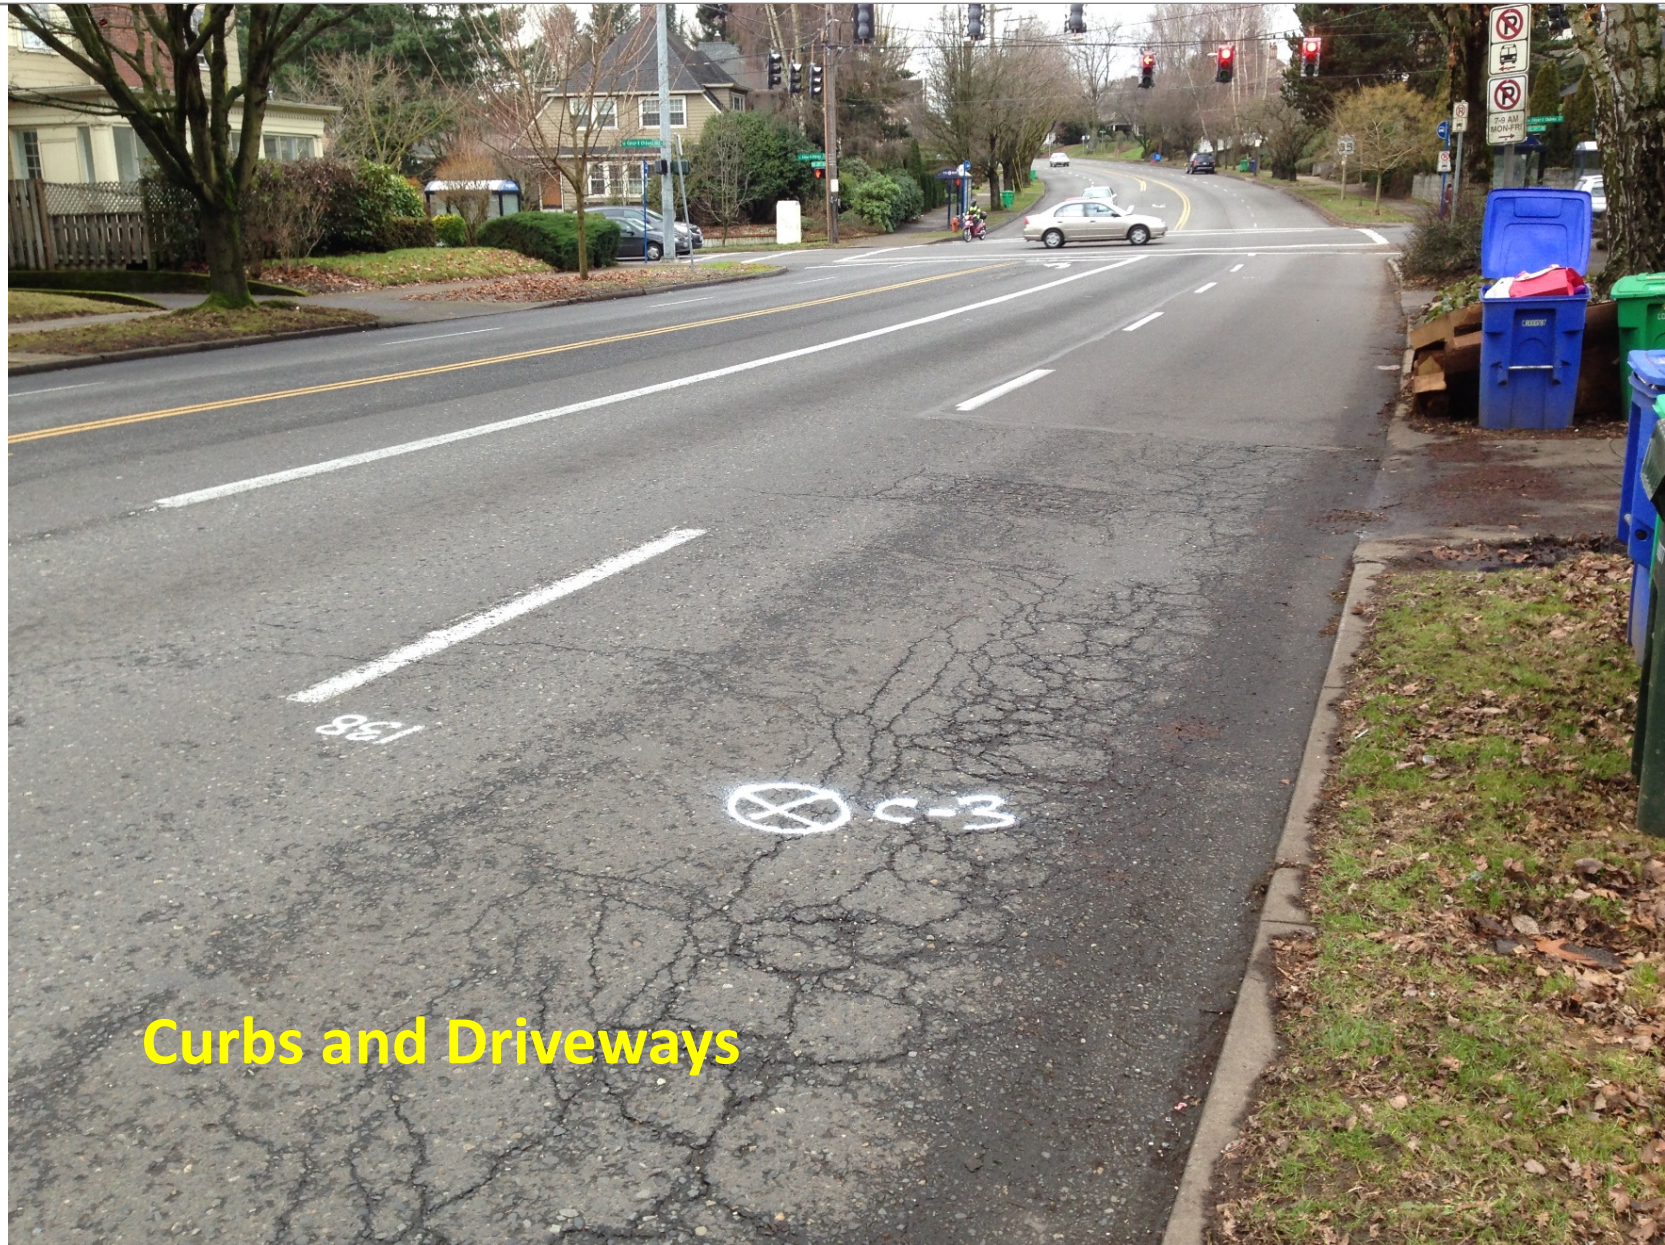
Grade Constraints

Curbs and Driveways

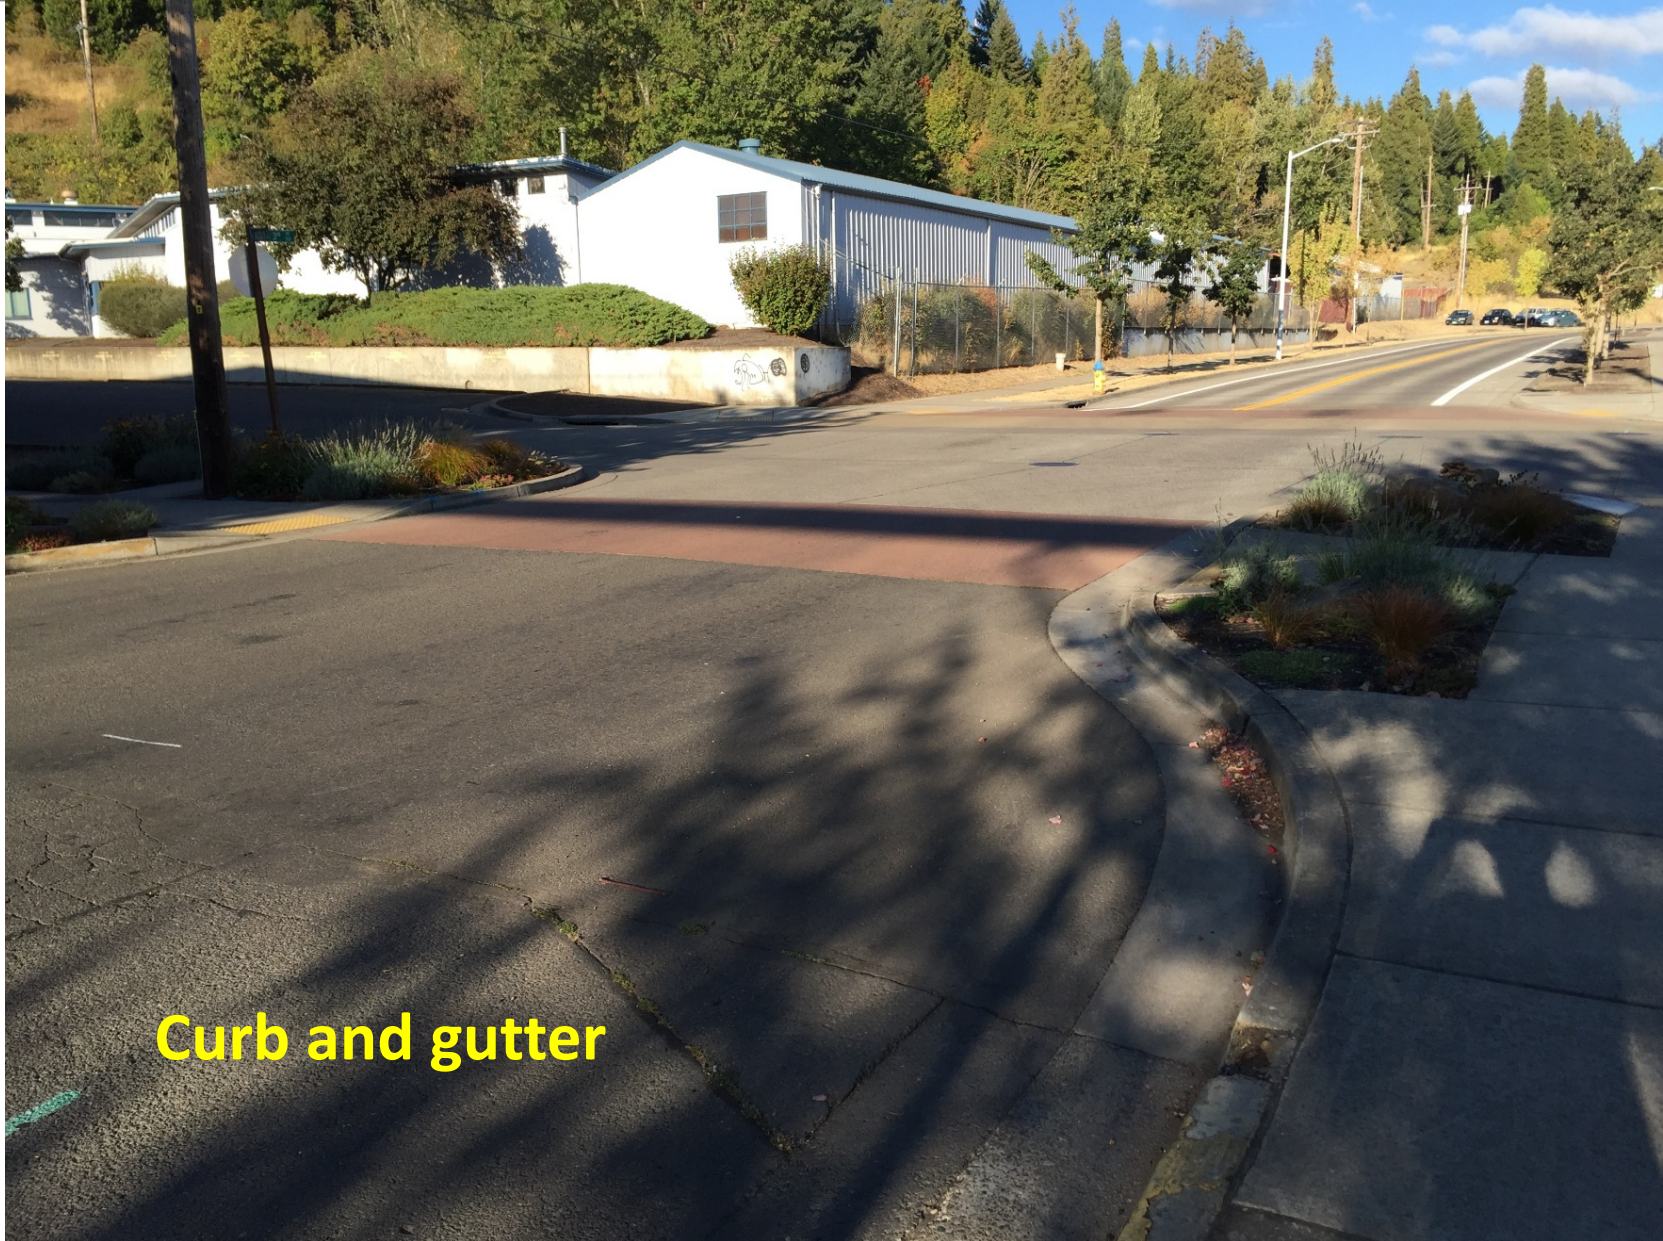
Grade Constraints

Curb and gutter

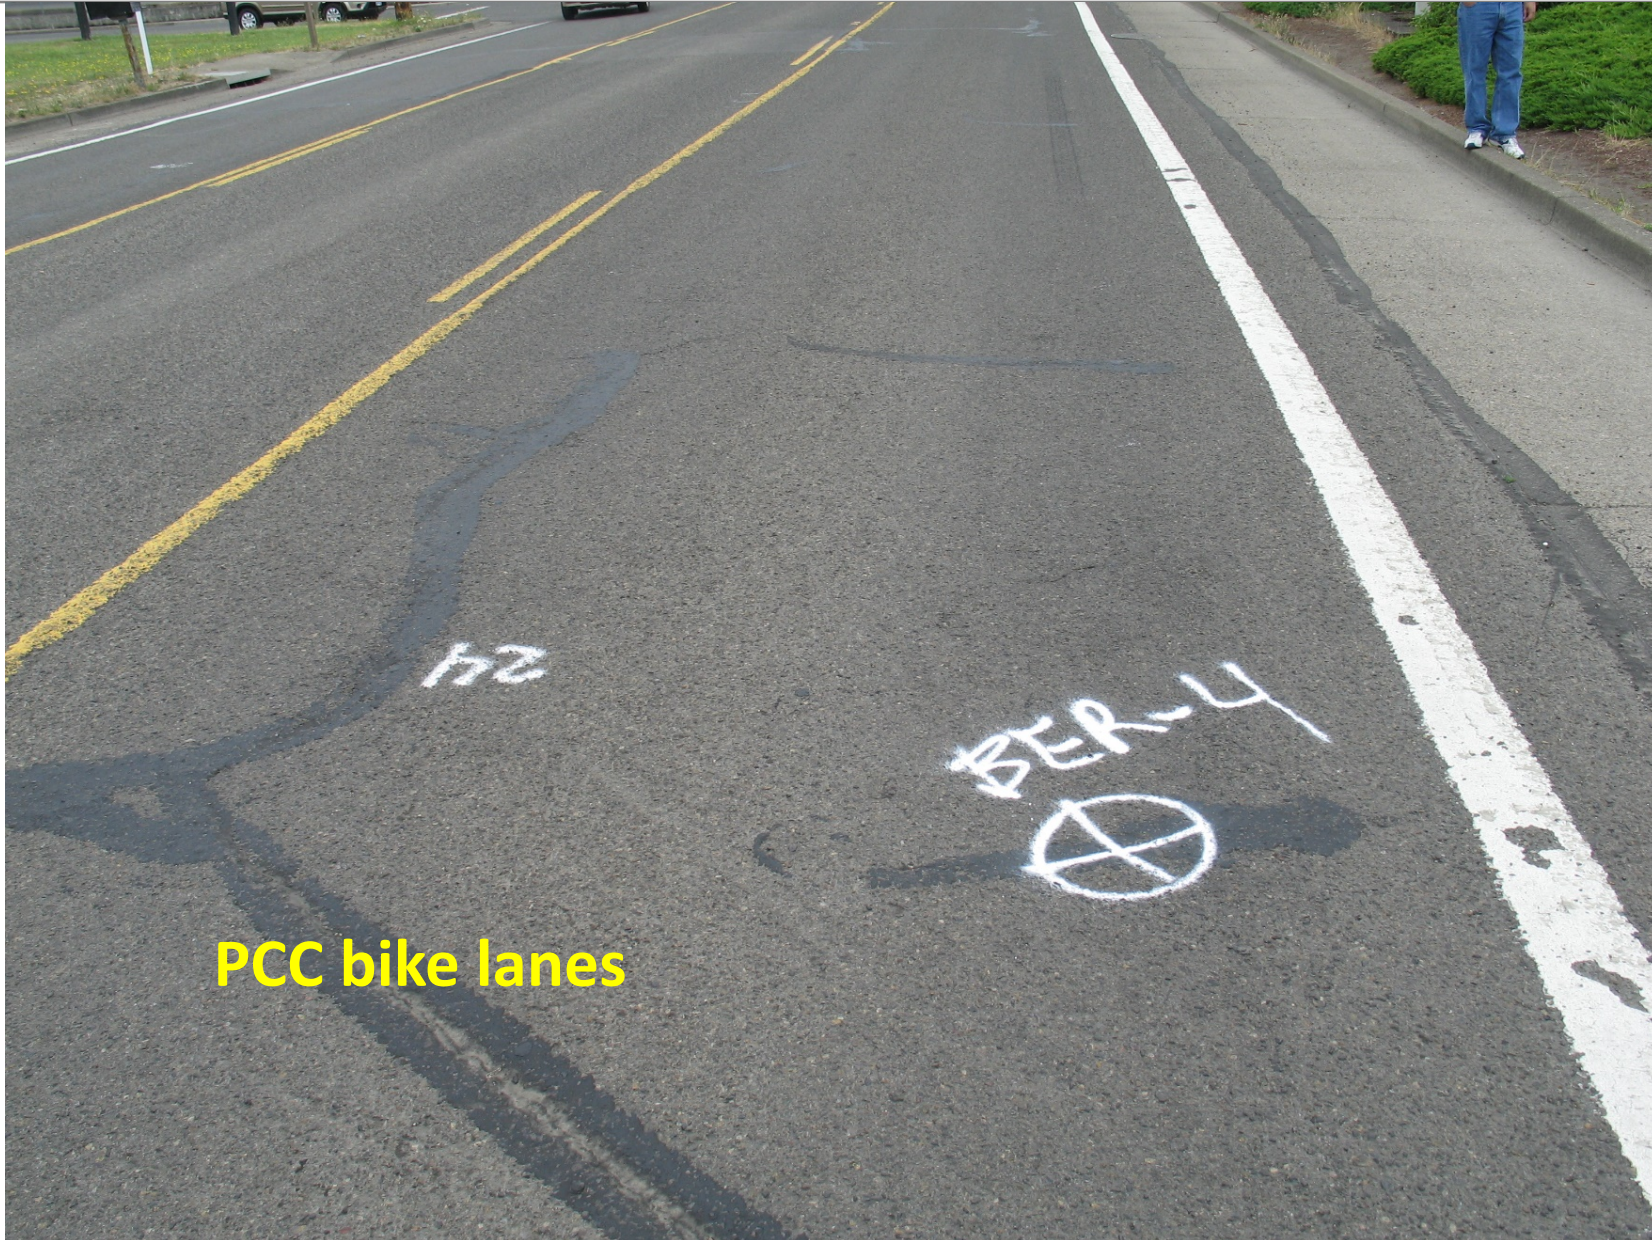
Grade Constraints

PCC bike lanes

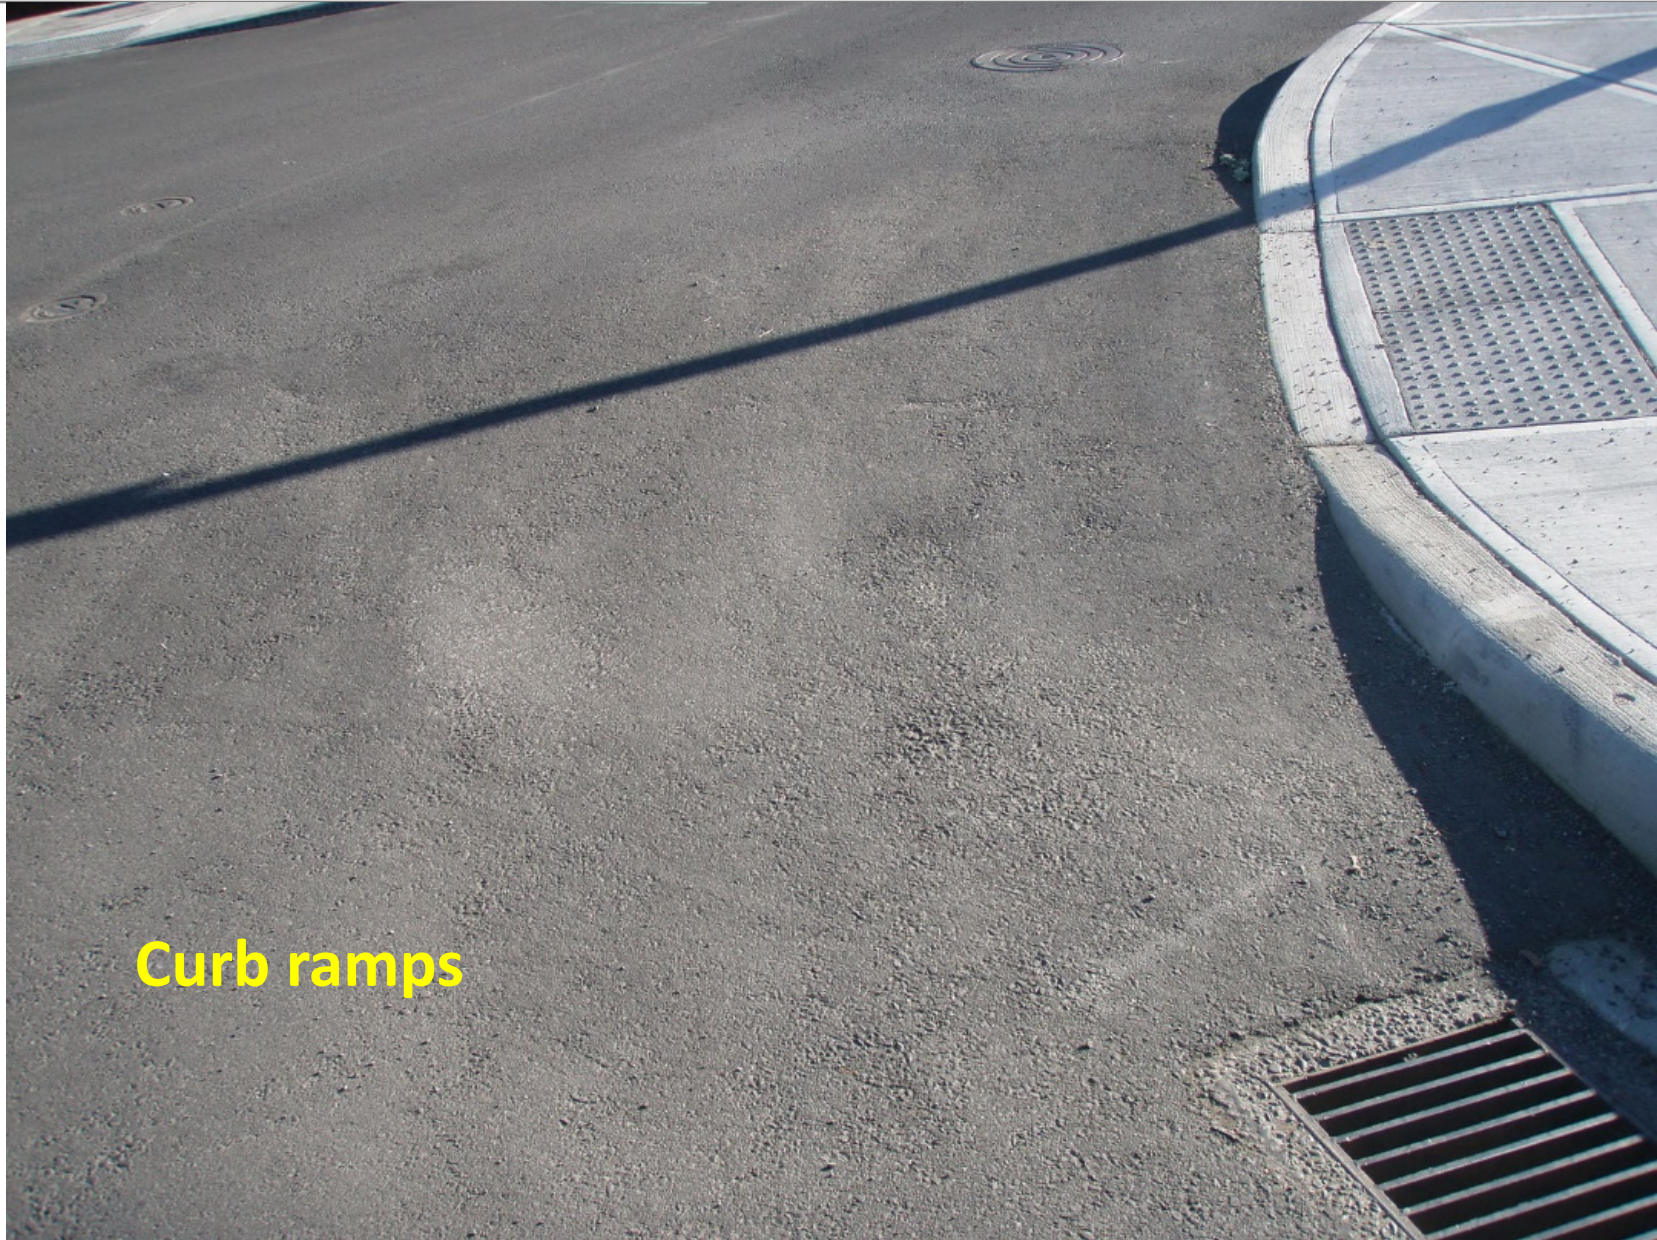
Grade Constraints

Curb ramps

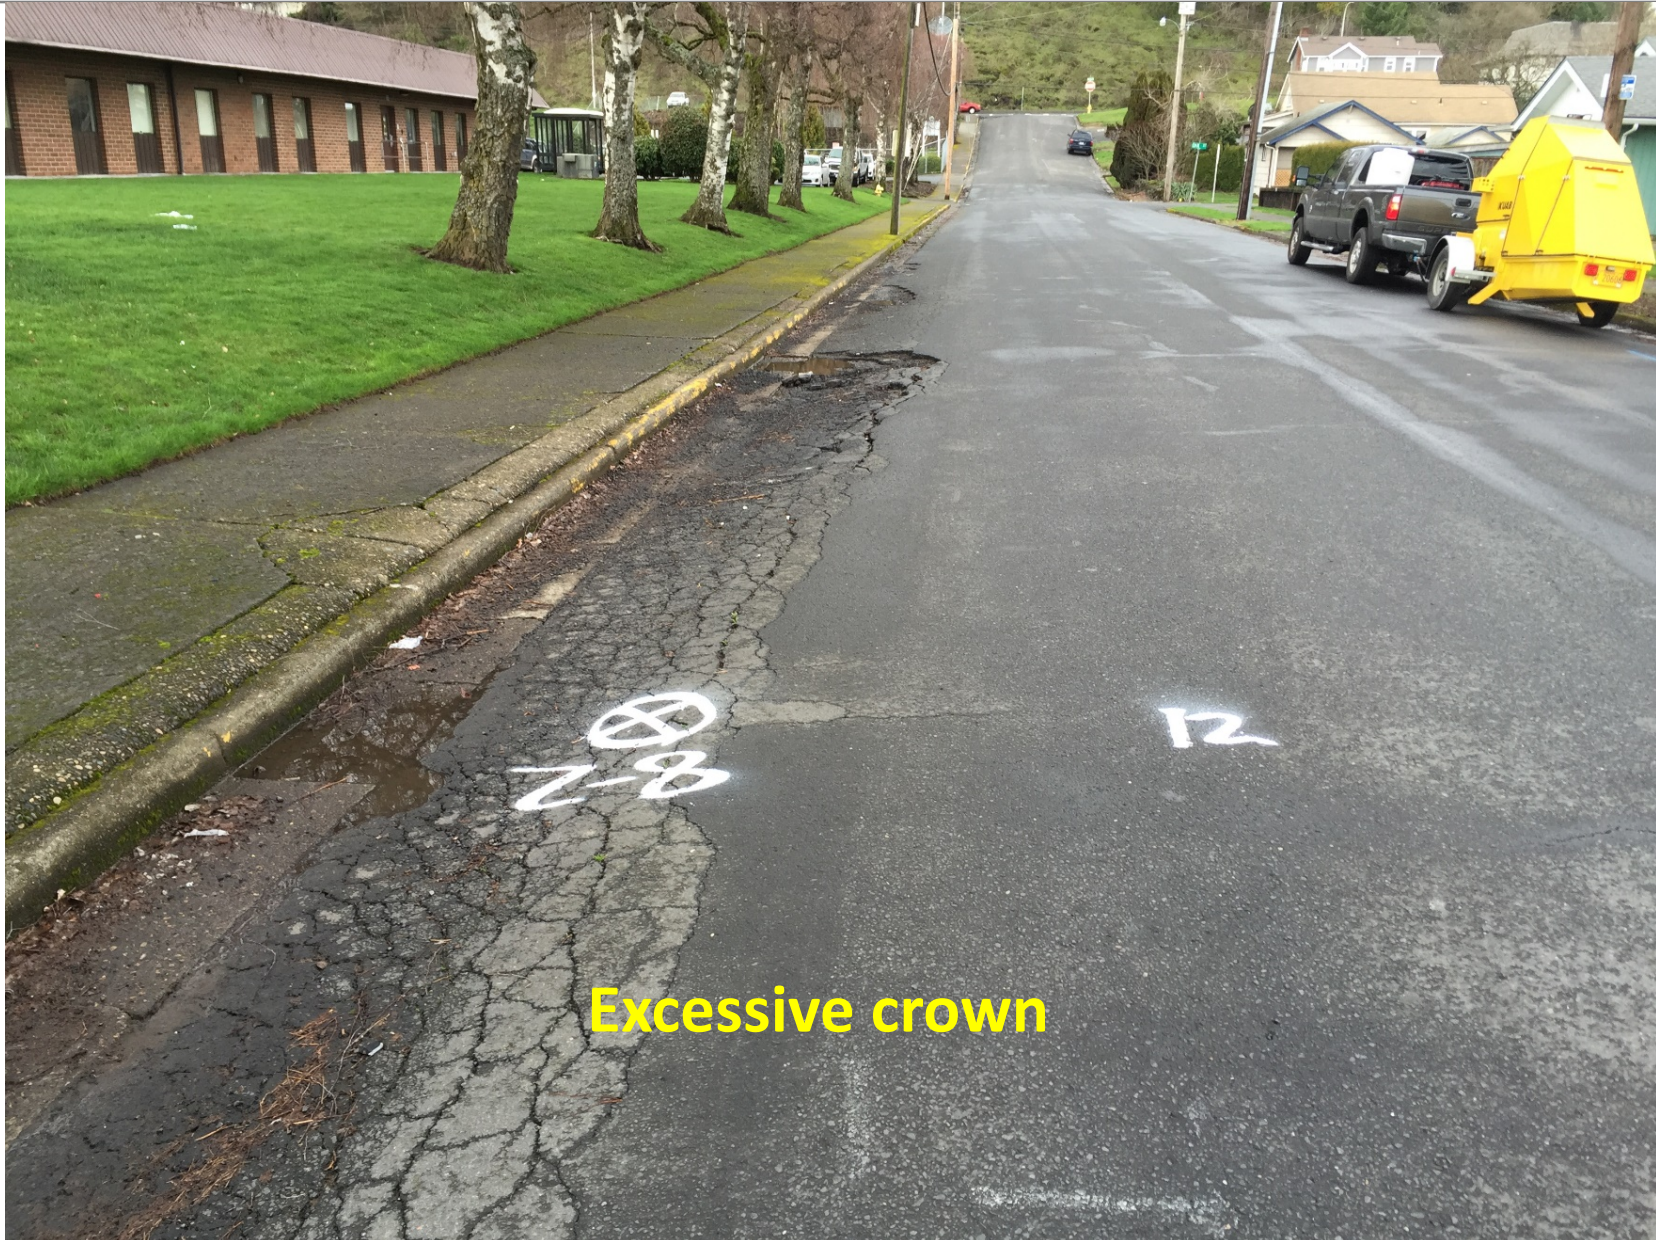
Grade Constraints

Excessive crown

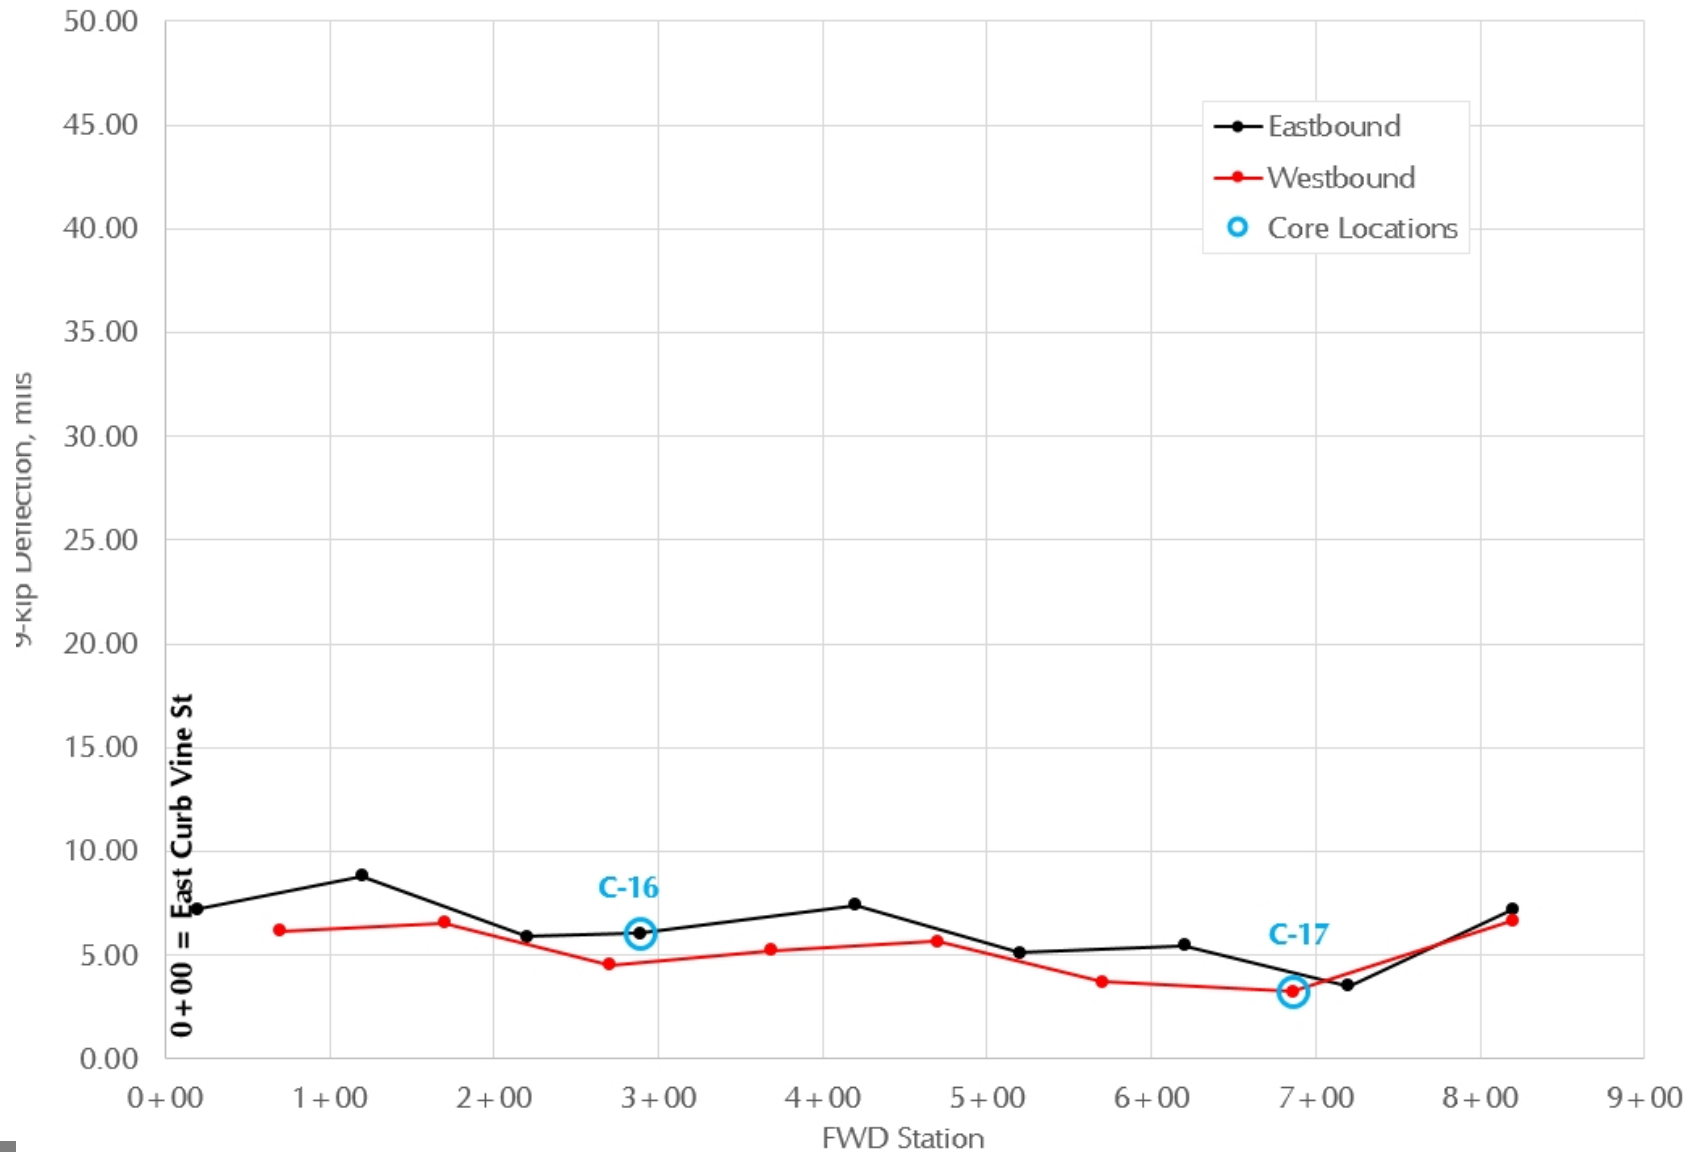
Figure 1H - 9-Kip Deflection Profile

FWD Testing - Alameda

Test No.	Test Station	Dir	Unit	D0, mils	Overlay Thickness above Existing Pavement, in.	Overlay Thickness above the Milled surface with 3.5-inch milling Depth
1	0+20	EB	1	7.23	zero	zero
2	1+20	EB	1	8.81	zero	zero
3	2+20	EB	1	5.9	zero	zero
4	2+89	EB	1	6.03	zero	zero
5	4+20	EB	1	7.42	zero	zero
6	5+20	EB	1	5.1	zero	zero
7	6+20	EB	1	5.45	zero	zero
8	7+20	EB	1	3.52	zero	zero
9	8+20	EB	1	7.21	zero	zero
10	8+20	WB	1	6.68	zero	zero

Statistical Summary						
Structural Unit #	From	To	Dir	Average D0, mils	Average Overlay, in.	Average Overlay above the Milled Surface (3.5-in. Mill Depth), in.
1	0+20	8+20	Both	5.79	zero	zero

- No Strengthening Required
- Surface Rehabilitation Required due to Extensive Top-Down Random Cracking
- 4" Mill
- 4" Inlay
 - 2- 2" Lifts
