High Friction Surface Treatment

King County's Experience

NW Pavement Management Conference
October 24, 2018
Kennewick, WA

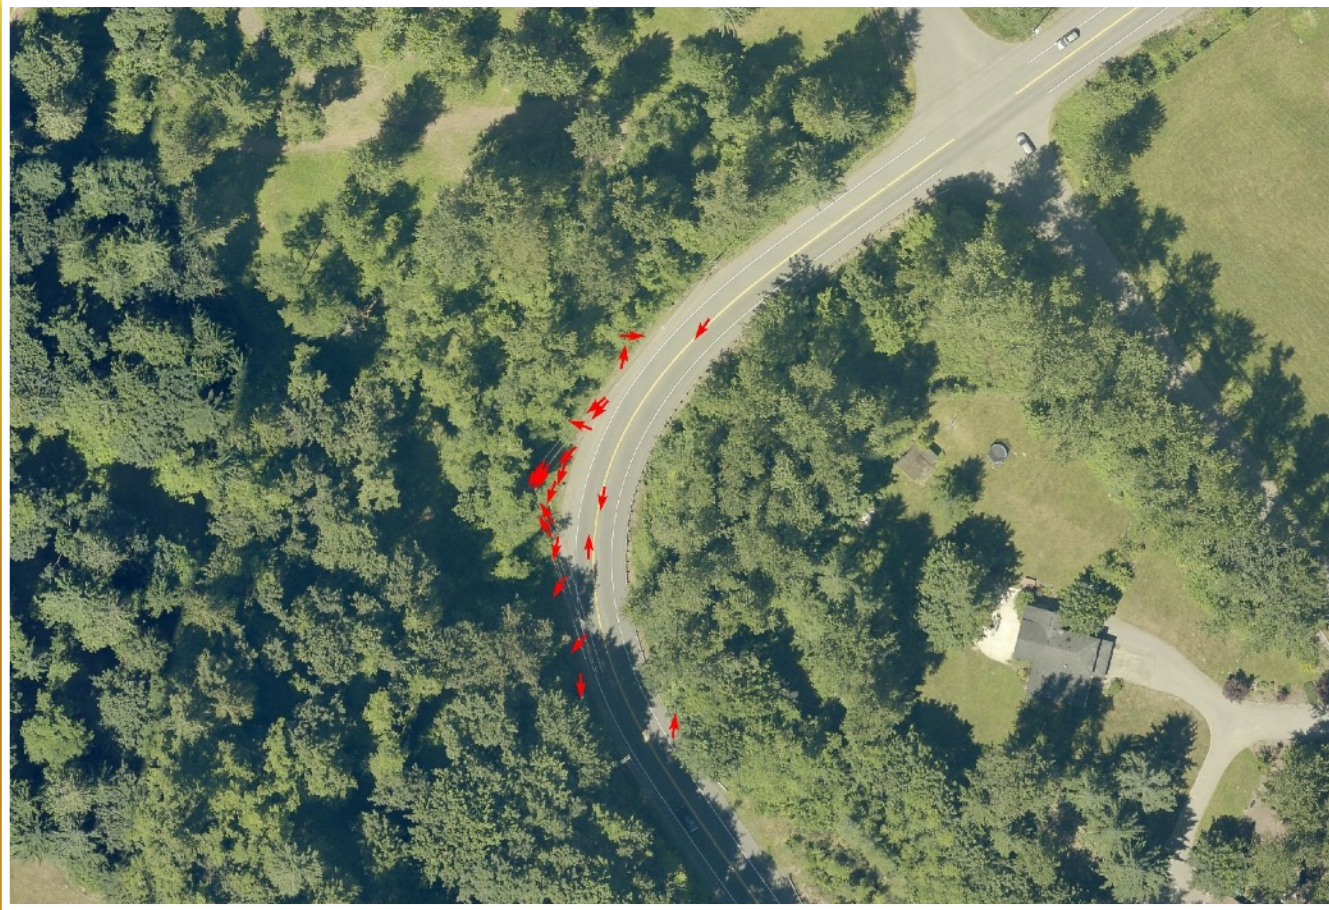
Analysis - *Mapping Collisions*

- **Started in 2007**
- **Geospatial Data**
- **ArcGIS 10.3**

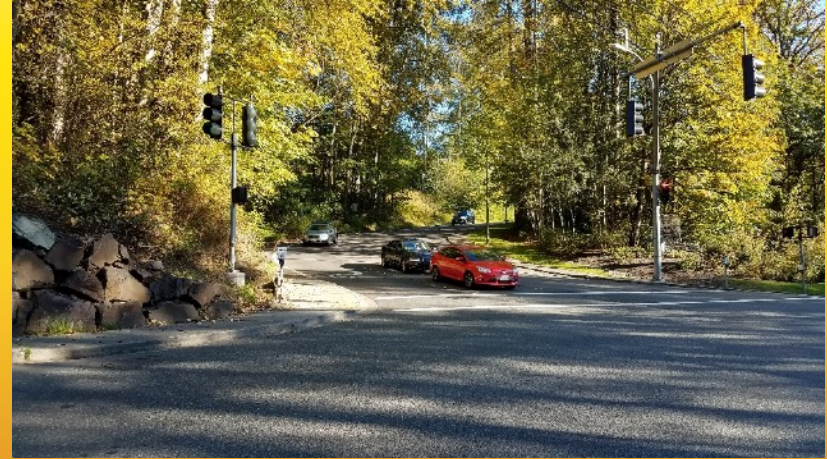
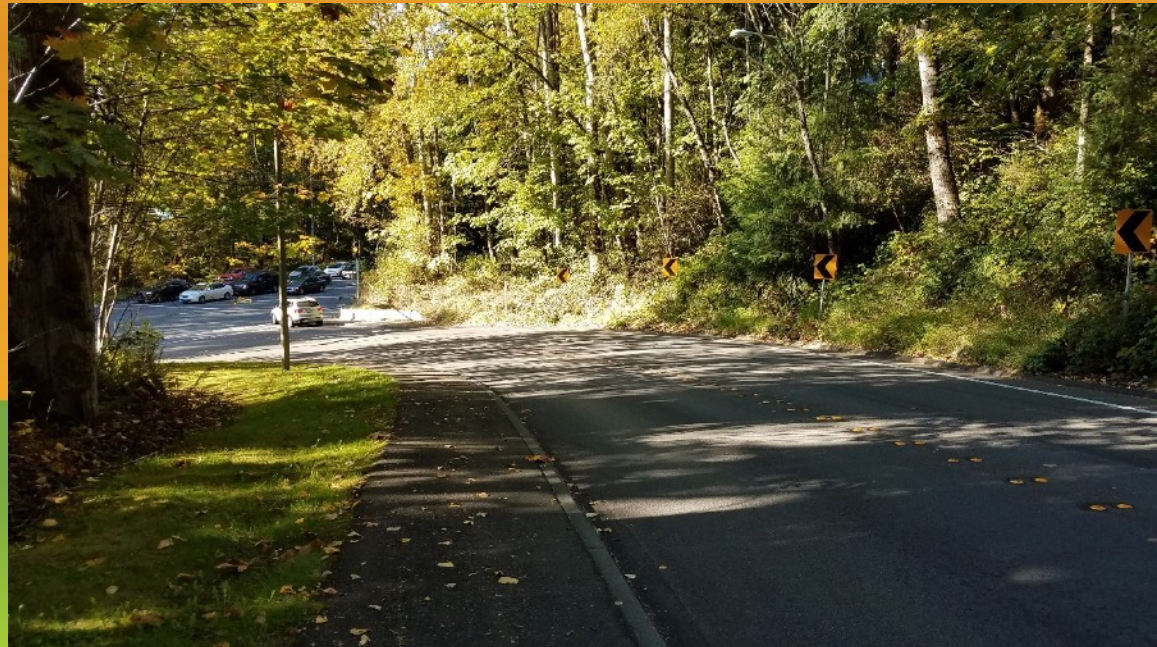
City of Bellevue – Forest Drive

- HFST installed in 2004
- Reapplied in 2007
- 5,000 AADT
- 15% Downgrade
- “T” intersection
- Icy conditions
- 78% crash reduction

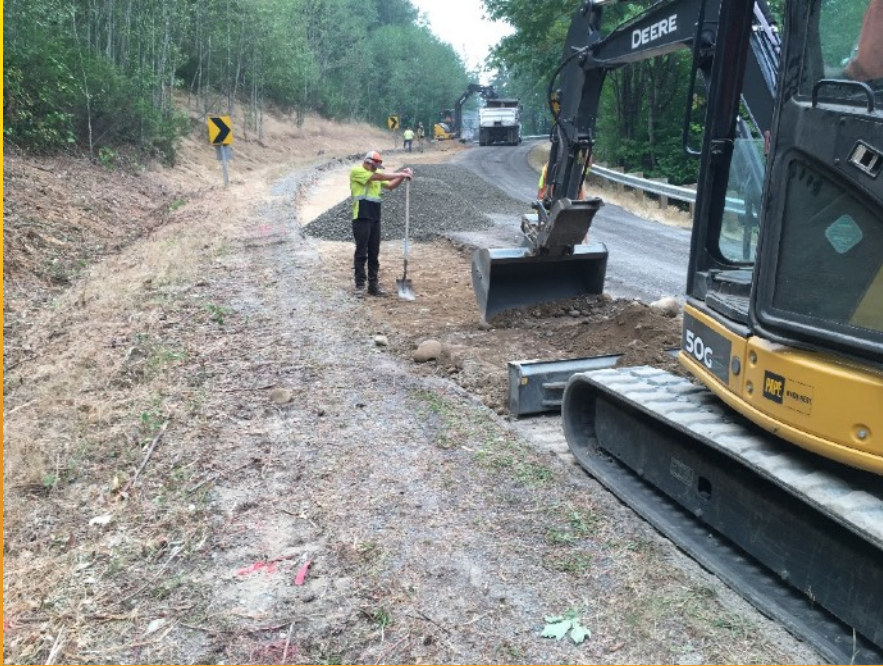
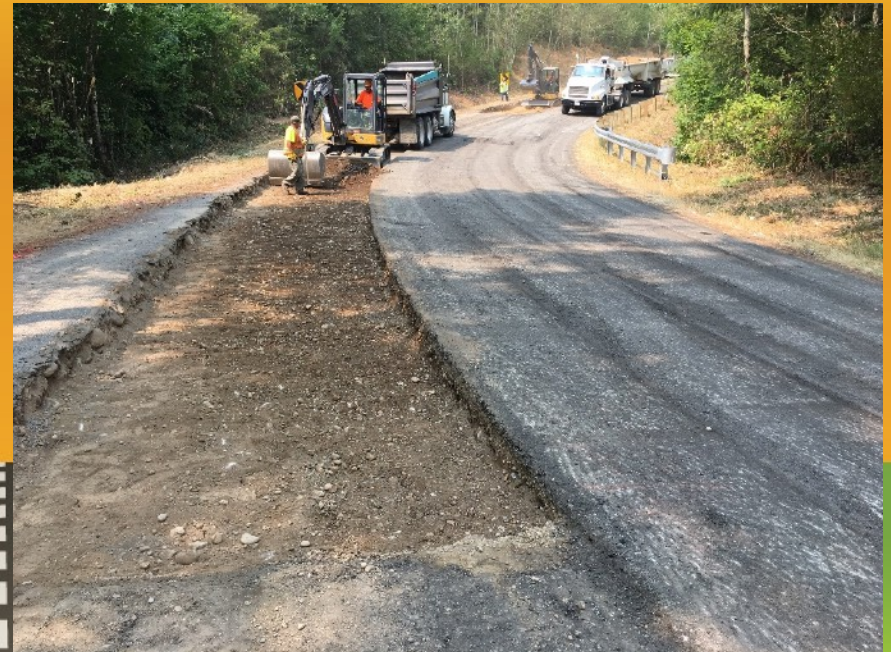
Subgrade Replacement

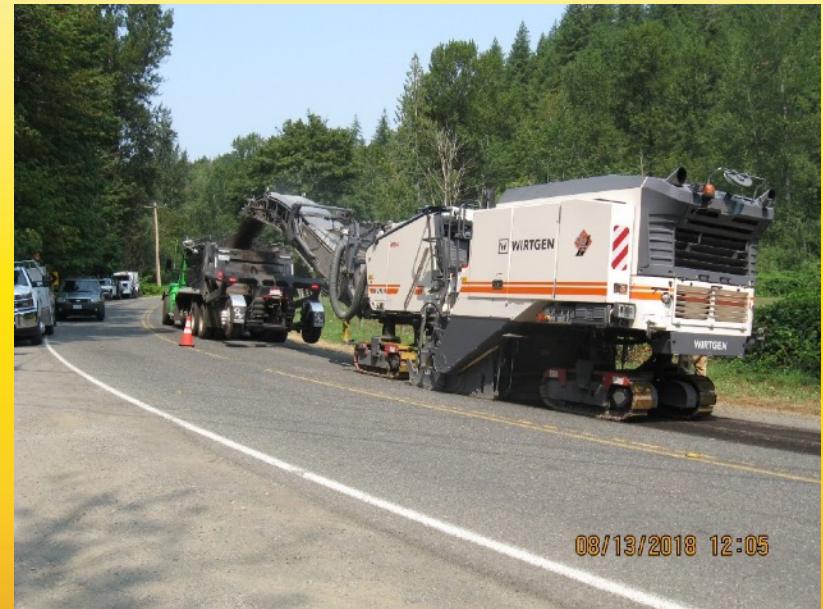
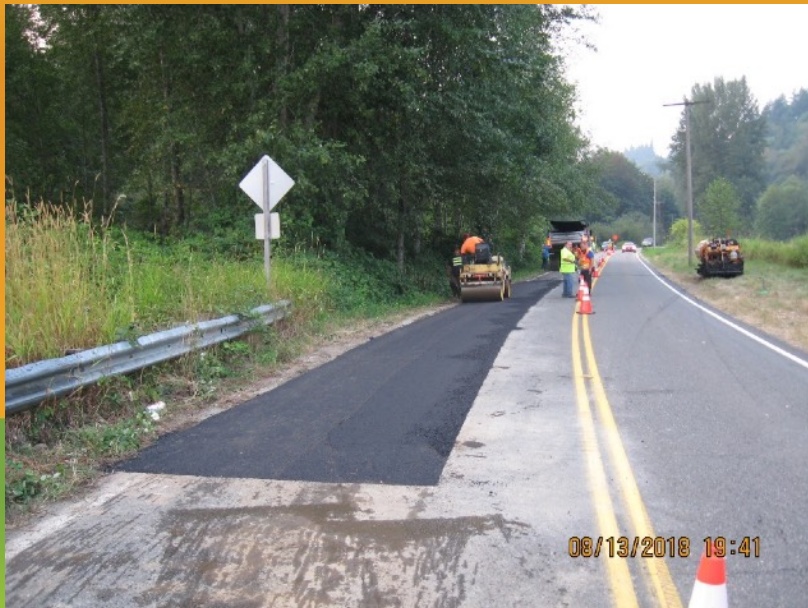
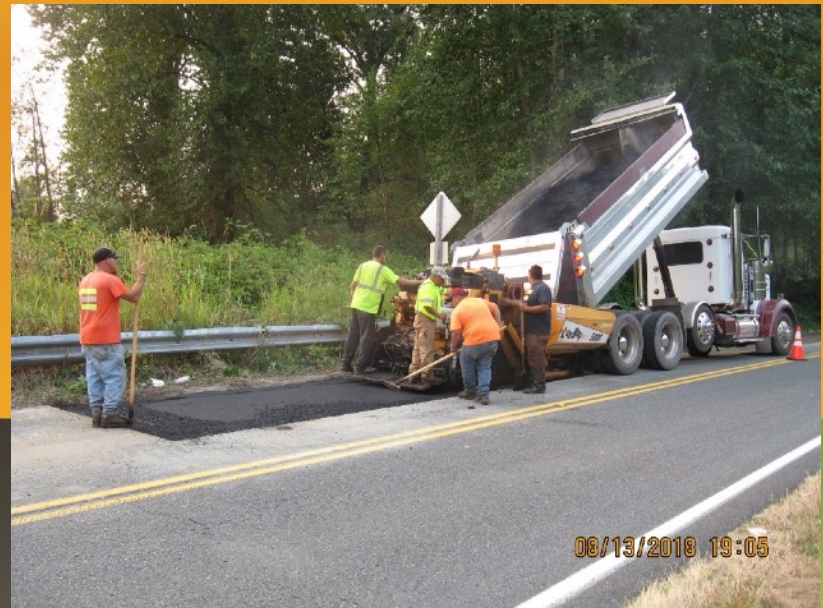
Pavement restoration

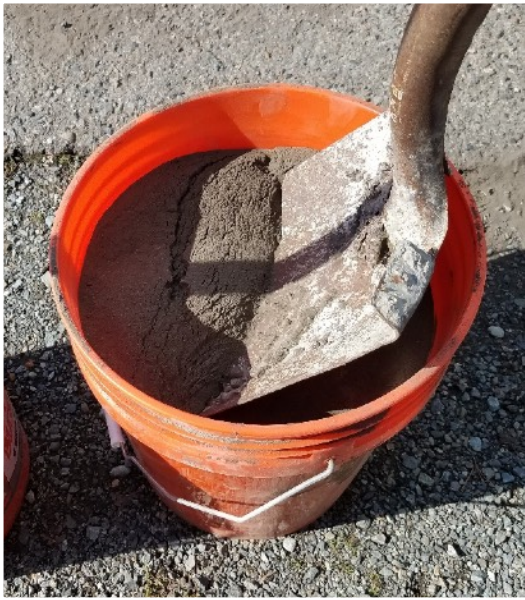
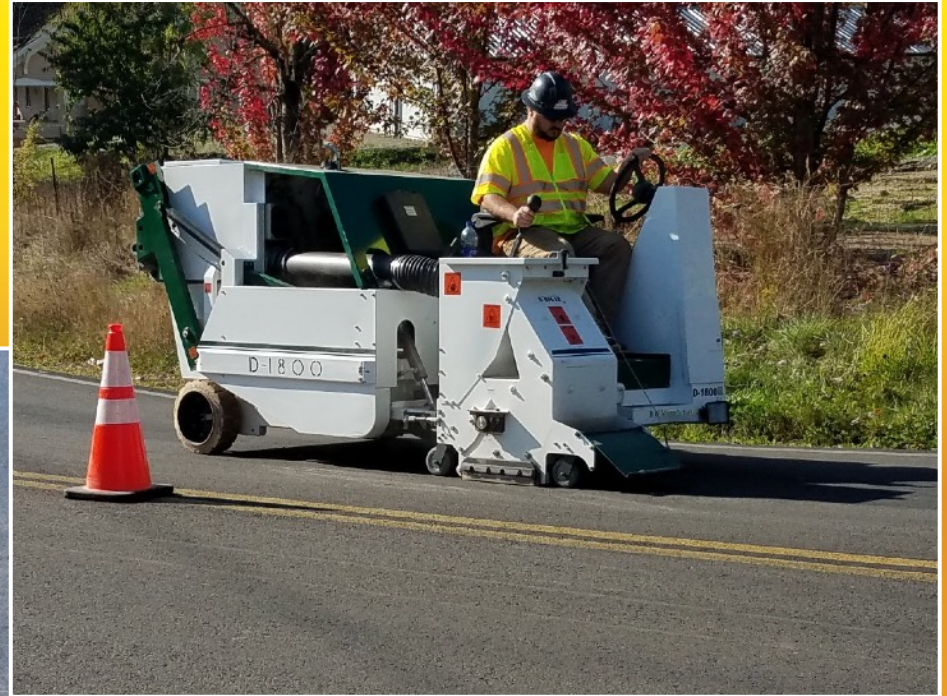
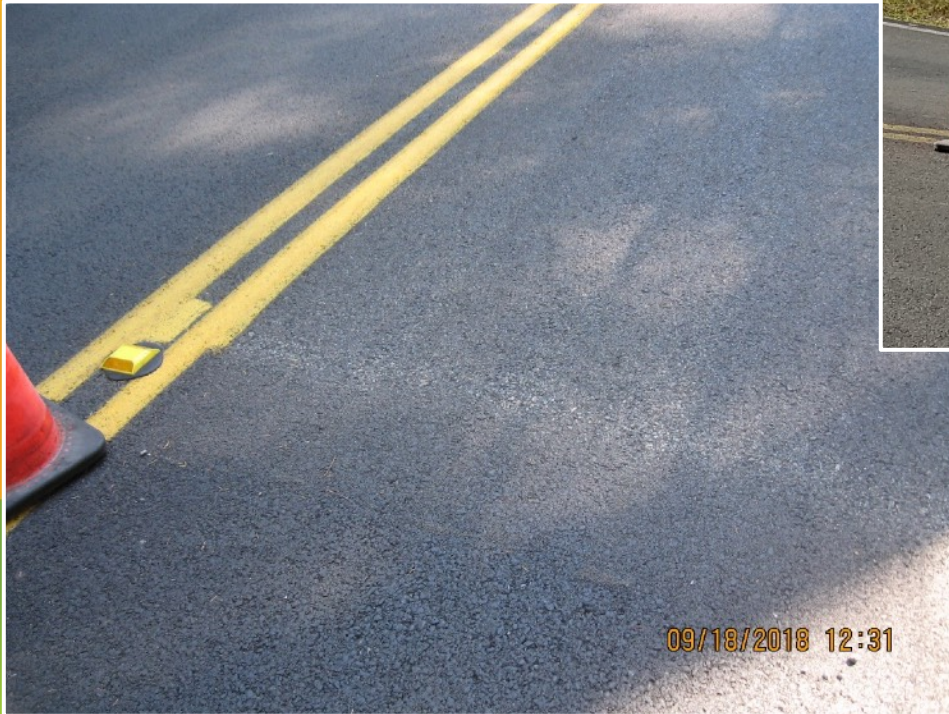
Surface preparation

- Temperature 50°F and rising
- Time of year June 1 to Sept 30
- Surface preparation medium shot blast
- Epoxy
 - Cure time 1-2 hours (varies w/temp)
 - Thickness 50-65 mils
- Aggregate
 - Moisture content 1.2% max.
 - Coverage 13 lbs/SY
- Friction Number 72 min.
- Materials Two-part epoxy, calcined bauxite
- New pavement 30 day period before HFST

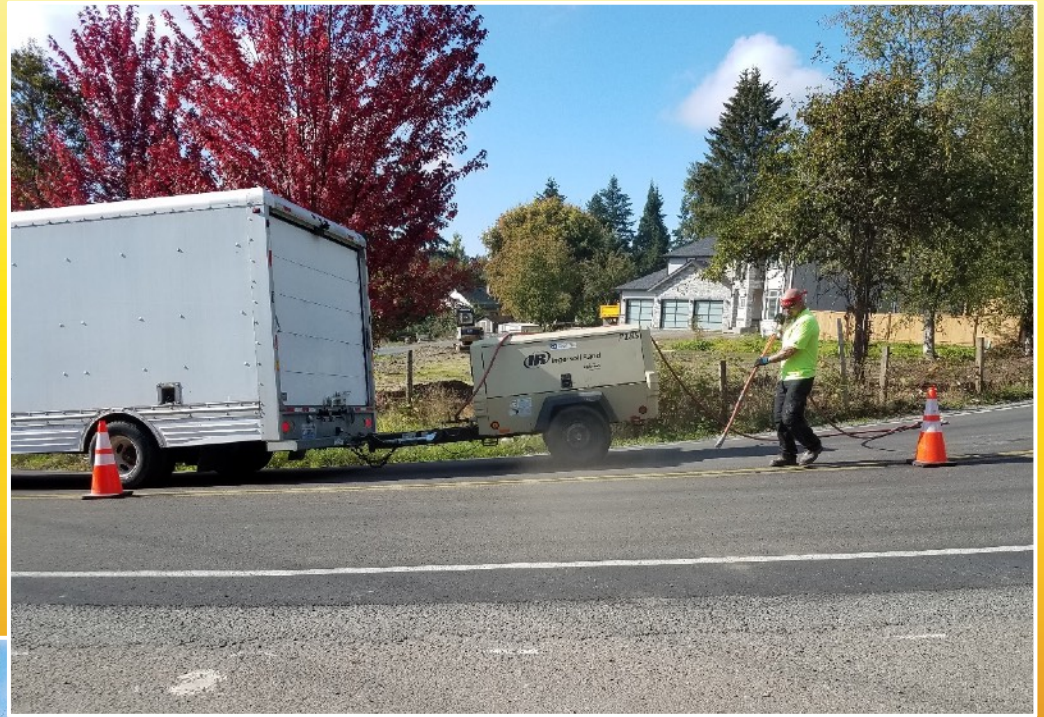
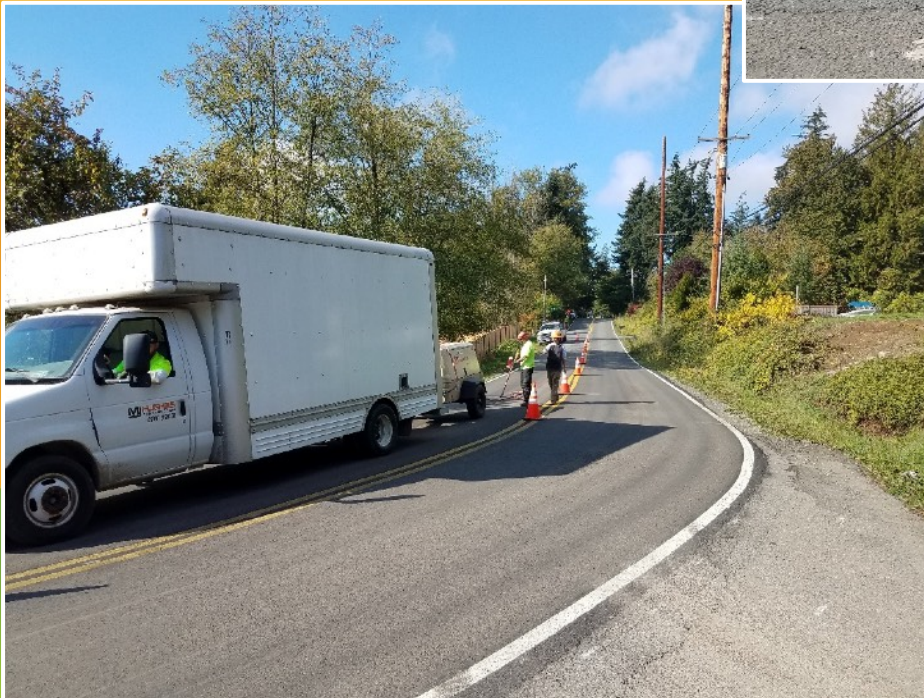
Dust removal

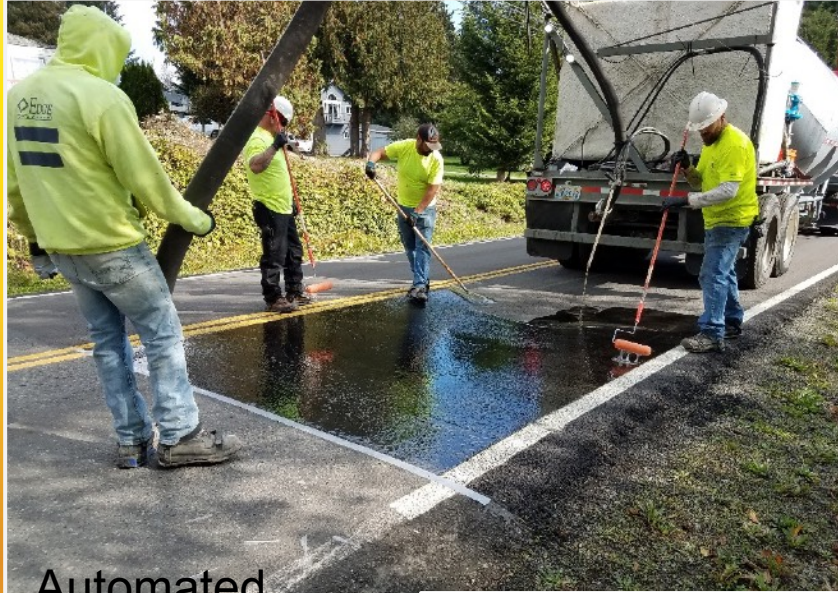
Applying epoxy

Automated

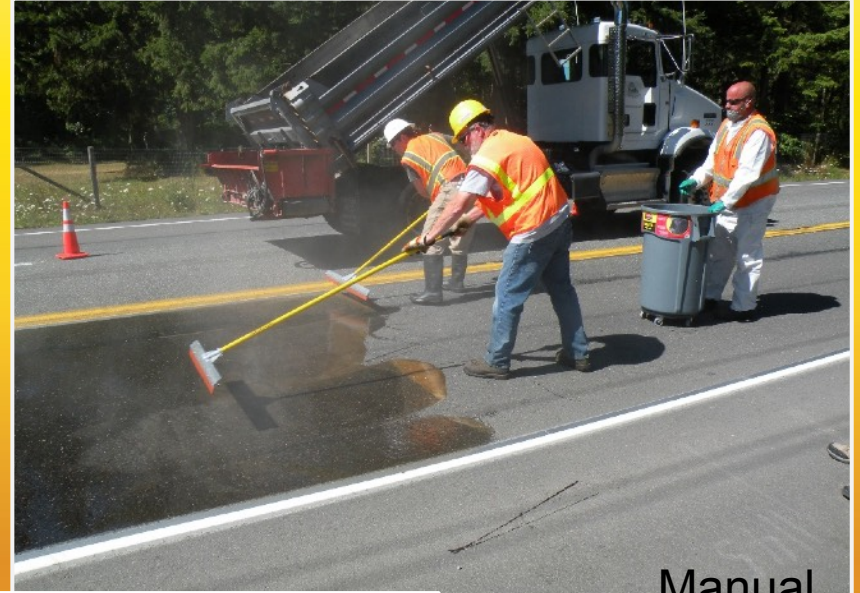
Manual

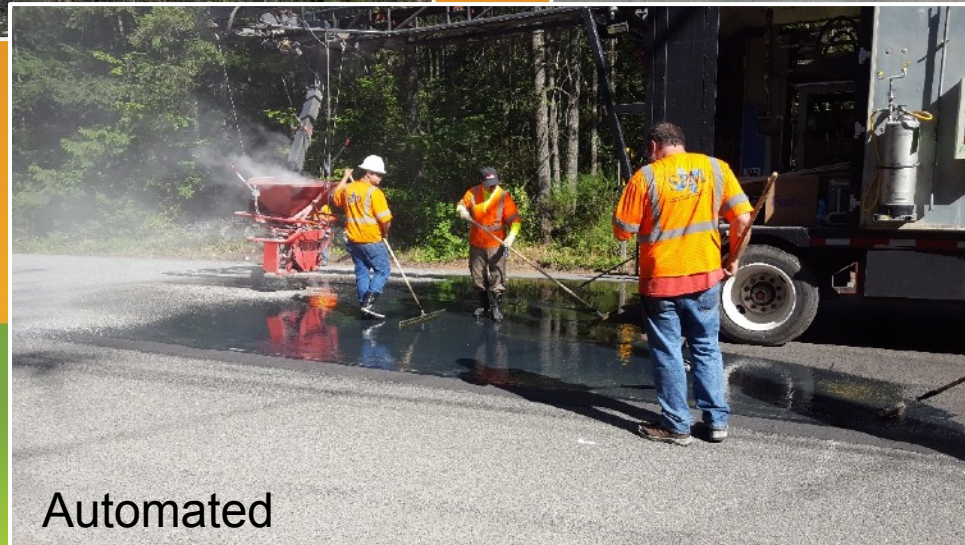
Automated

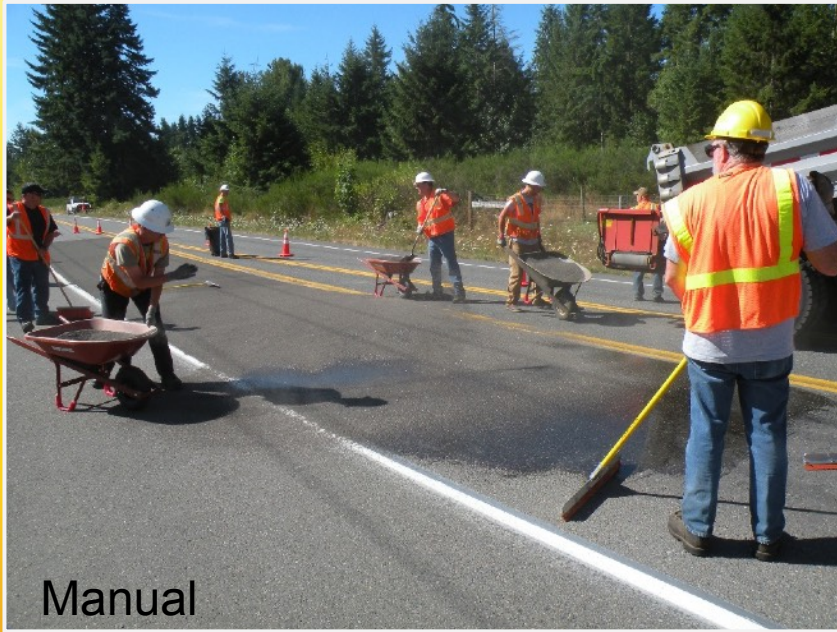
Applying calcined bauxite

Manual

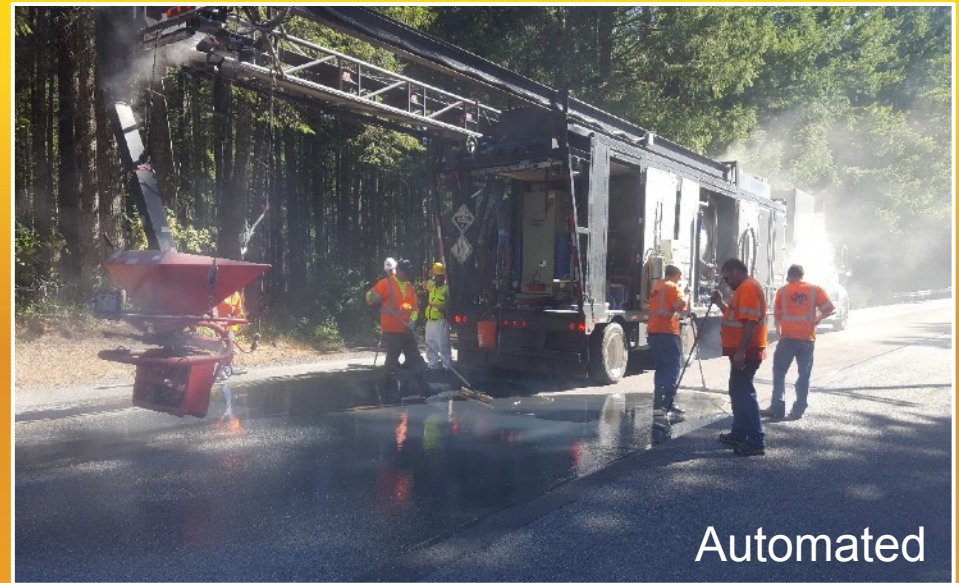
Automated

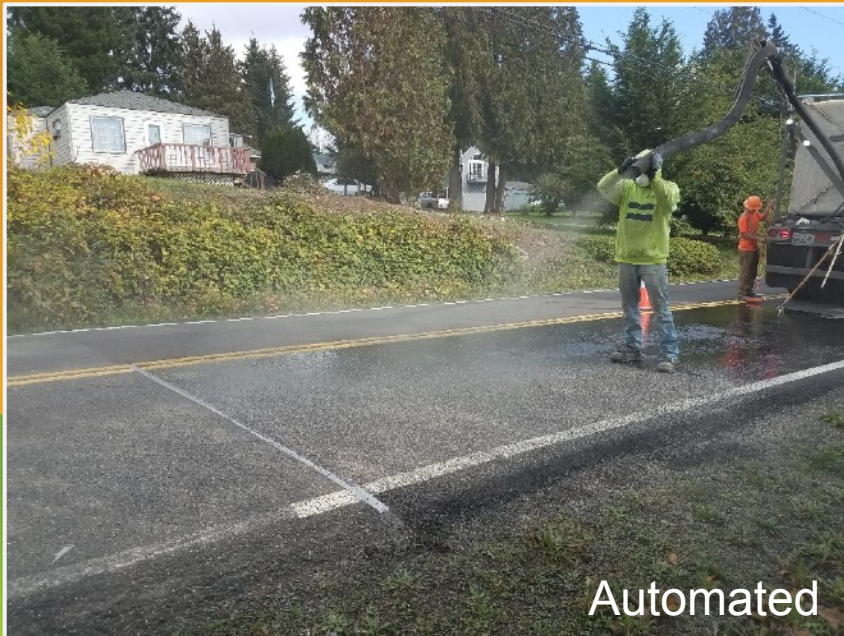
Automated

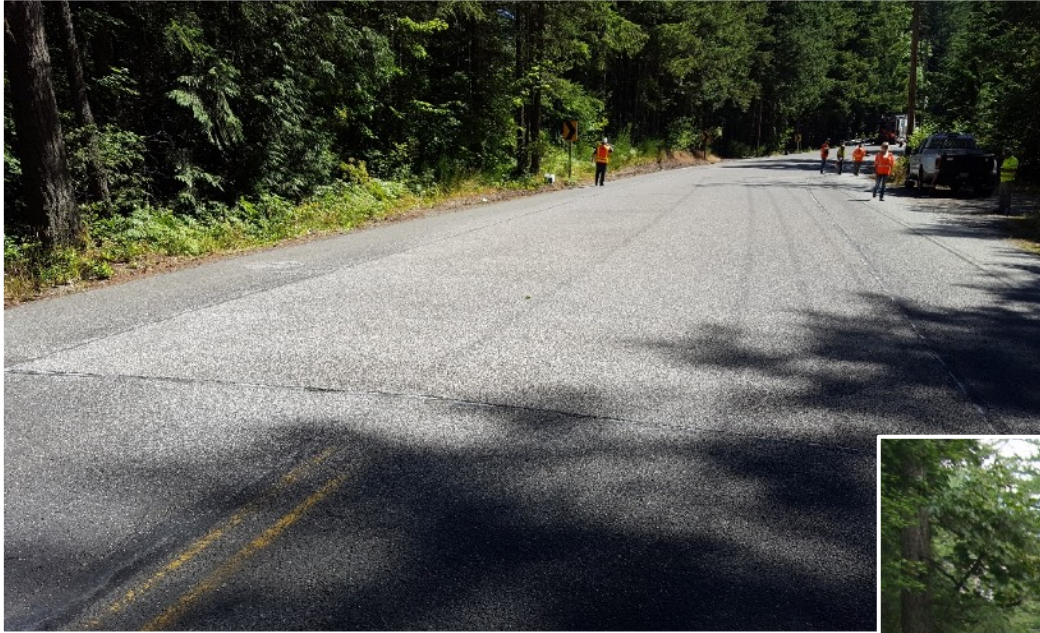
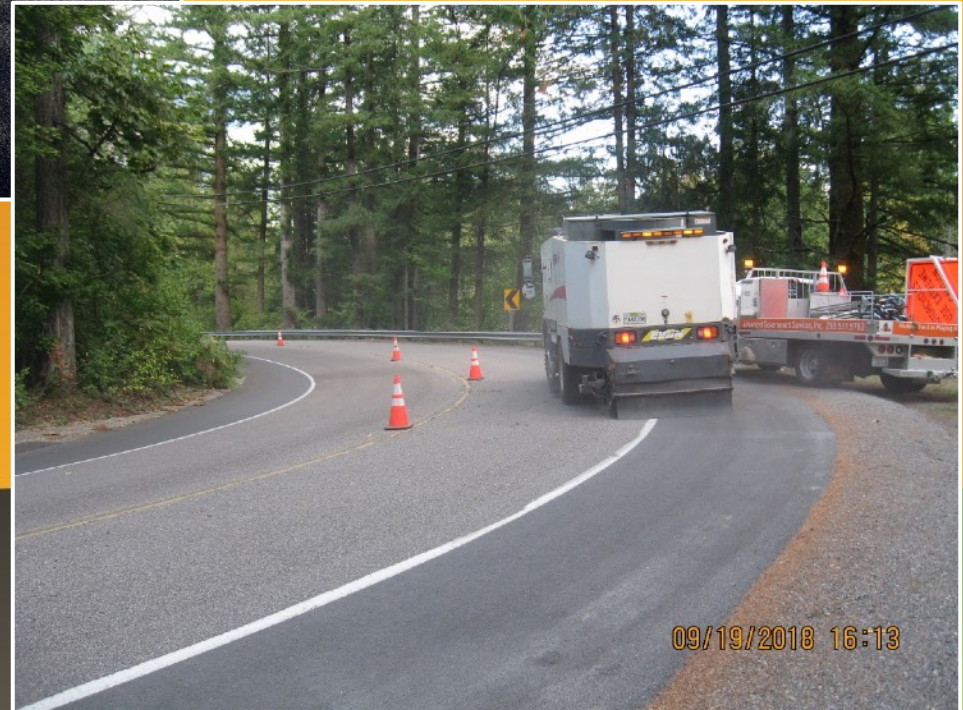
Curing & Sweeping

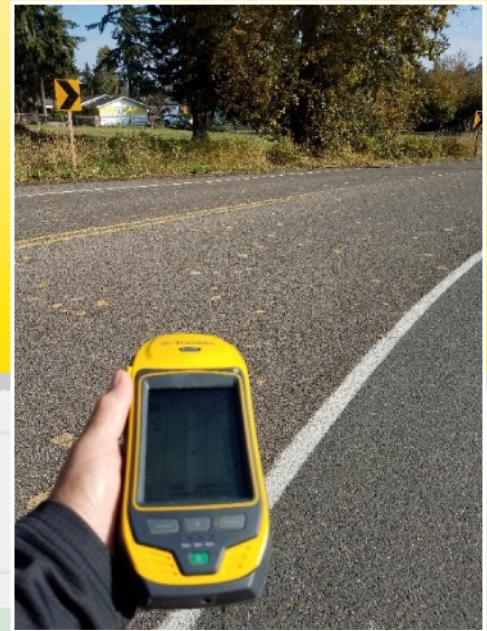
- Trimble GPS Receiver
- ArcGIS & ArcPad
- CityWorks

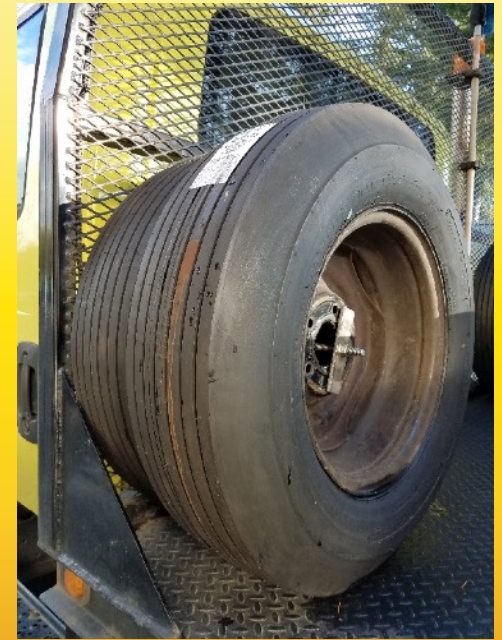
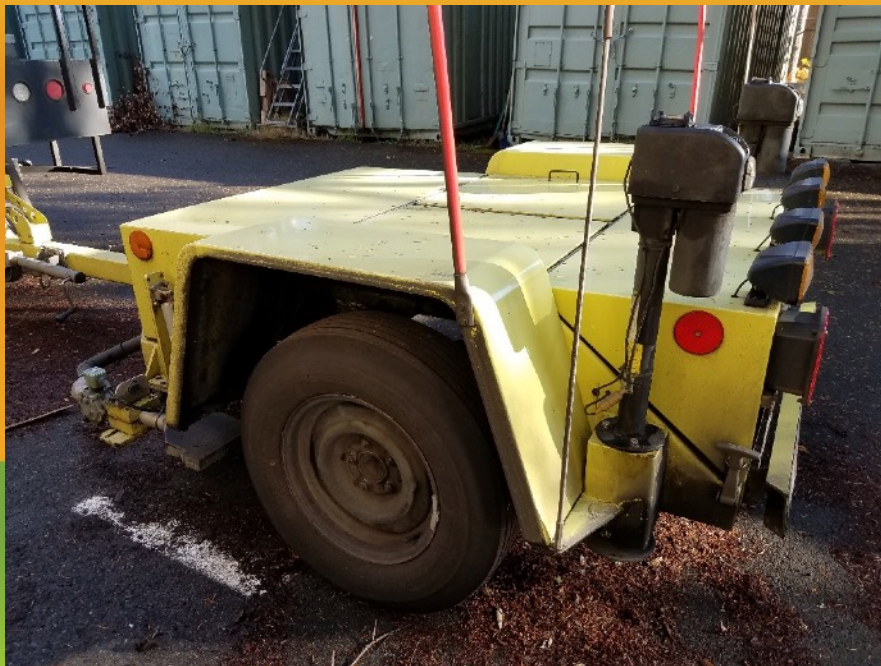
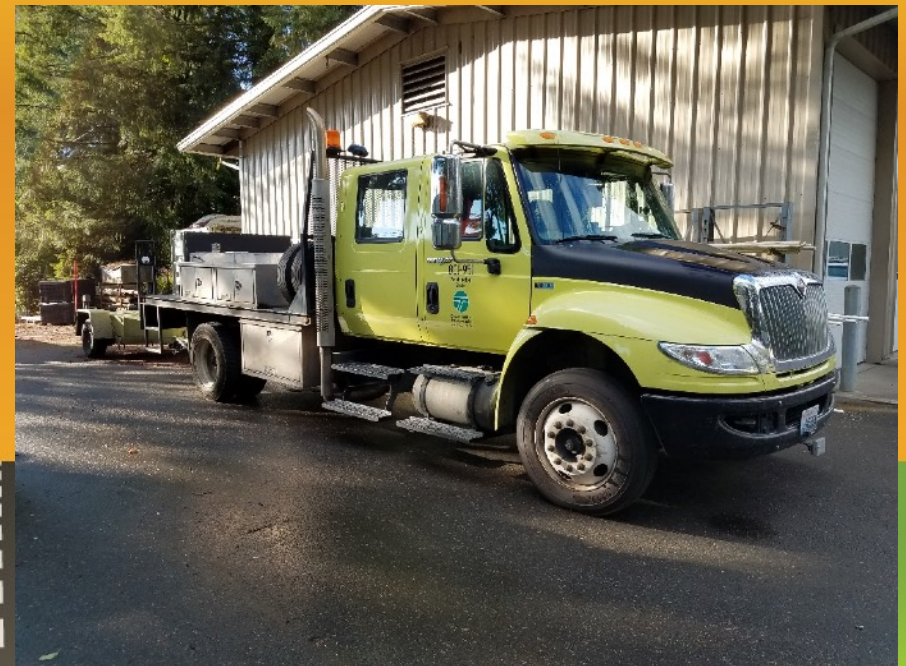
Maintenance *Testing*

- Locked Wheel Test
- Friction Number (FN)
- Tested annually

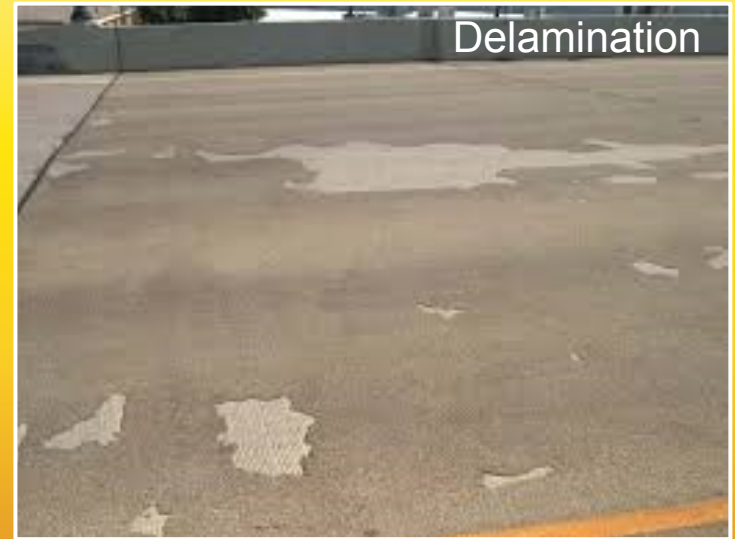
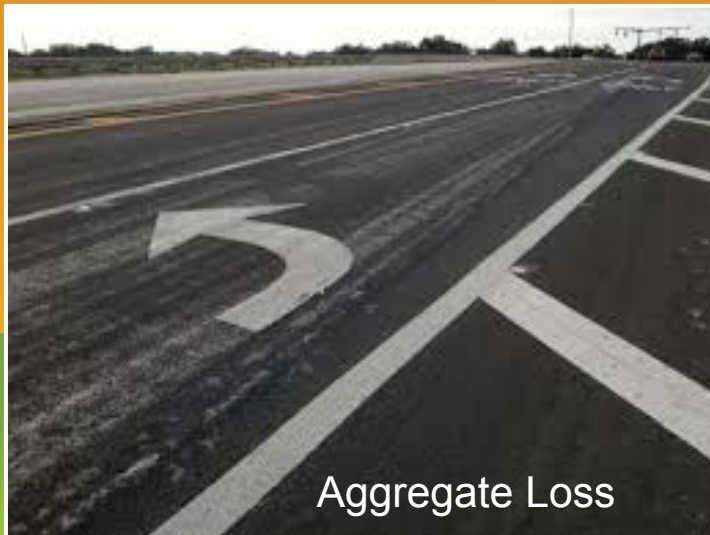
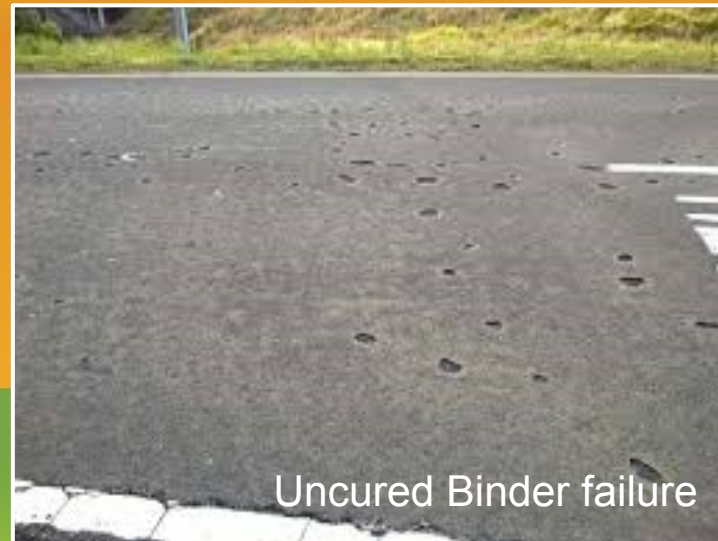
Potential problems

- Aggregate loss
- Delamination
- Uncured binder failure

Underlying pavement must be in good condition for long term performance of HFST

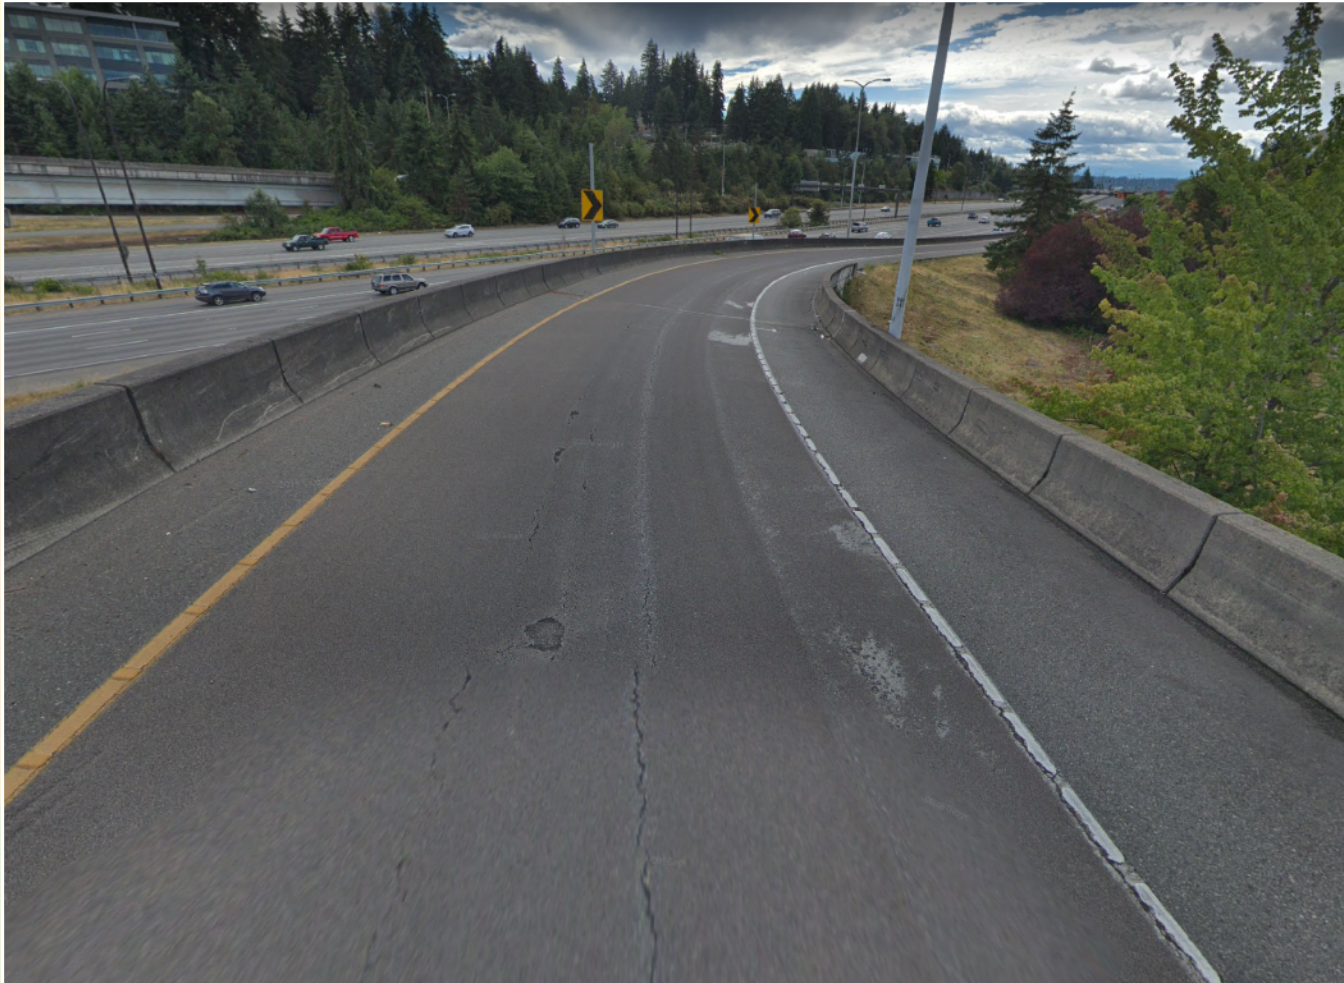
Substrate Failure

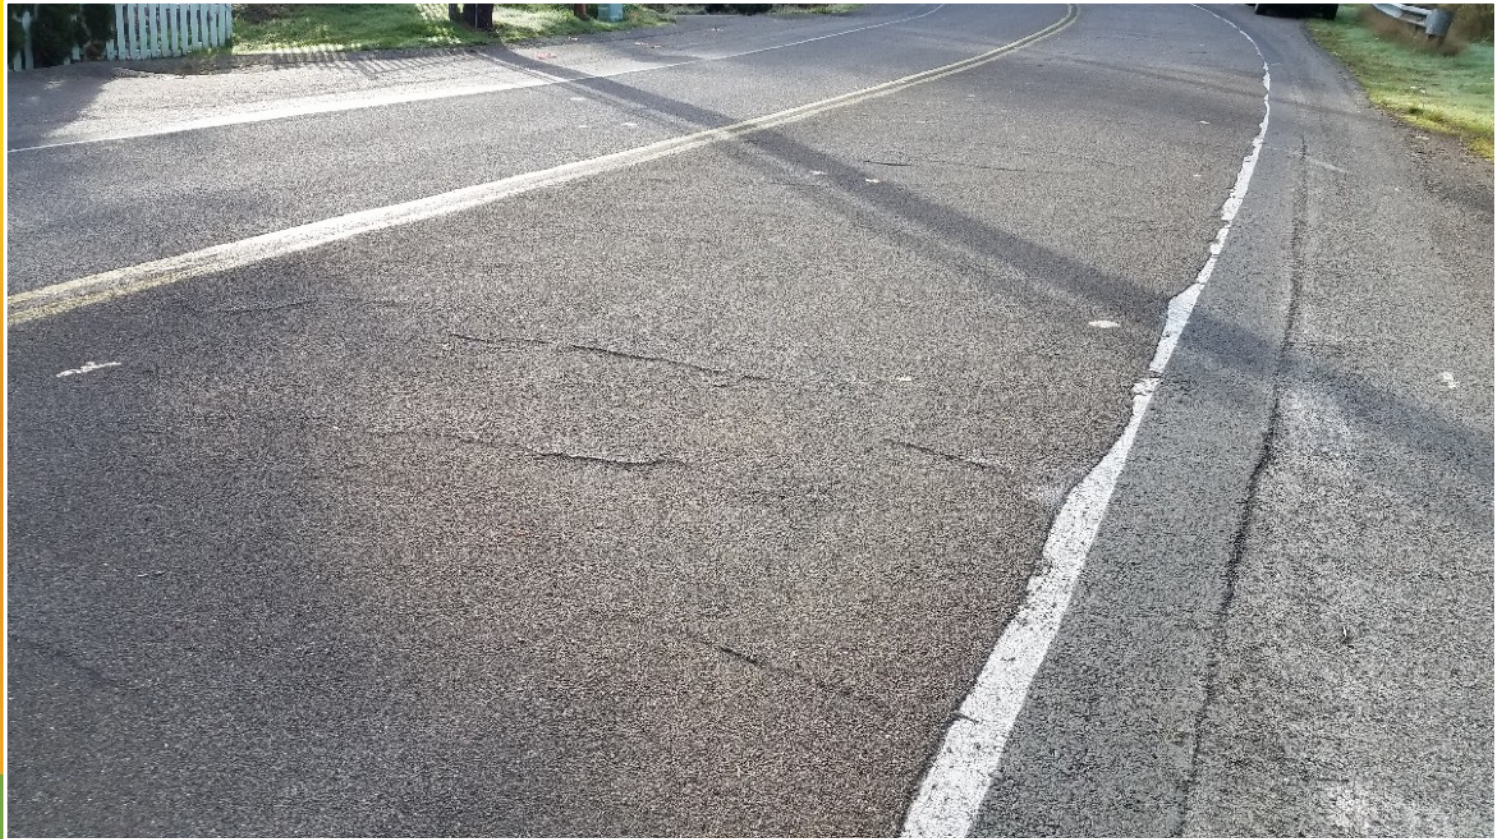
Slipping Epoxy

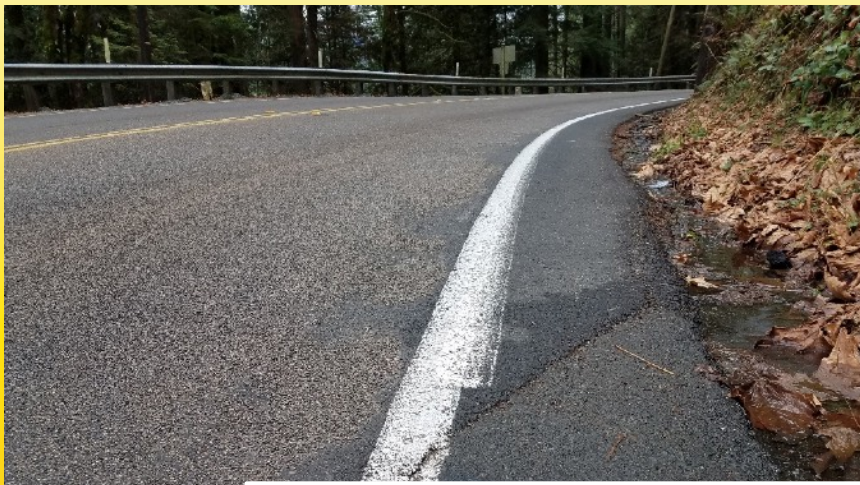
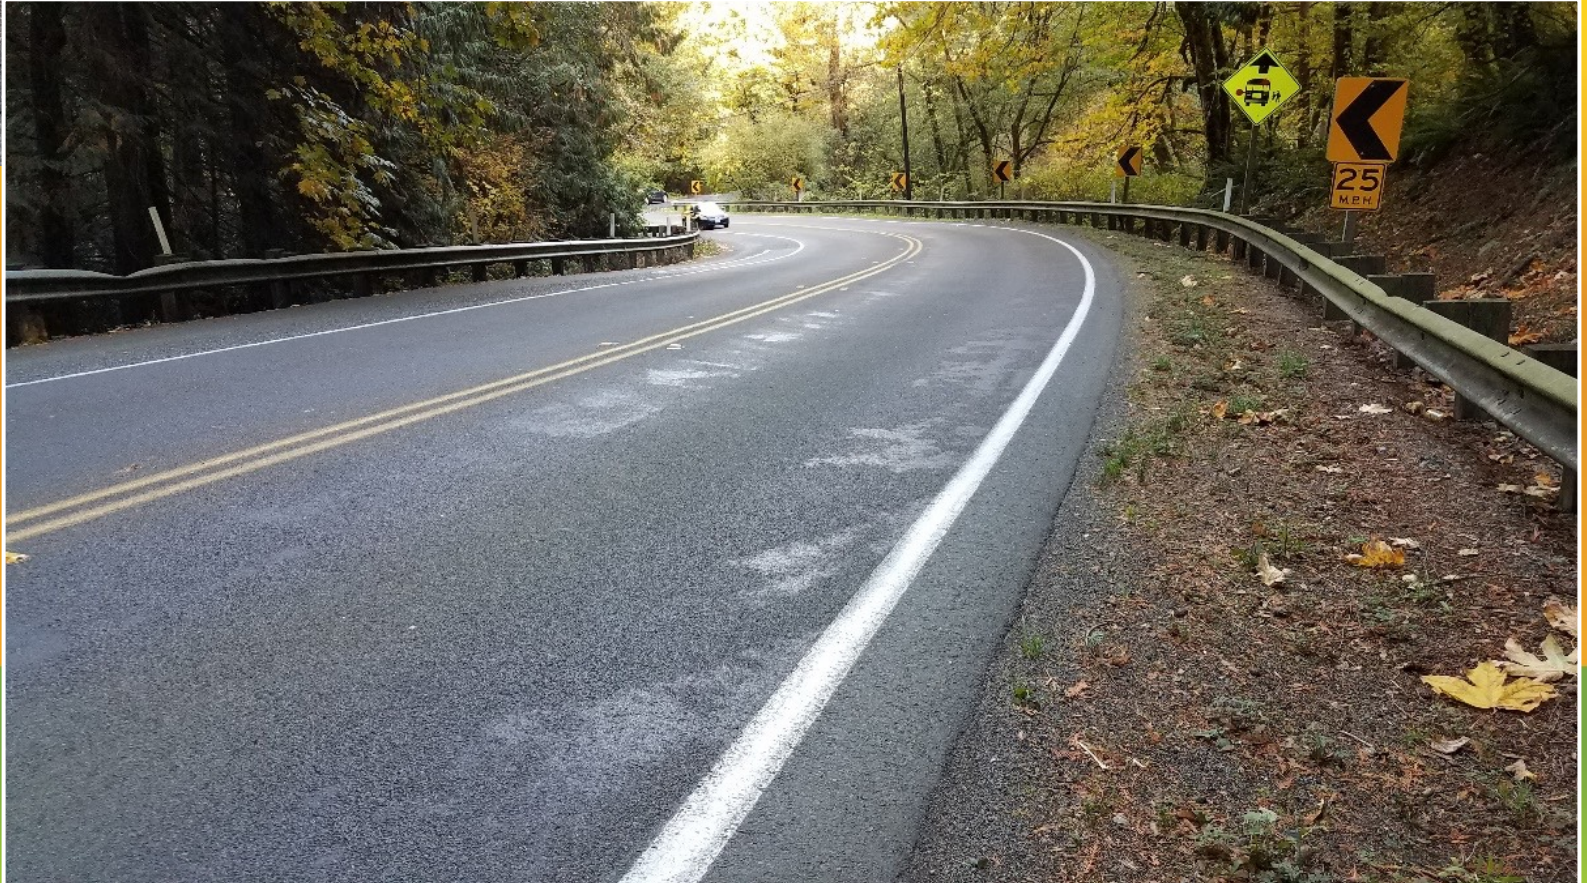
Aggregate Loss
