**The Streets of Seattle:**  
Collecting and assessing year-over-year pavement condition data for a unique network of pavements

**QES IMS**  
Infrastructure Management Services

NWPMA PRESENTATION

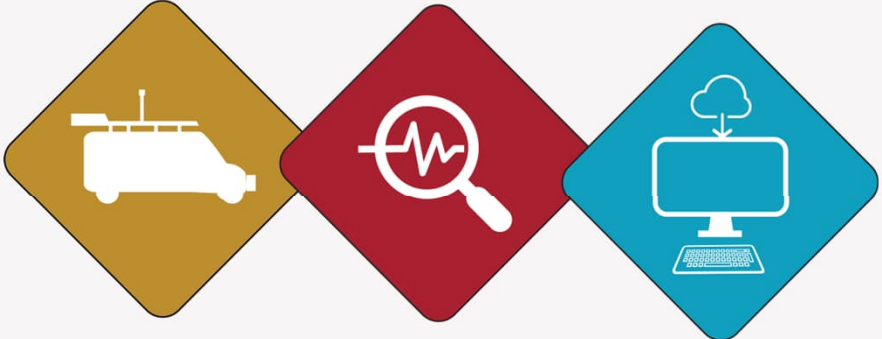
Drive™      Connect™      Inform™

# Unify Suite

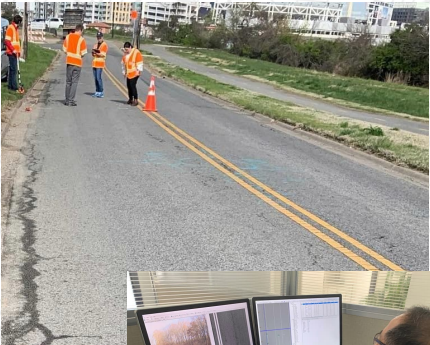
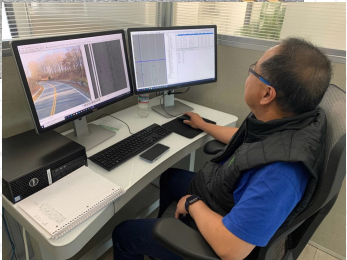
## USE OF MULTIPLE CALIBRATION SECTIONS

1. Ground Reference Measurements (2 QES Raters with SDOT Conformation)
2. Calibrate Semi-Automated Rating Process
3. Sampling Rate vs. Full Lane Survey

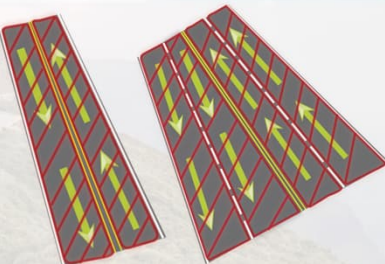
## SAMPLING VS FULL LANE SURVEYS

Manual PCI Surveys Based on Approx. 10% Sampling

Automated PCI Surveys – All Lanes  
*Good for Baseline Surveys*

Automated PCI Surveys – 1 Pass/2 Pass  
*Most Common Approach for Routine Surveys*

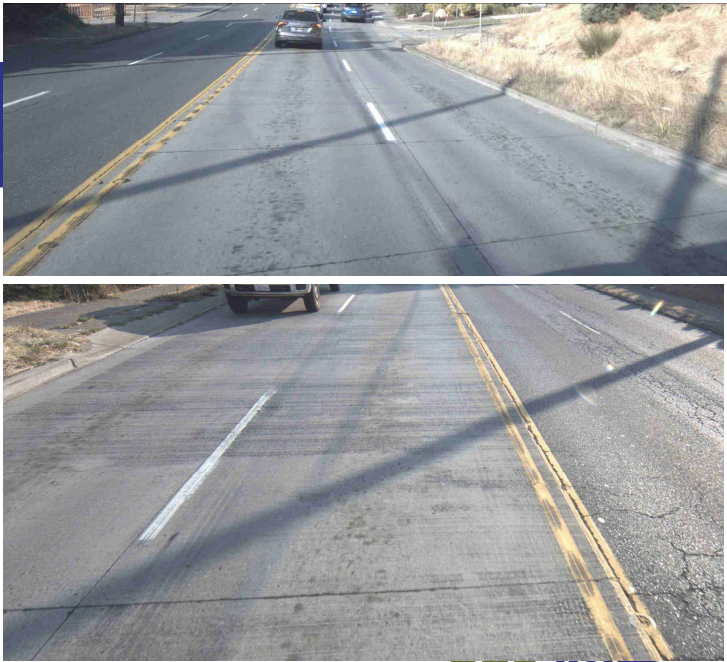
## CHALLENGES

- Primary and Secondary Segments Associated with the Same Centerline ID
- Multiple Pavement Types in the Same Block
- Urban Area with Dense Traffic and Parked Cars

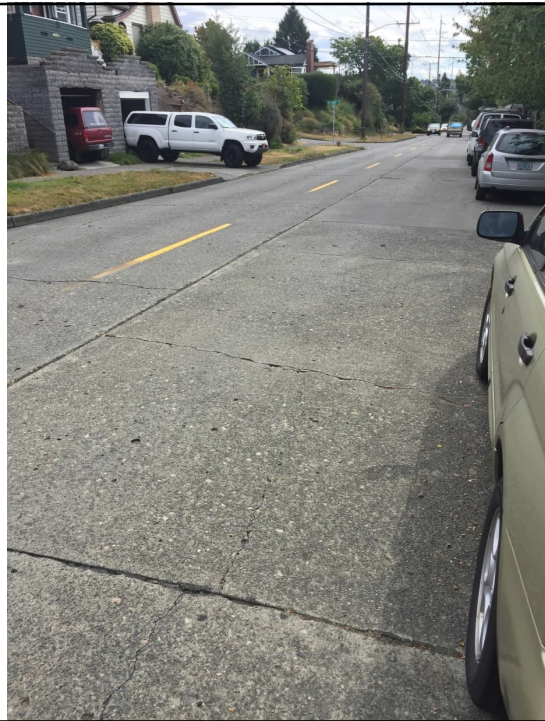
## JOINTED CONCRETE PAVEMENT CHALLENGES

- Non-Typical Joint Configurations
- Longitudinal Joints Don't Match Lane Striping
- Wide Slabs
- Parked Cars

- 100% Manual Image Reviews
- Outlier Analysis
- Google Earth Street View
- Compare to Last Survey
