Managing Risks on Your Pavement Preservation Project

City of Tigard

Case Study: City of Tigard

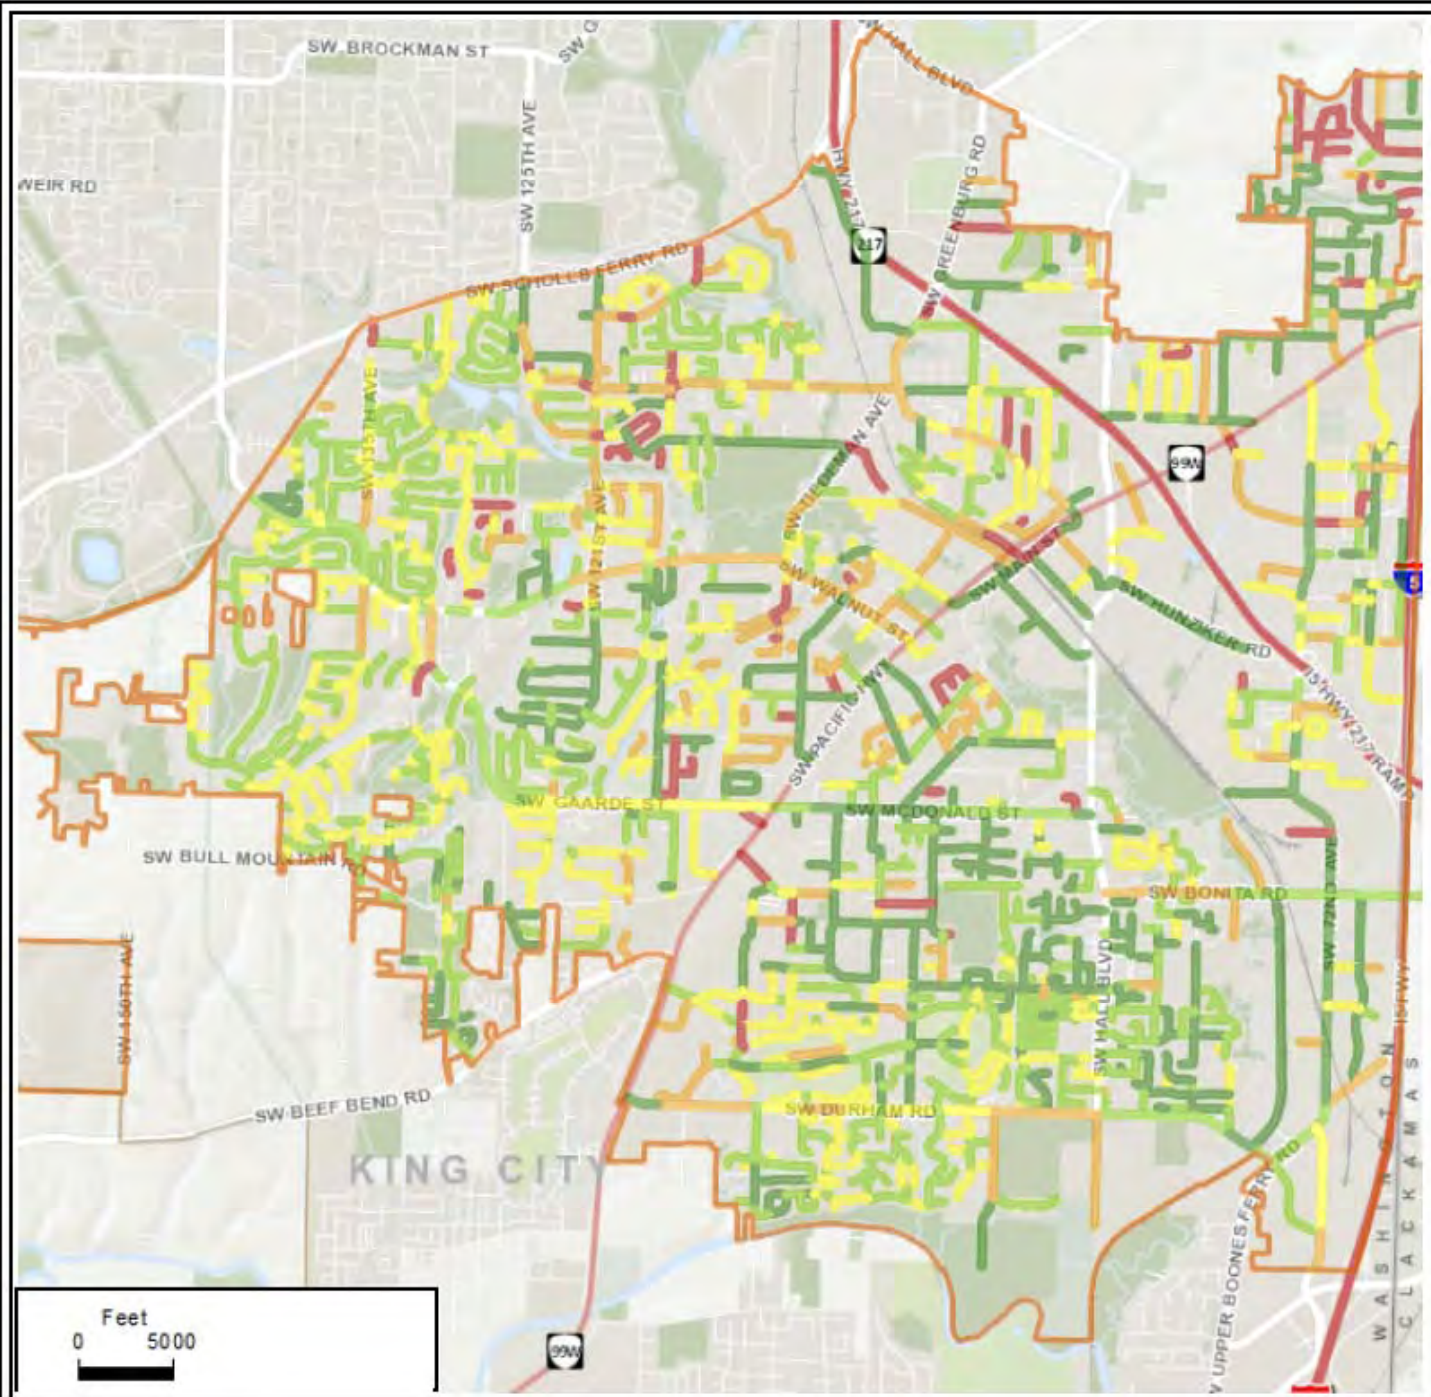
Pavement Condition Index

- Pavement Condition
- █ Very Good
 - █ Good
 - █ Fair
 - █ Poor
 - █ Very Poor
 - No Data

PCI: 71

Backlog:
22 Miles

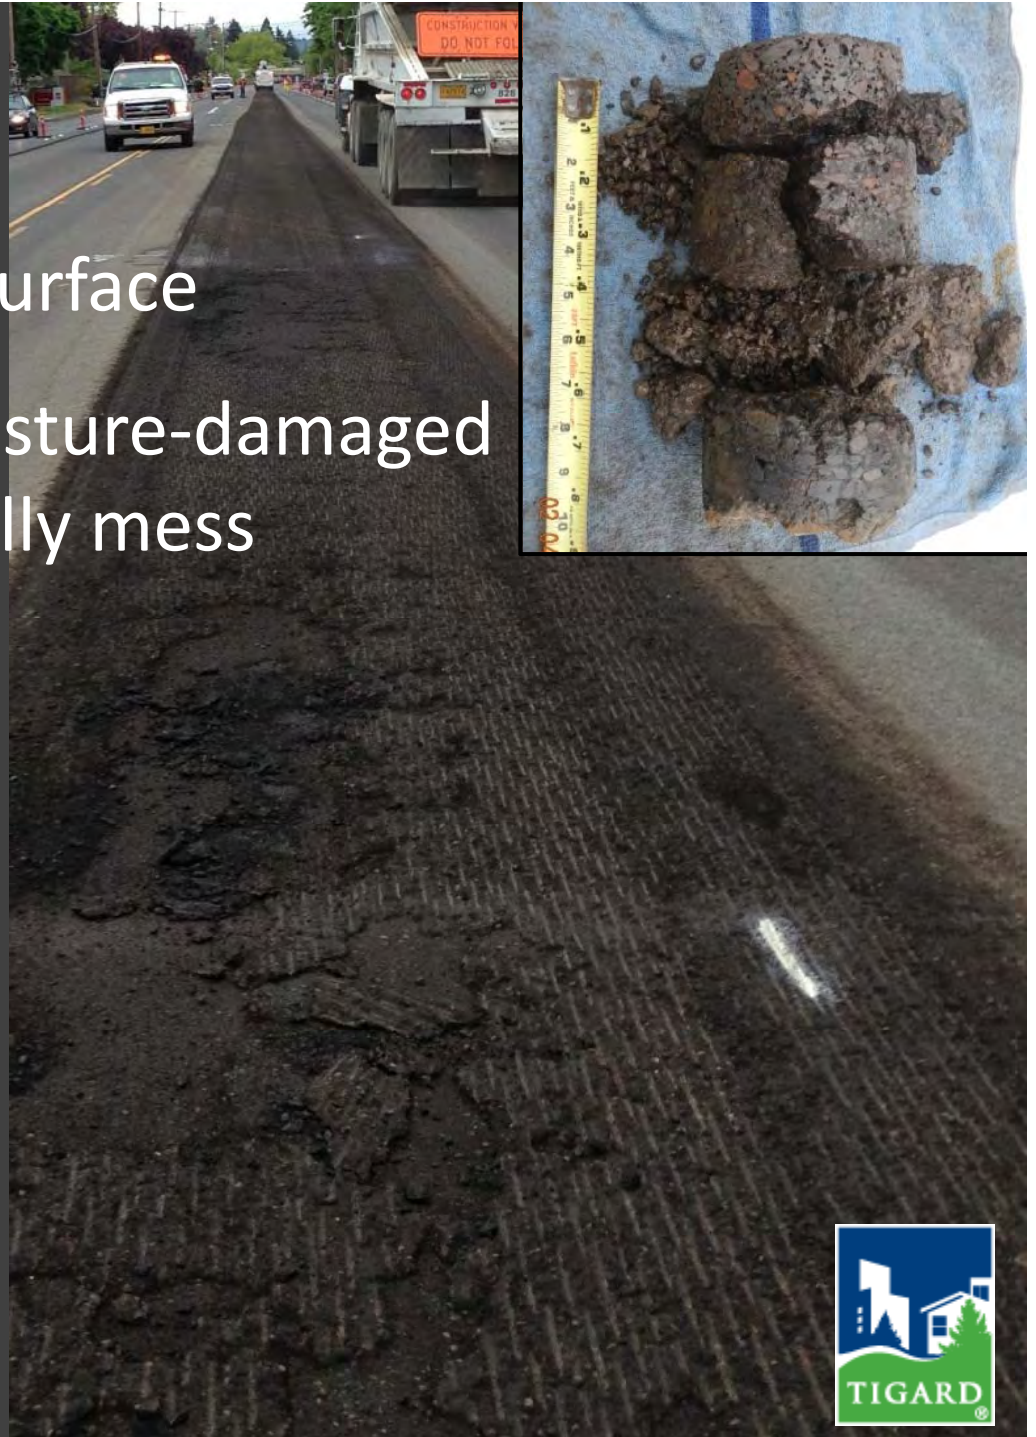
Moisture Damage

- Not readily visible from surface
- Milling into or above moisture-damaged pavement causes a gravelly mess
- Detection
 - Core
 - Ground penetrating radar
- Risks:
 - Deeper grind
 - More AC

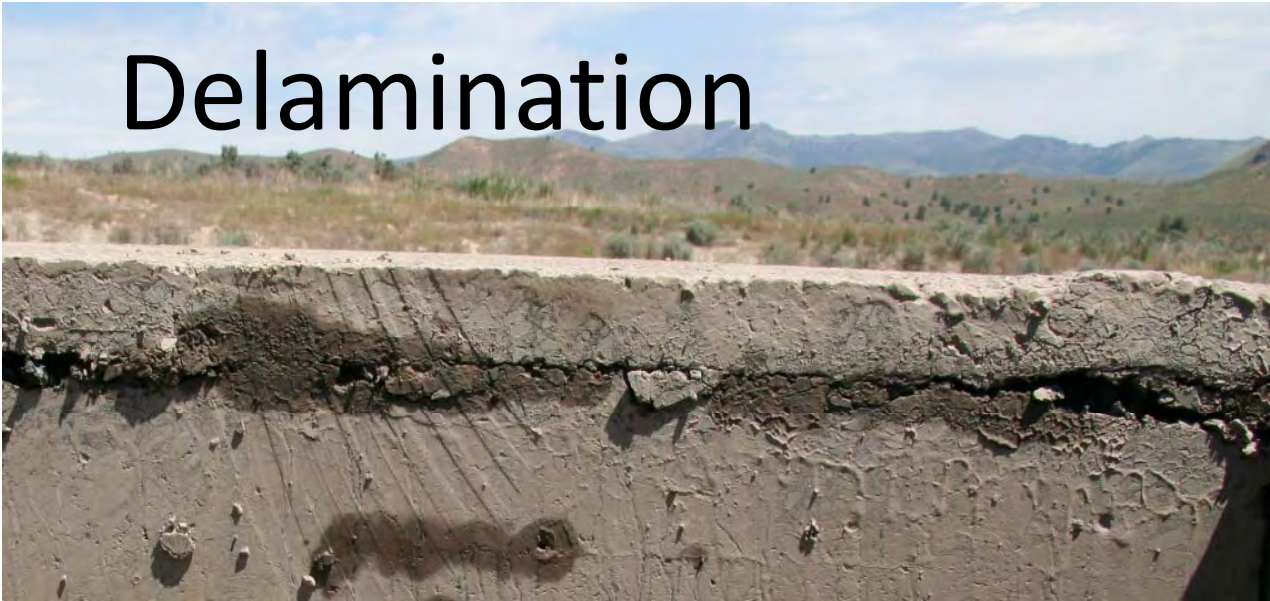
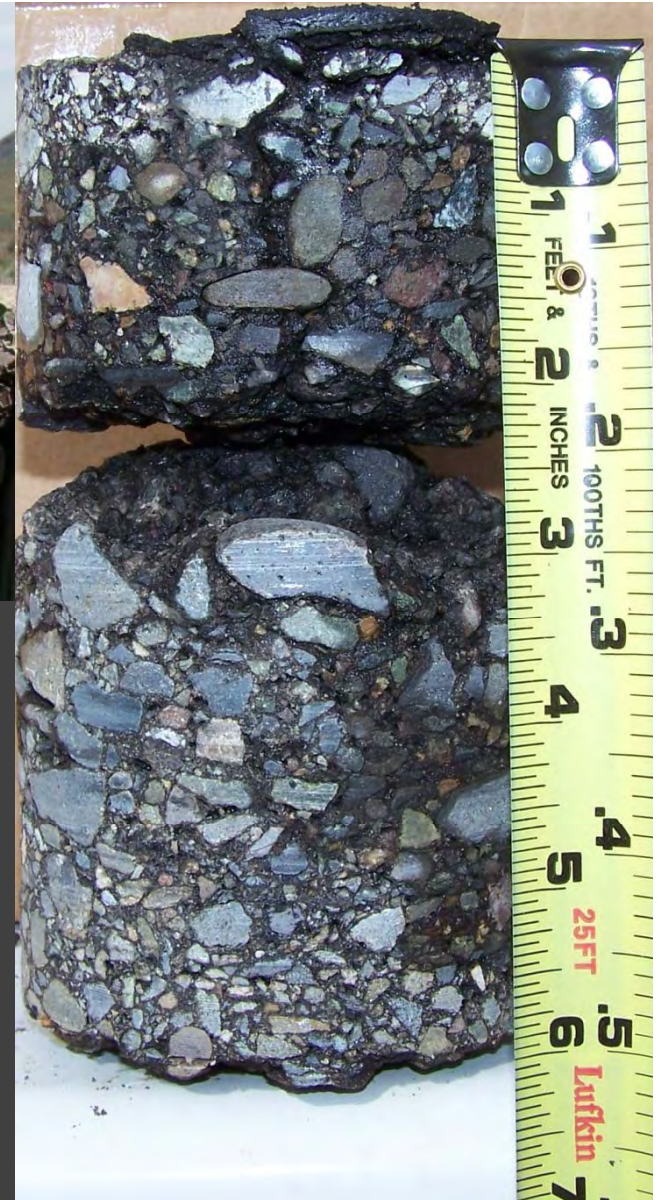
Delamination

- Commonly not visible from surface
- Detection and repair same as for moisture damage
- Risks:
 - Deeper grind
 - Increased AC

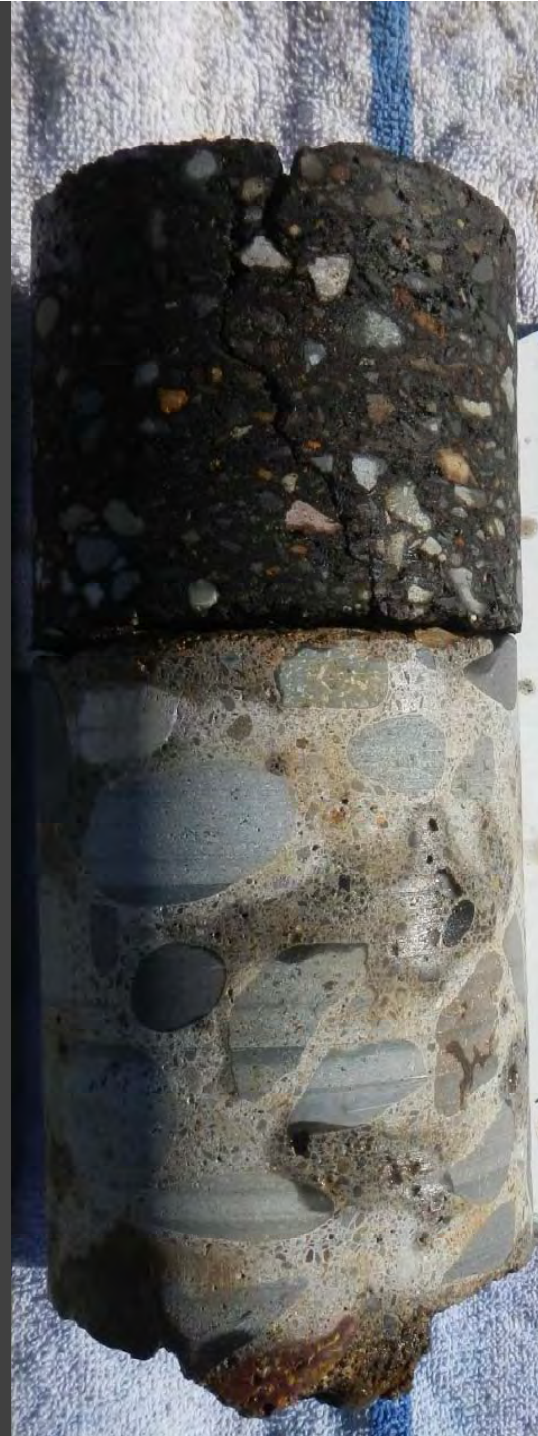
Variable Pavement Conditions

- Widened roads
- Overlain trench patches
- Thickness variation
- Composite pavement
- Detection:
 - As-built drawings
 - Cores
 - Ground penetrating radar
- Risks:
 - Accelerated distresses
 - Extra work at time of construction
 - Reflective cracking
 - Variable life of treatment

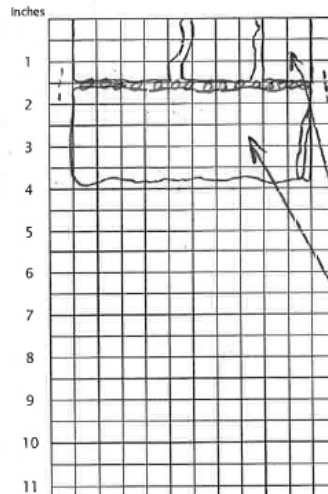
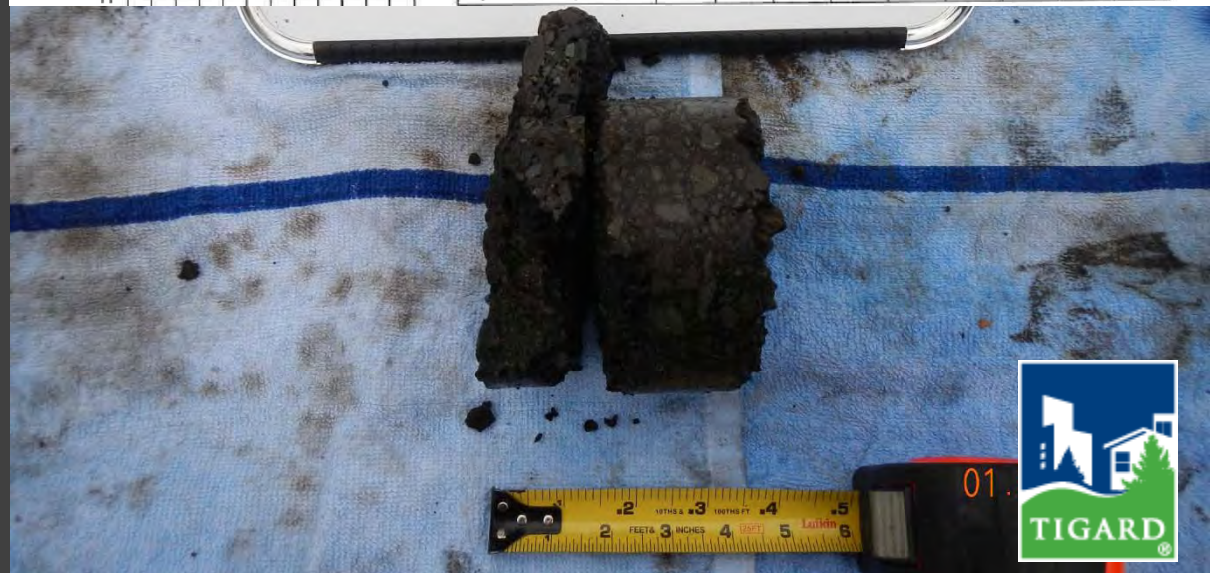
PAVEMENT CORE LOG

Core Length: 3 3/4"	Aggregate Depth:	GDI Project: Tigard -23	Core Number: C-3
Core Size: 5"	Final Depth:	Project Name:	Page: 1 of 1
		Street Name / Direction / Travel Lane: N Dakota St WB OWT	Core Date: 1-22-15
		Drilling Contractor: Dan F Dan	Start Time:
		Coring and Sampling Methods:	Station:
			Sampled By: JGH

Cored Through Patch: Yes No
 Cored On Crack: Yes No
 Comments for PM: **Mod Fat**
NB & SB OWT Mod Fat intermittent
min low Block cracking in center
Raveling low-mod

TYPE						CONDITION		
	Dense AC	Open AC	PCC	CTB	Oil Mat	Other	Good	Fair	Poor
Layer 1 Description:	X						X	X	
Layer 2 Description:	X						X		
Layer 3 Description:									
Layer 4 Description:									
Layer 5 Description:									
Layer 6 Description:

- Agency benefit:
 - Pavement thickness data
 - Cracking depth
 - Moisture damage measurement
 - Aggregate base condition

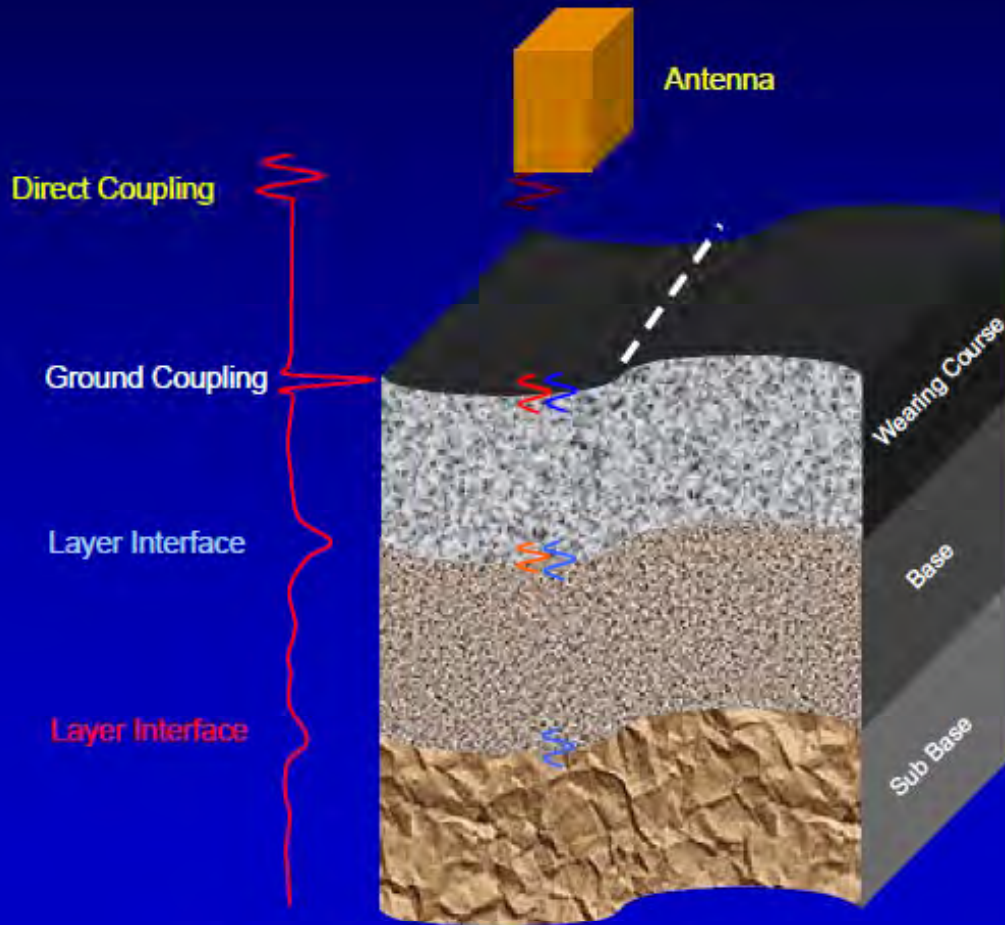
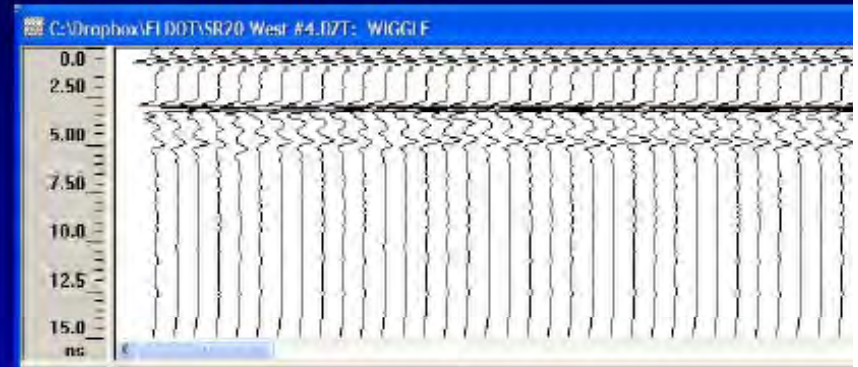
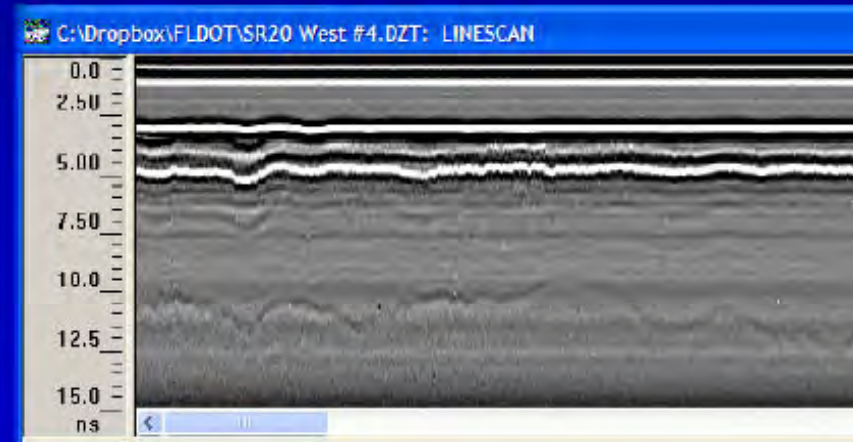
Understanding GPR

Reflections are produced when the pulse encounters a material with different dielectric constant

Dielectric Constant: Air = 1 Asphalt = 3-5 Concrete = 6-8

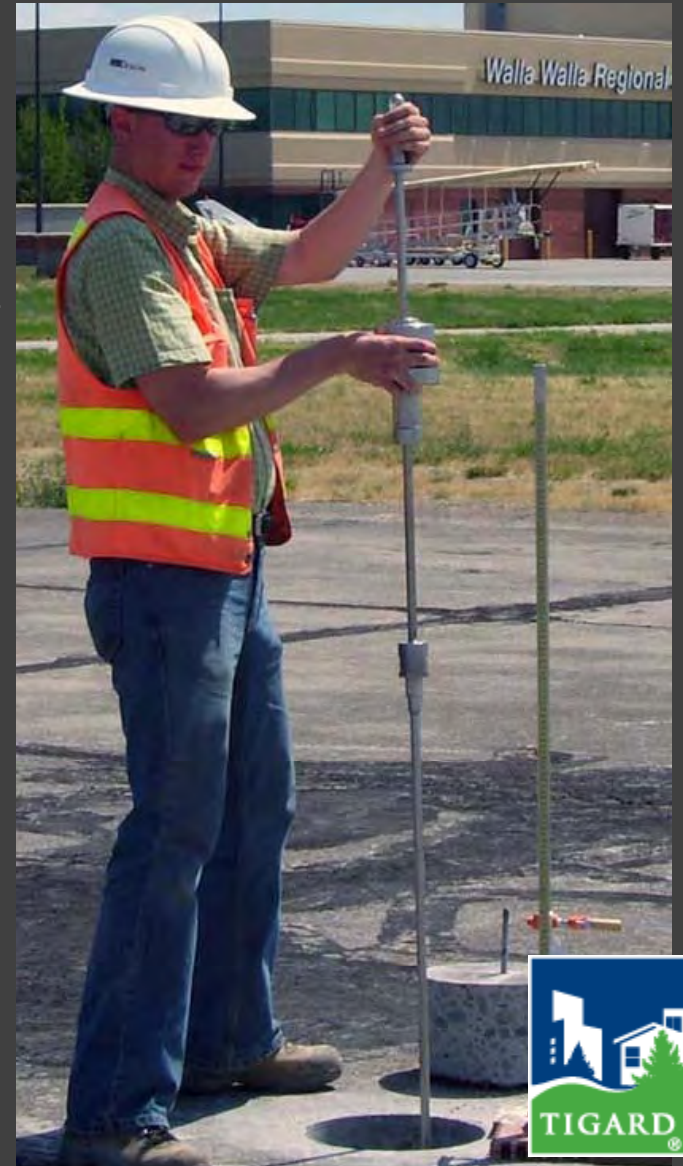
Dynamic Cone Penetrometer (DCP)

- Agency benefits:
 - Inexpensive
 - Assessment of layer properties beneath surface layer
 - Accurate rehabilitation design
- Drawbacks:
 - Requires access to base layer
 - Limited evaluation locations

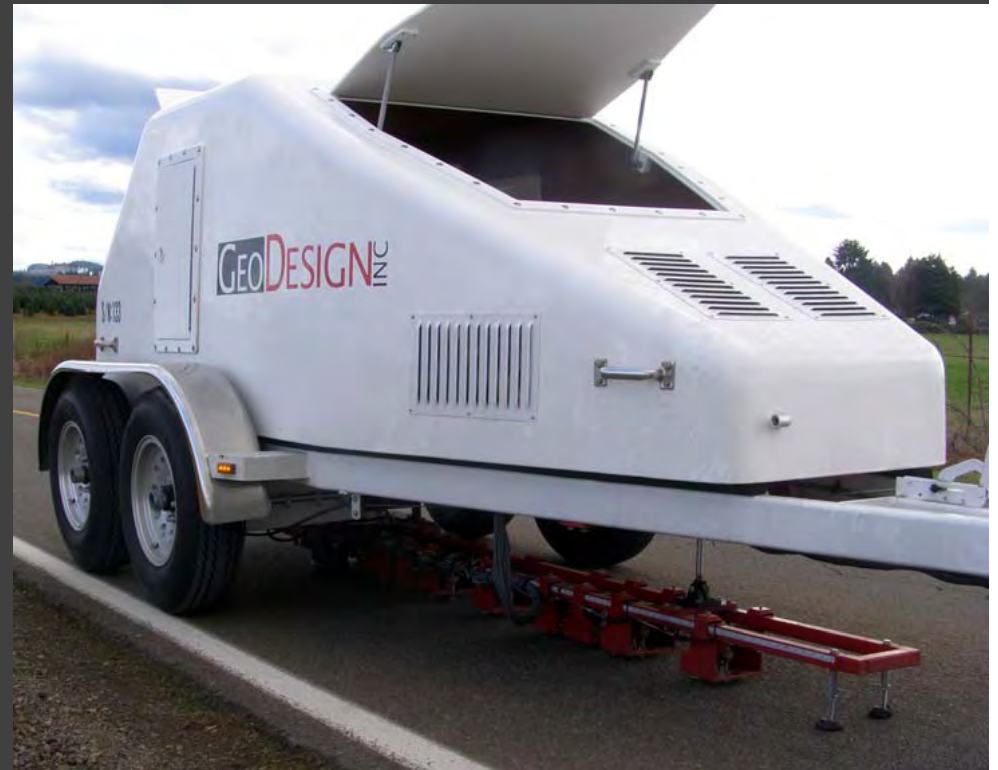
Falling Weight Deflectometer (FWD)

- Agency benefits:
 - Non-destructive
 - Direct pavement capacity assessment
 - Accurate rehabilitation design
- Drawbacks
 - More expensive
 - Calculation intensive

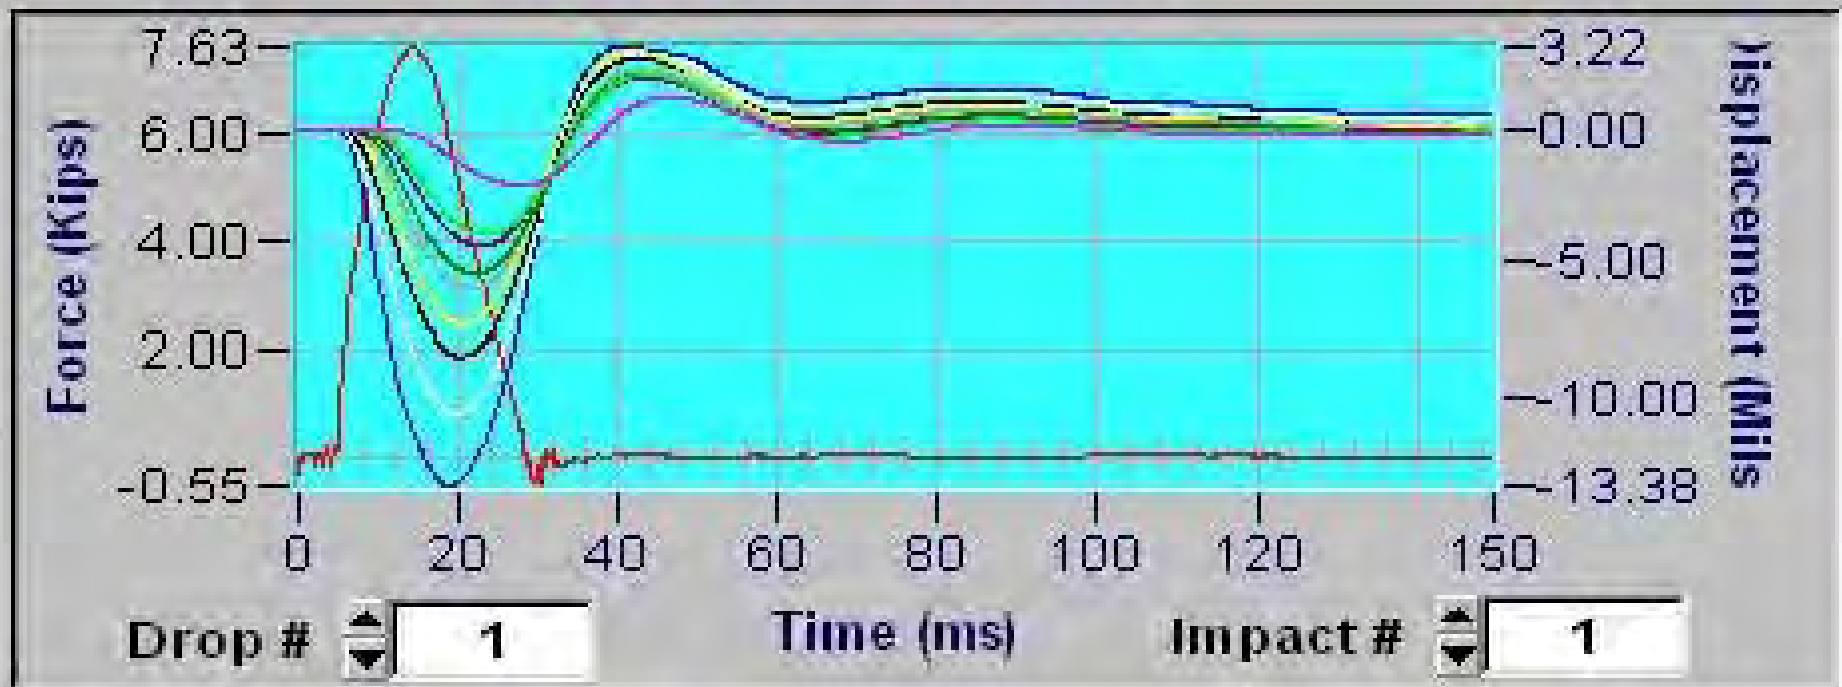
Understanding FWD

Force & Displacements

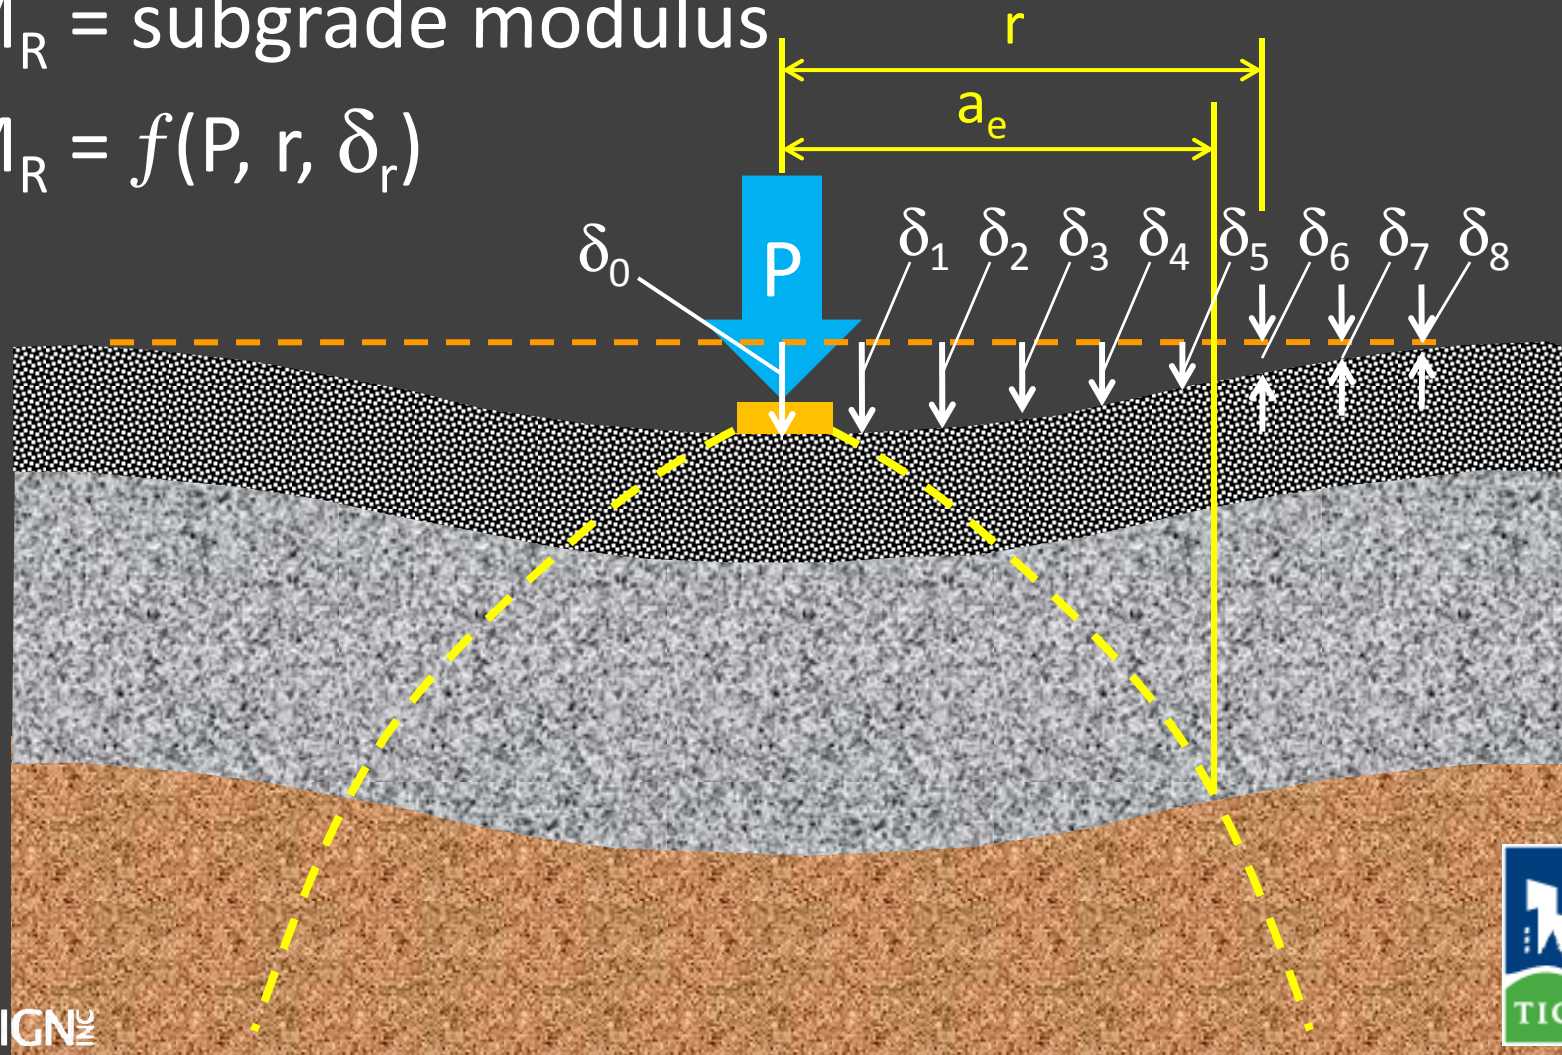
Understanding FWD

- M_R = subgrade modulus
- $M_R = f(P, r, \delta_r)$

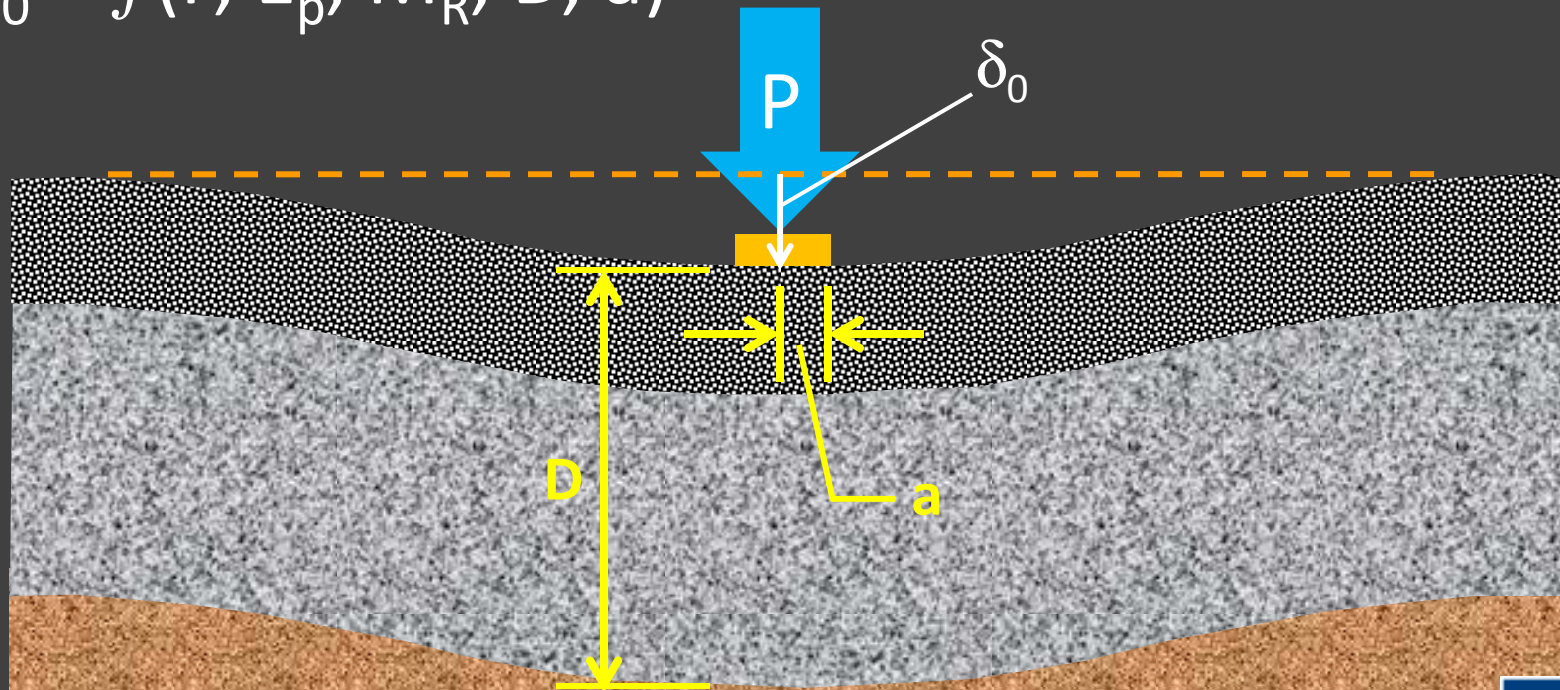
Understanding FWD

- E_p = effective pavement modulus
- $\delta_0 = f(P, E_p, M_R, D, a)$
