Building **HIGHER PERFORMING** HMA Pavements with High Tensile **REINFORCEMENT**

HMA Pavement Reinforcement

HMA Pavements Rehabilitation for Higher Performance

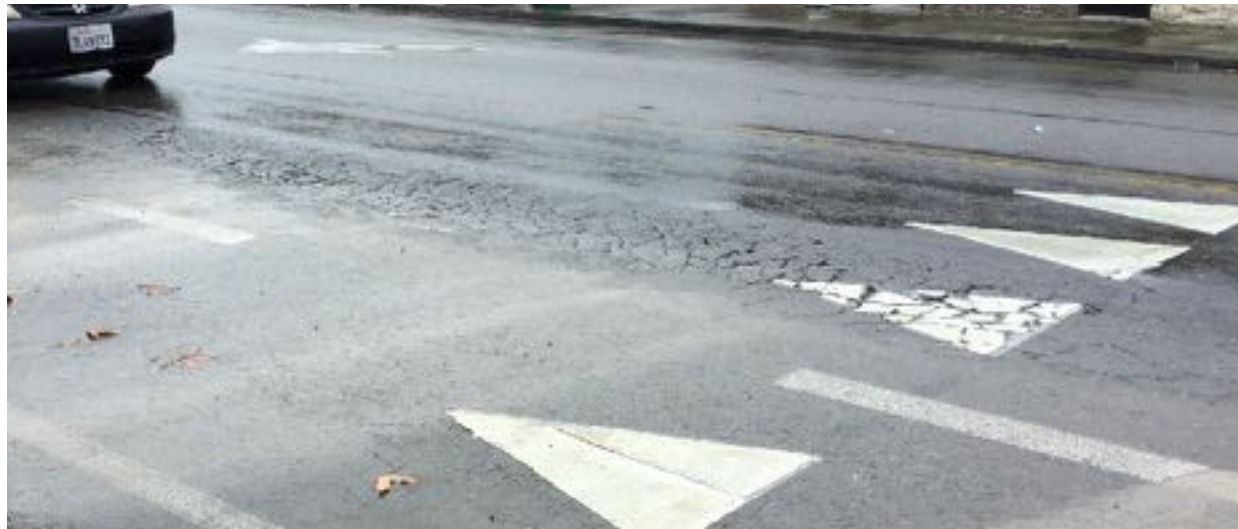
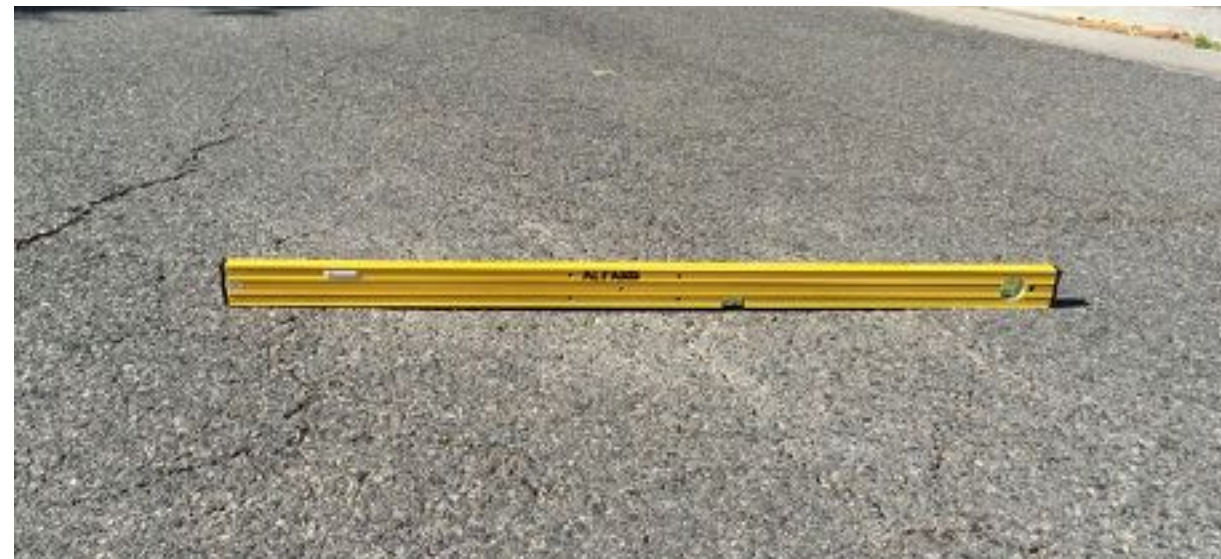
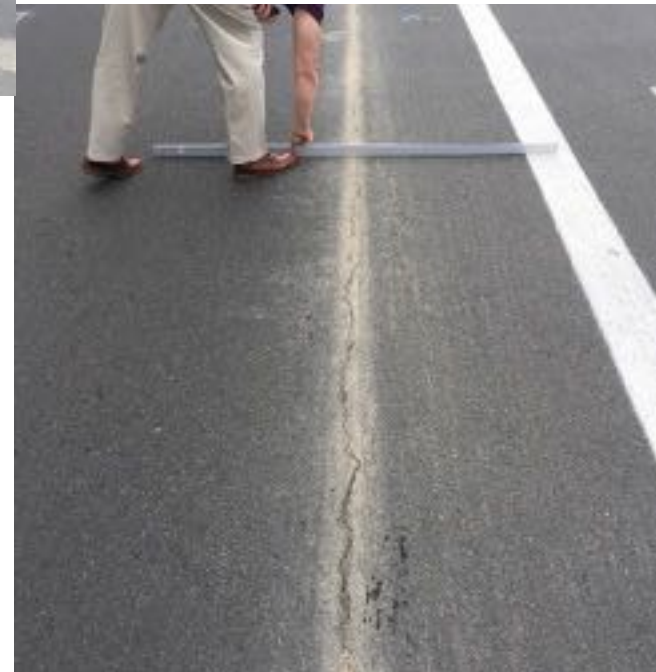
Reading A Road – Base Issues

**Check for
Rutting**

Greater than $\frac{3}{4}$ " depth is a concern

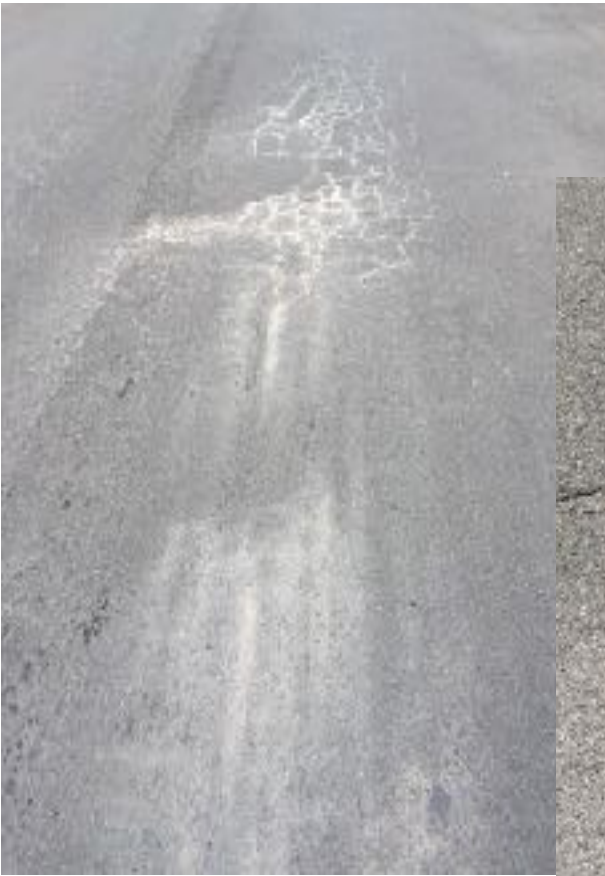
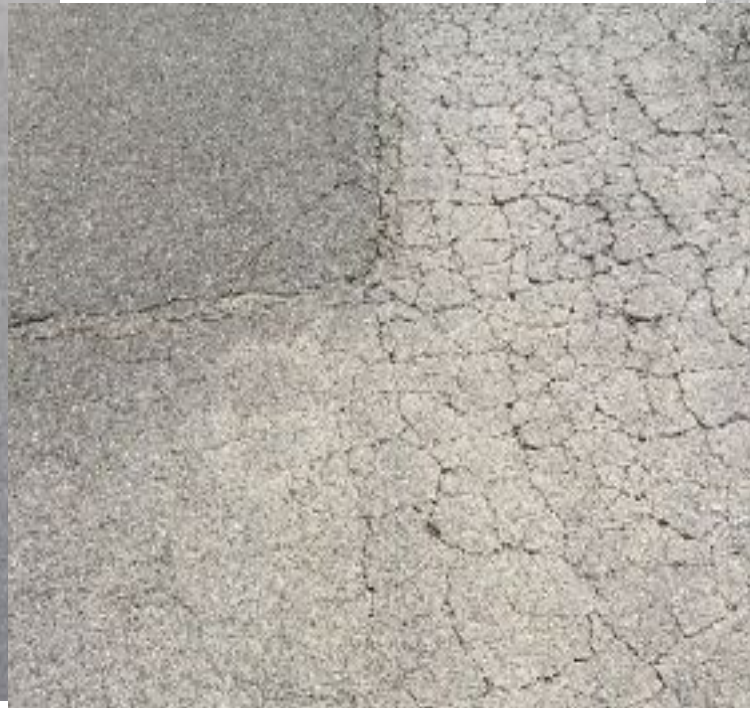
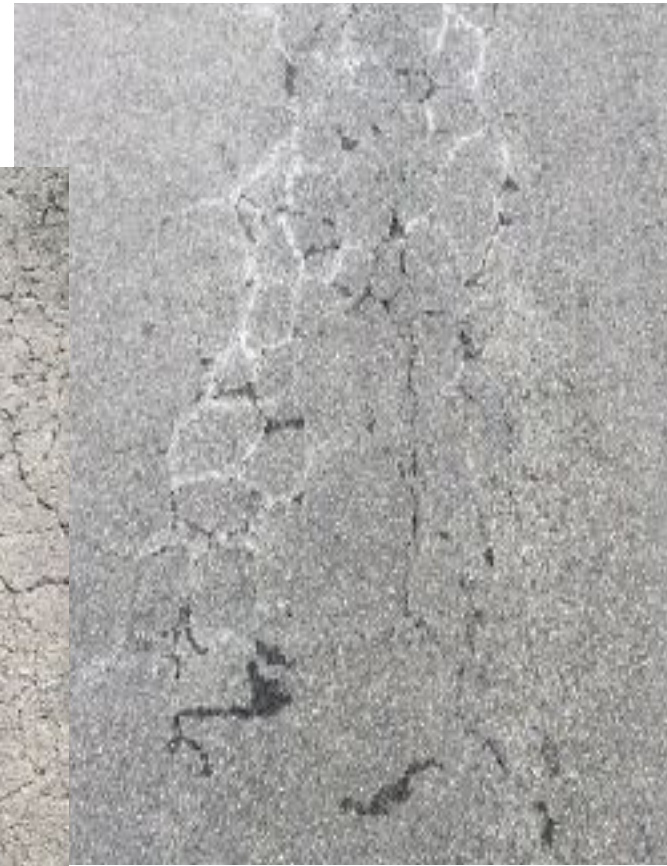
Reading A Road - Base Issues

**Check for
Pumping**

Alligator/Chicken Wire with fines
pumping

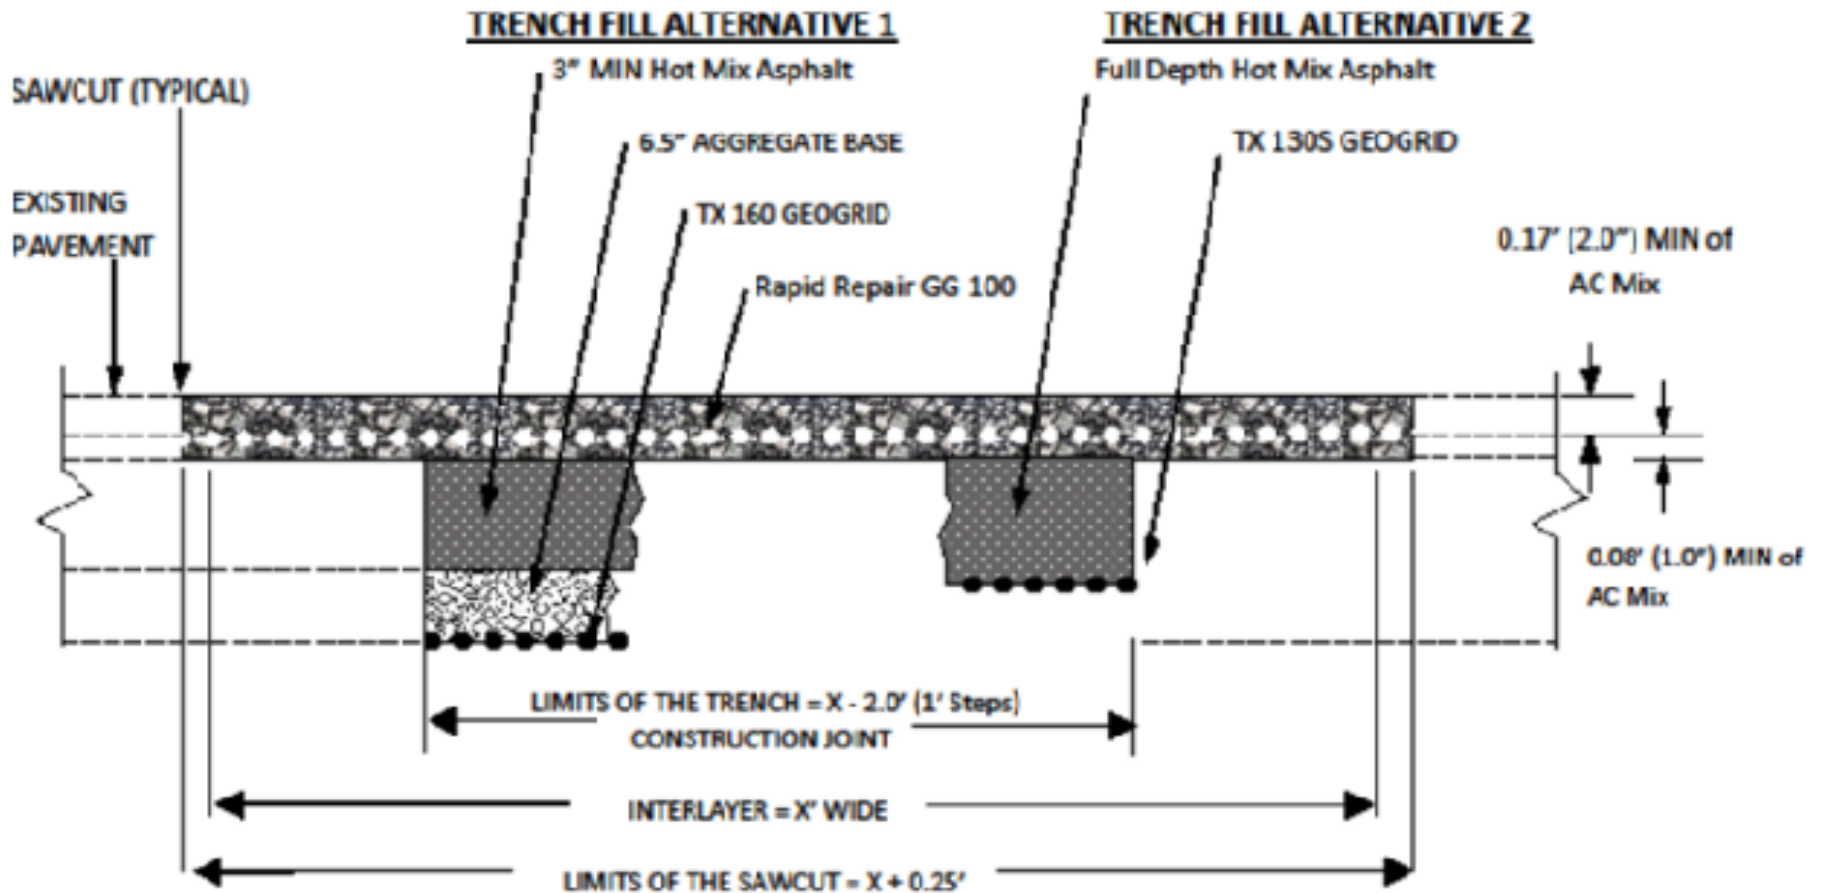
Trench Cut- Dig Out Repairs

TriAx Geogrid & Rapid Repair GlasGrid 100 Trench Detail Alternatives

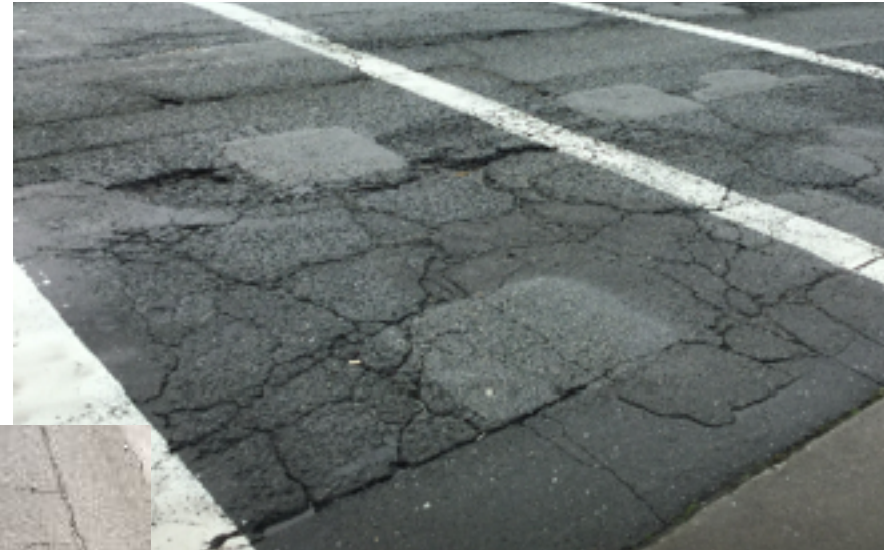
Delamination, Pop-outs,
Trench Cut, Block Cracks

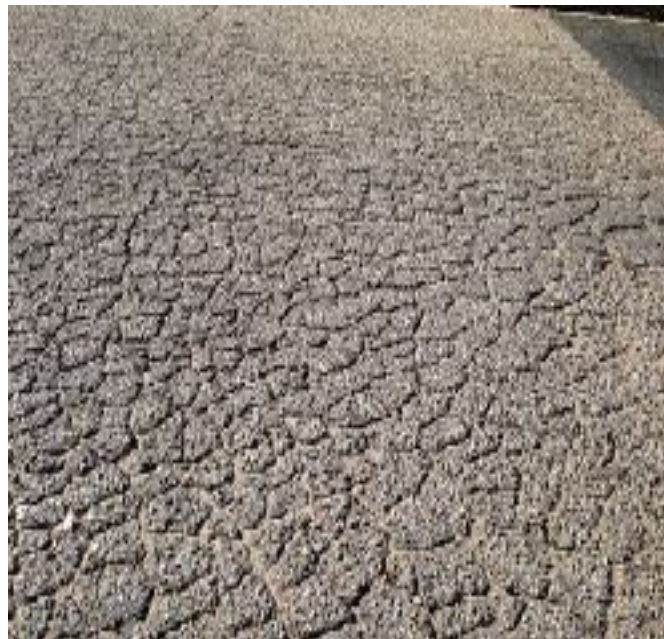
Alligator/Chicken Wire

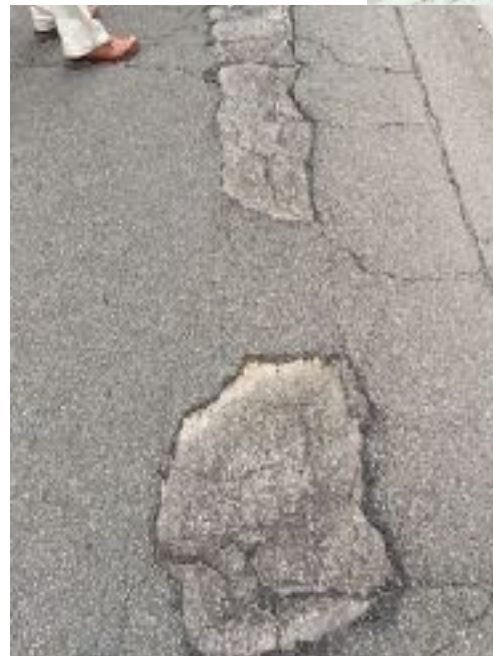
Delamination
Pop-outs

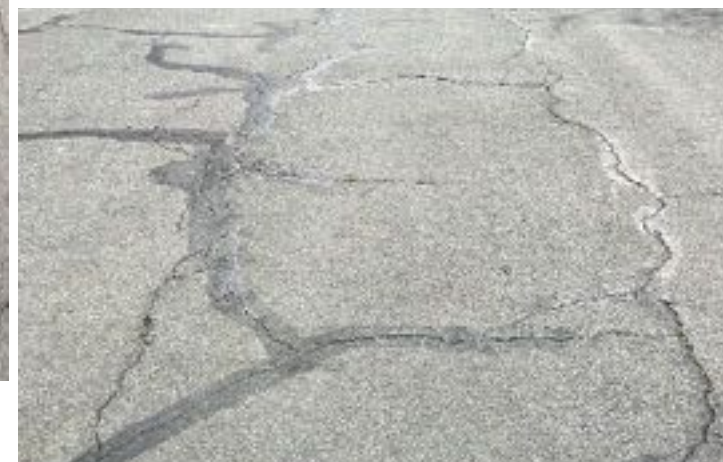
Block Cracking

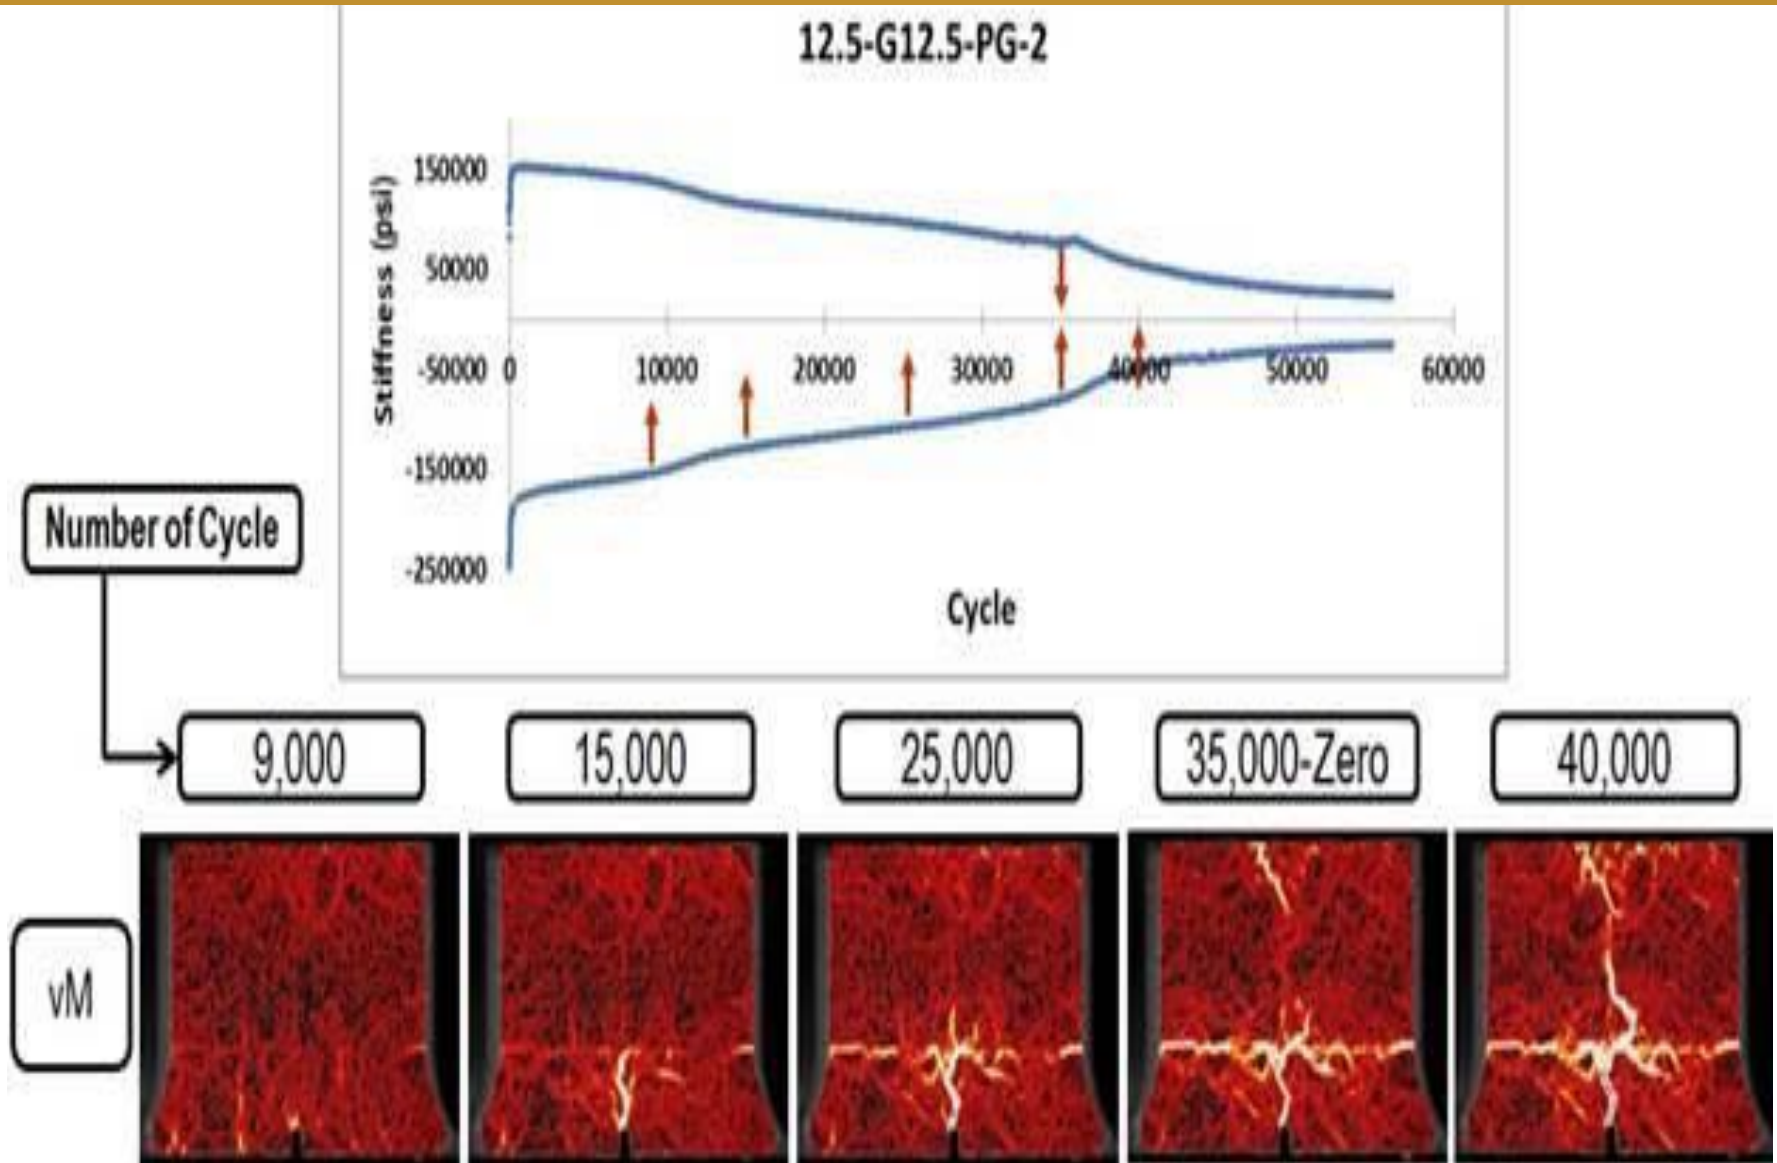
Digital Imaging – Not visible to naked eye

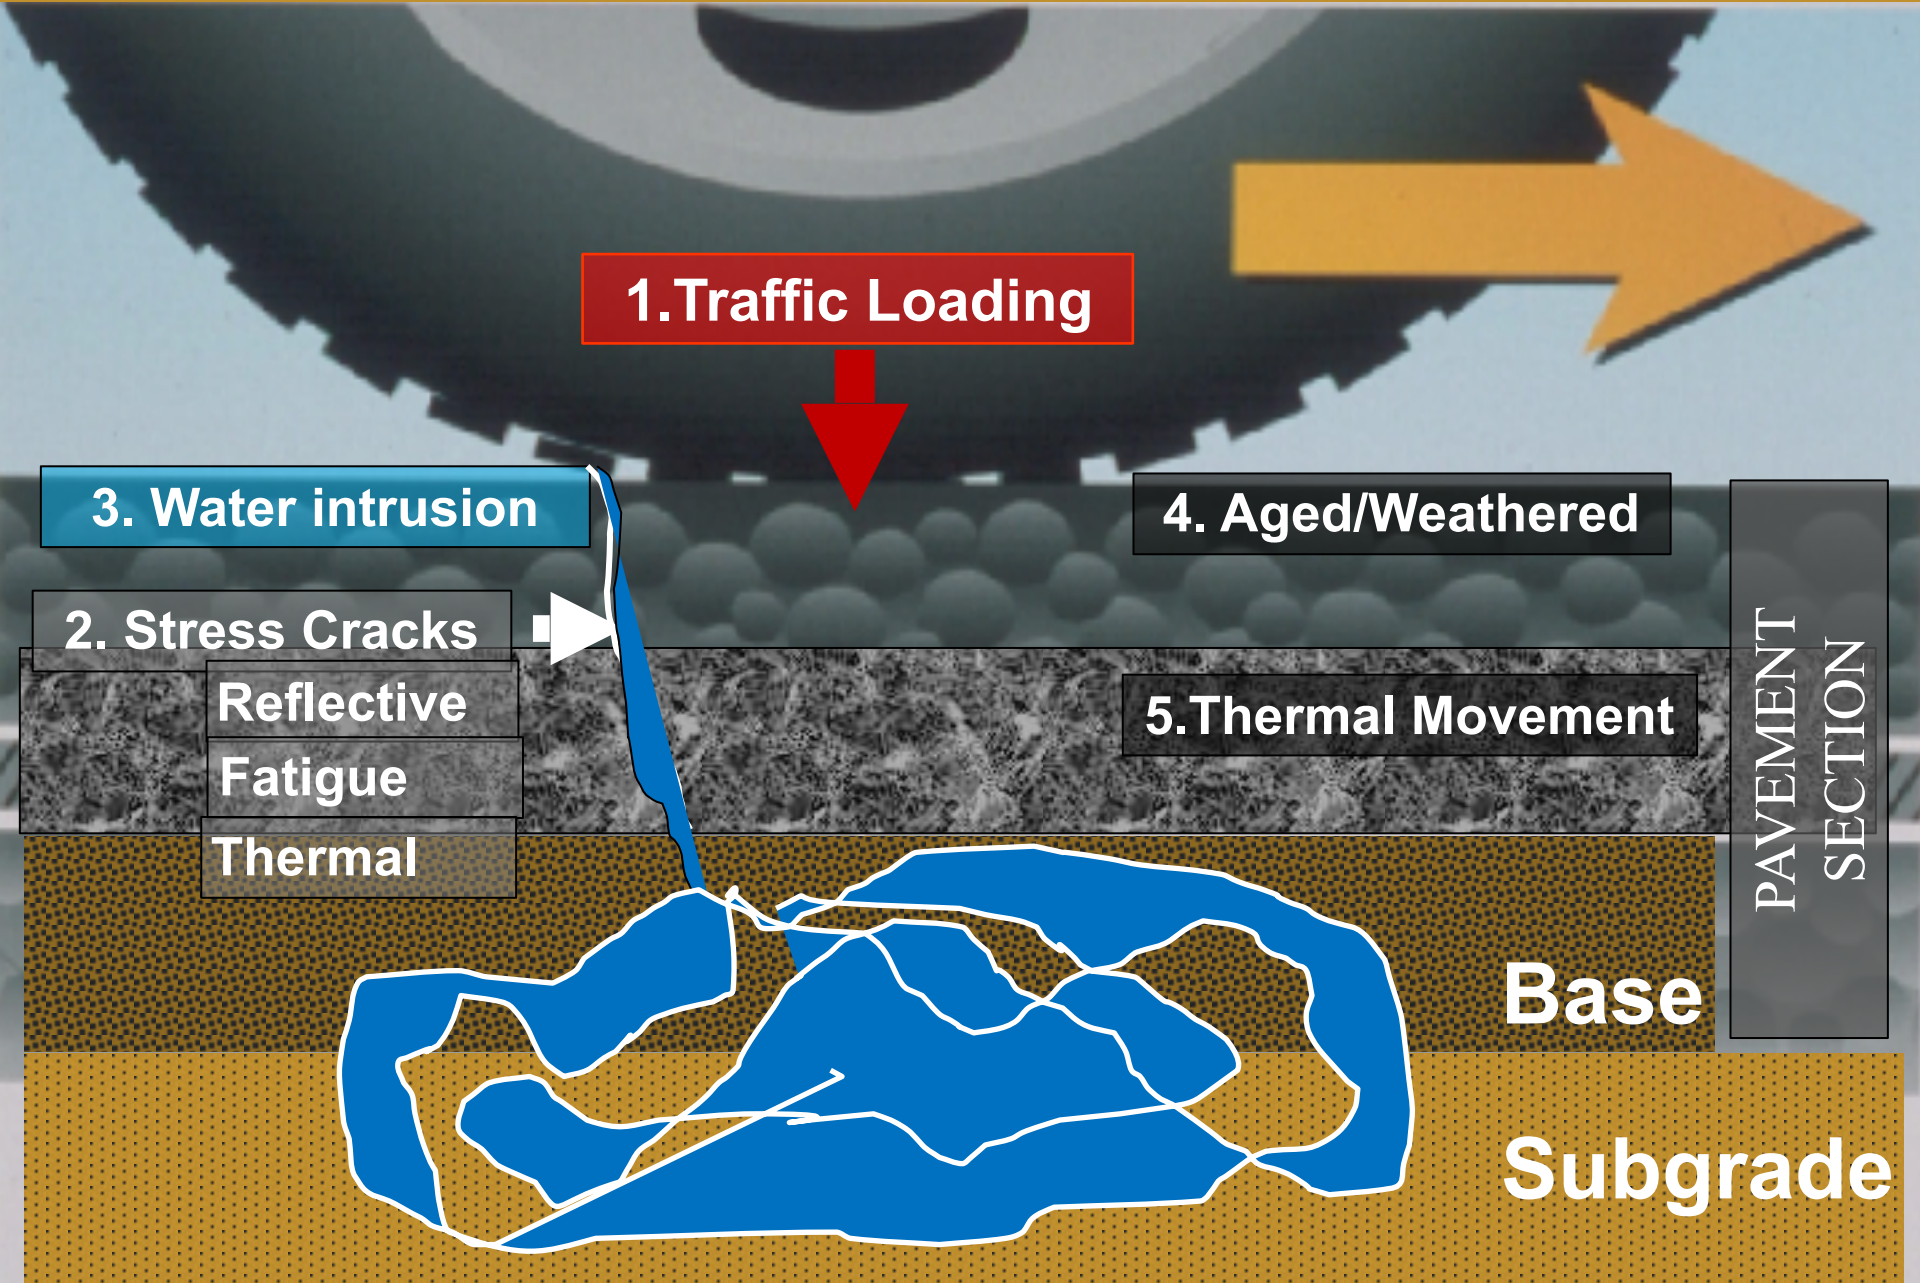
Deteriorating Effect

1. Traffic Loading

3. Water intrusion

2. Stress Cracks

Reflective
Fatigue
Thermal

4. Aged/Weathered

5. Thermal Movement

PAVEMENT
SECTION

Base

Subgrade

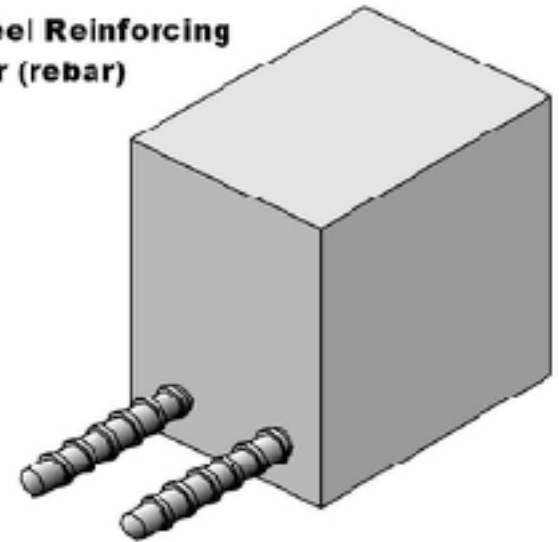
Steel Reinforcing Bar (rebar)

Continuous high tensile fiberglass is to asphalt as steel rebar is to concrete

Increase the structural life of the asphalt pavements using a high tensile rebar type fiberglass with a modulus advantage over the asphalt and is not water/temperature sensitive

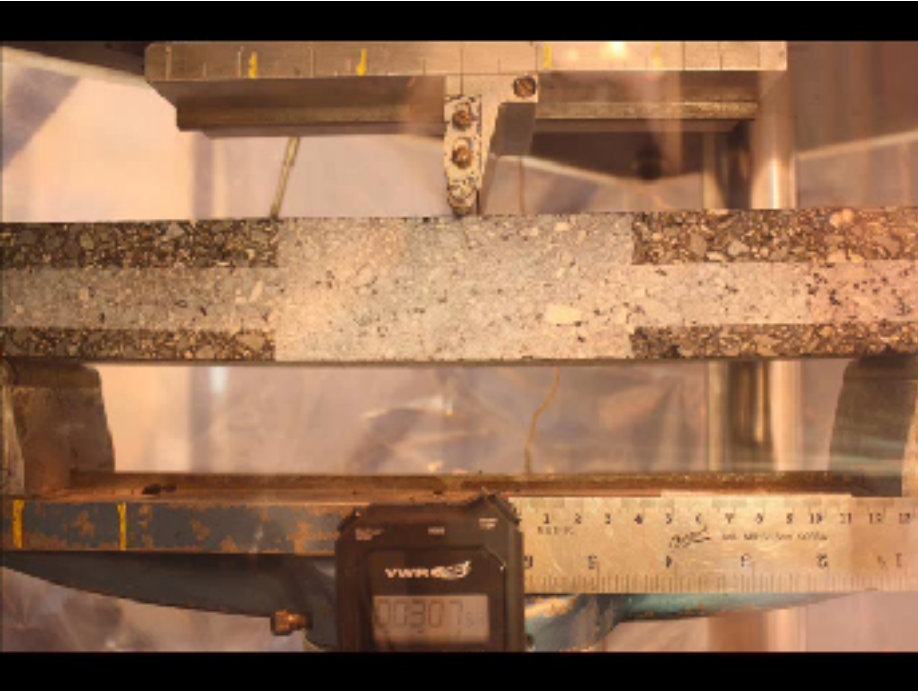
No Reinforcement

Run Time
0h 51m

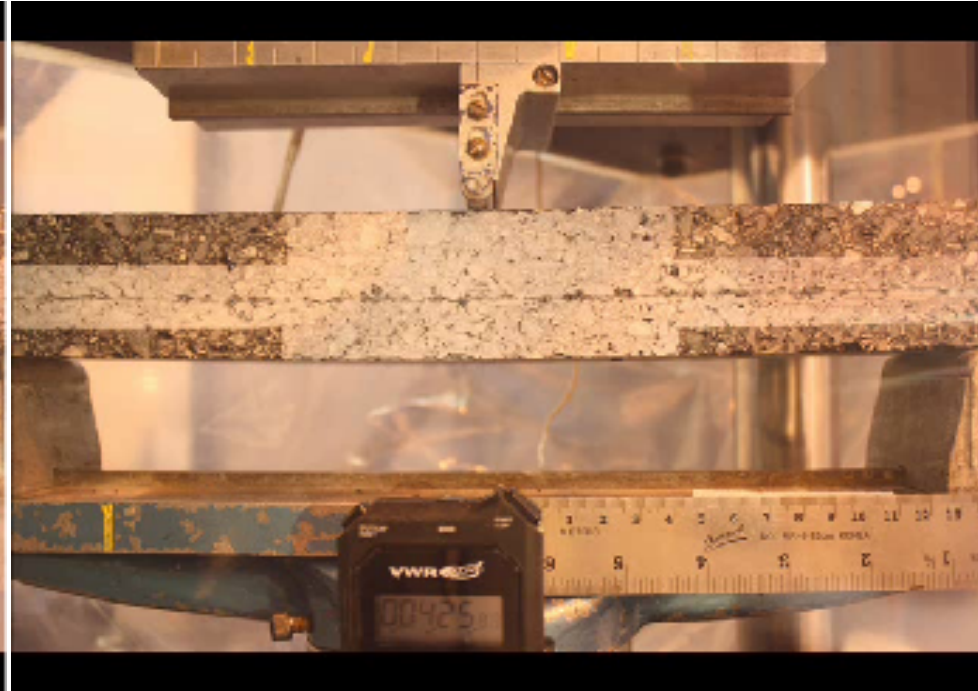
Reinforced with GlasGrid TF

Run Time
5h 30m

Over 5 Times Longer

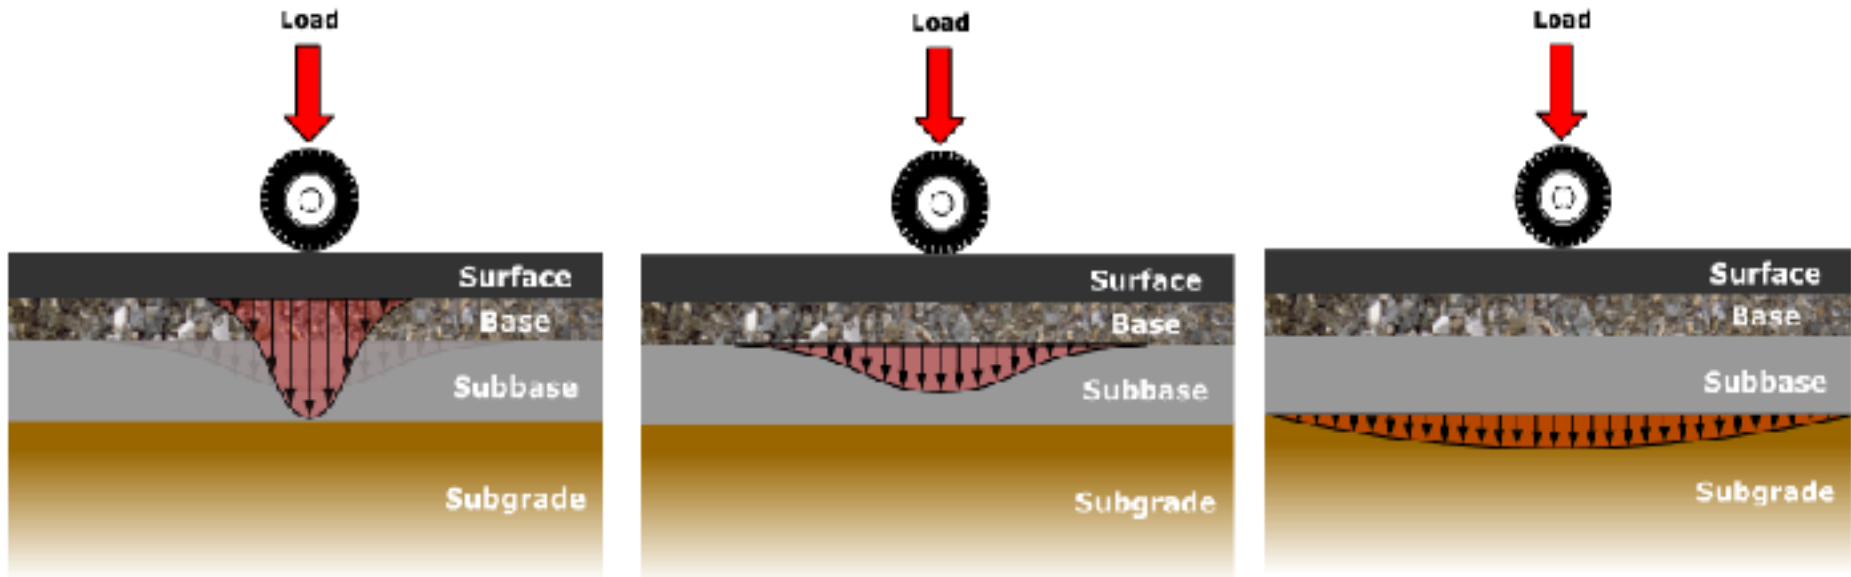
Conventional Pavement Load Distribution Curves

Maximum Load Distribution

Load distribution is one of the primary functions of a pavement

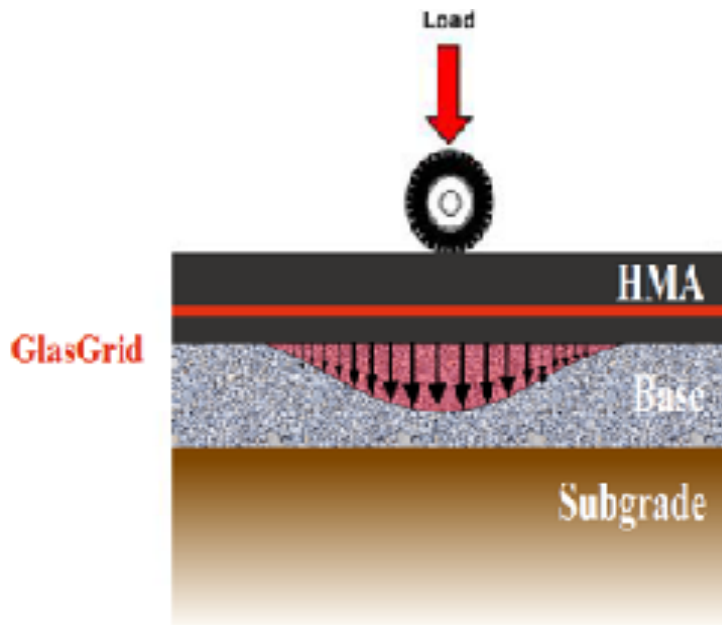
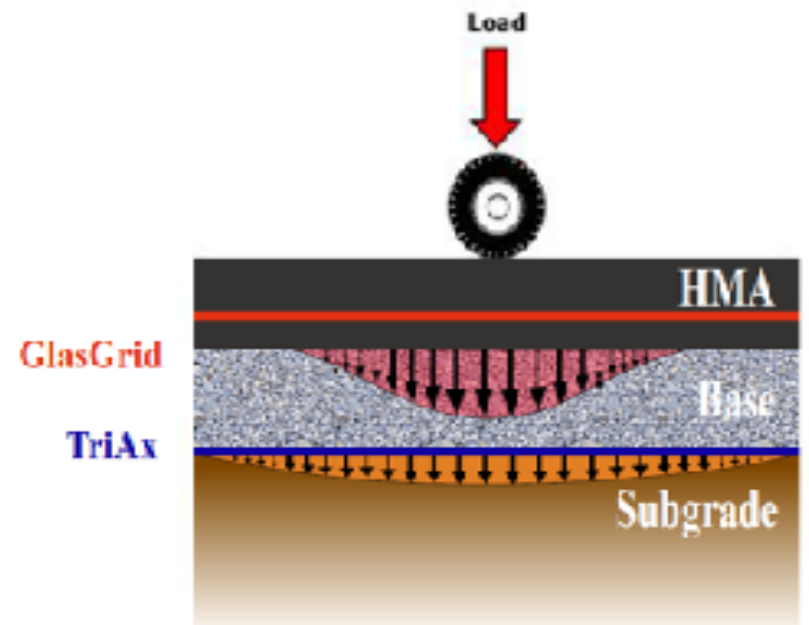
Most Efficient Pavement Load Distribution Curves

More Cost Effective and Higher Performing HMA Pavements

Rehabilitation

New or Reconstruct

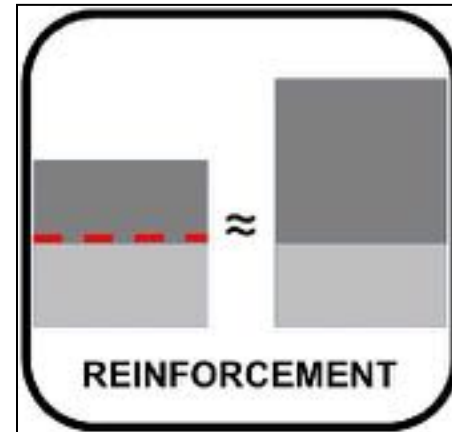
Structural Reinforcement

**Design to increase ESAL capacity
with continuous rebar type high
tensile fiberglass :**

- 1. HMA section must be critical layer**
- 2. Must be placed in the tension zone of
the pavement**

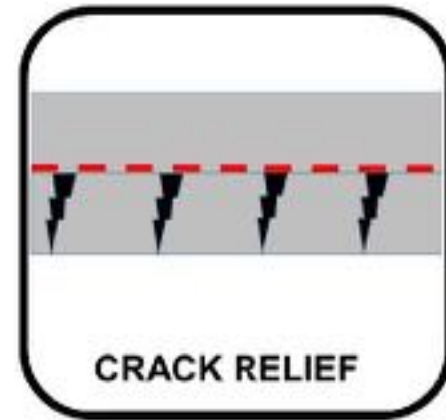
Crack Relief

High tensile rebar type reinforcing
+
Low tensile HMA =
Crack Resistant Pavements

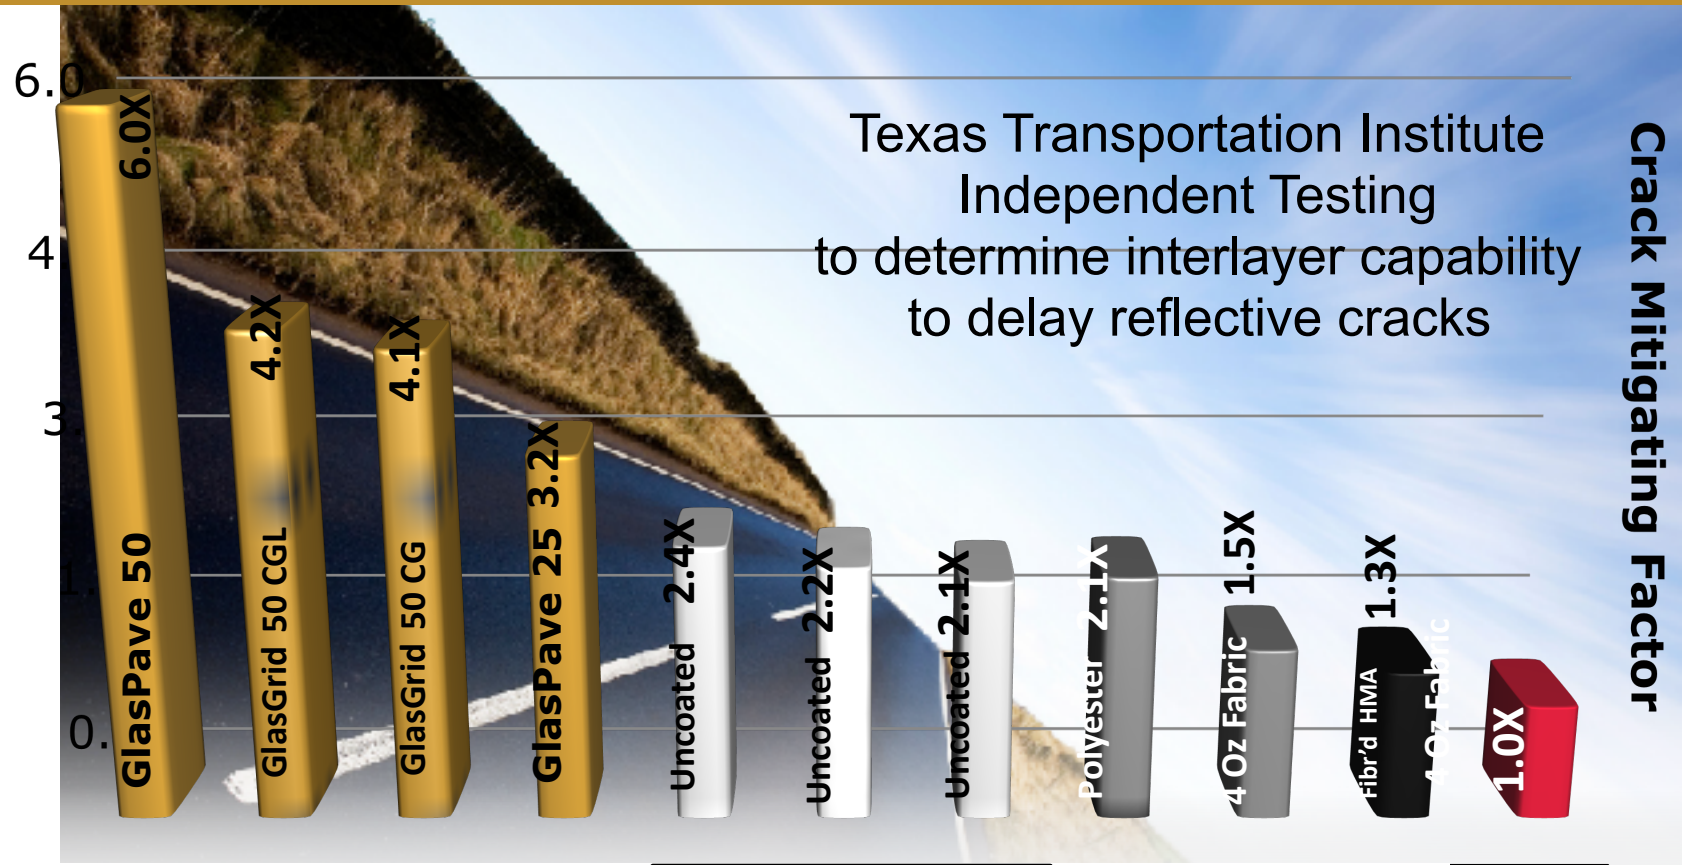
Pavements Ability to Resist Cracks

ALL Pavements (New, Overlay or Patch Repairs) Should Include reinforcement

Tensile (kN/m)	50	50	50	25	50	6.25	30	50	1	Min	No Inter-layer
%Elongation	<5	<5	<5	<5	<5	<5	<5	>12	>50	∞	No Inter-layer
Type	PM	CG	CG	PM	CG	PM	CG	CG	Fabric	Fibers	No Inter-layer
Elastomeric Polymer Coating	Coated Glass				Uncoated Glass			Polyest	PolyProp	Mix Add	No Inter-layer

PM=Paving Mat, CG=Composite Grid

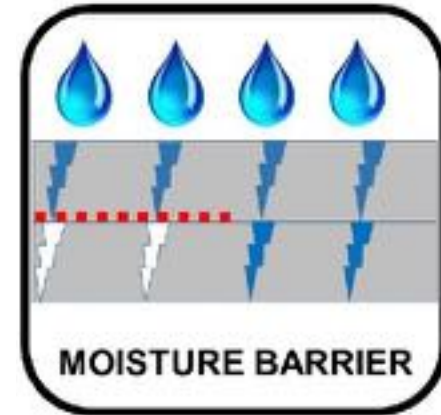
Moisture Barrier

Preserve the traffic bearing capacity of a dry Foundation:

Moisture barrier protects base from top down moisture intrusion into the base

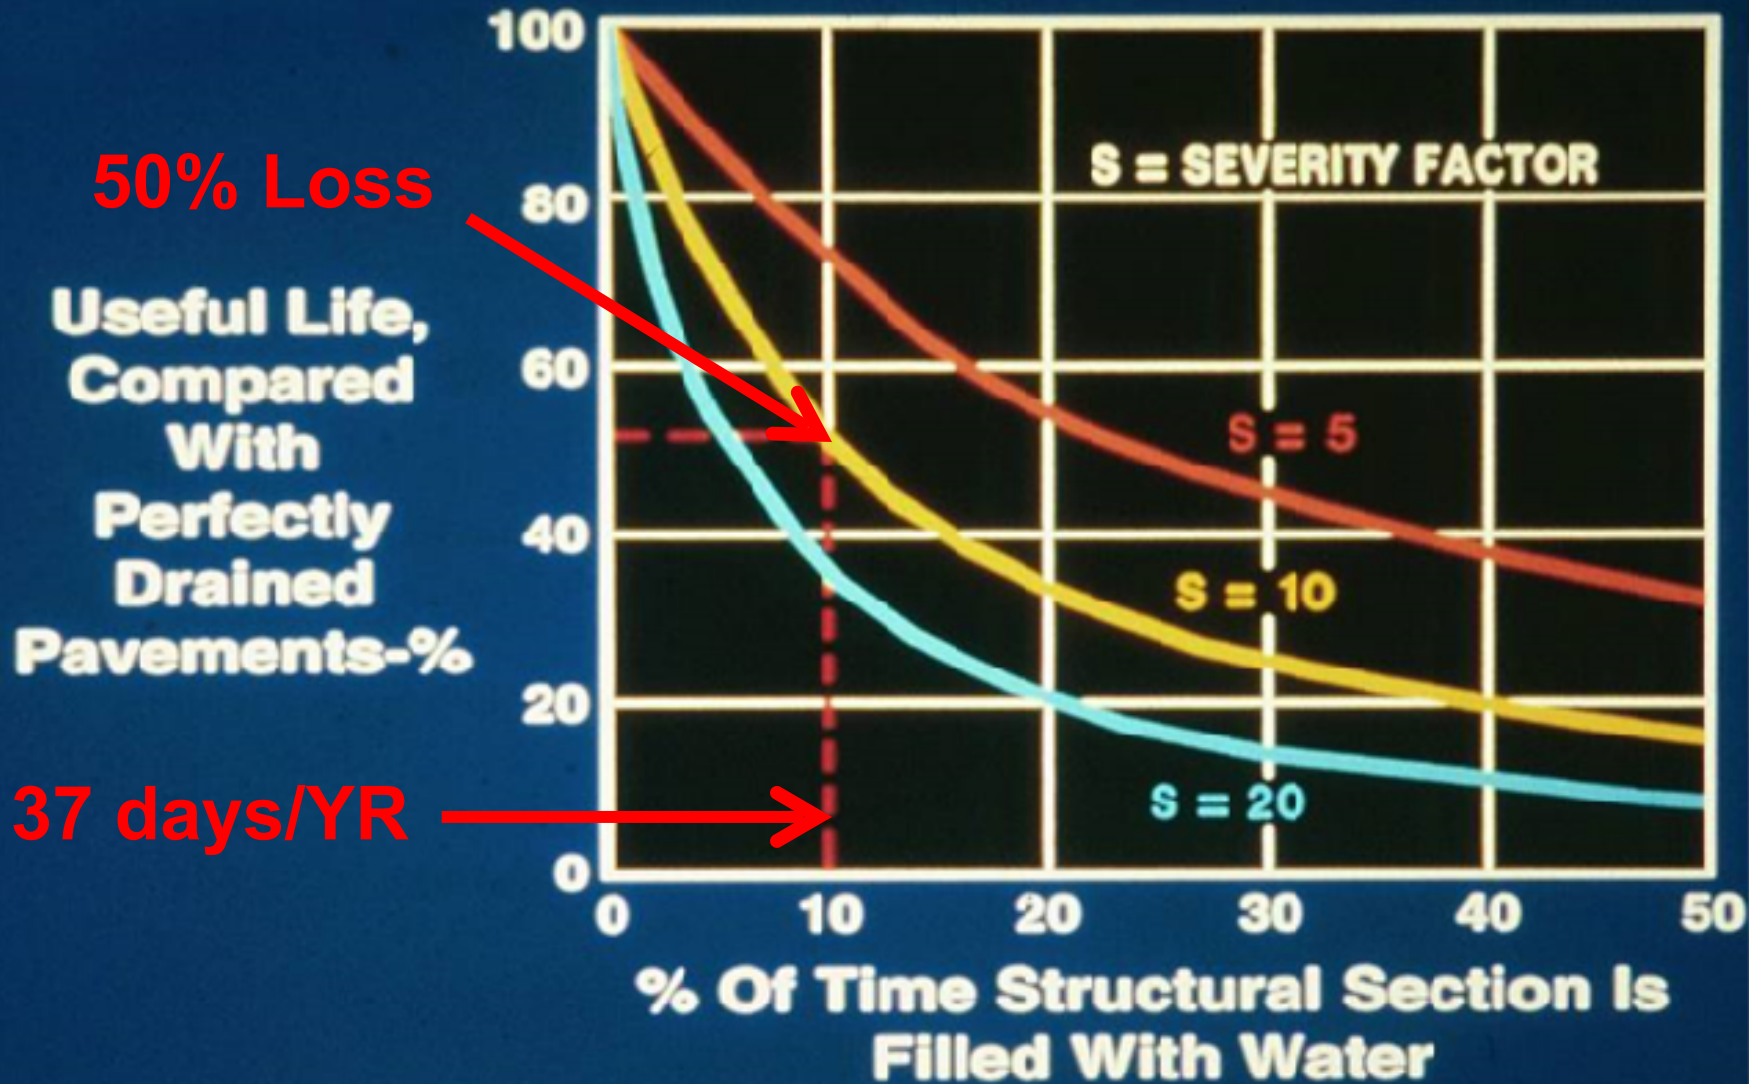
Water in Foundation Deterioration

From *Drainage Of Highway And Airfield Pavements*
By Harry R. Cedergren

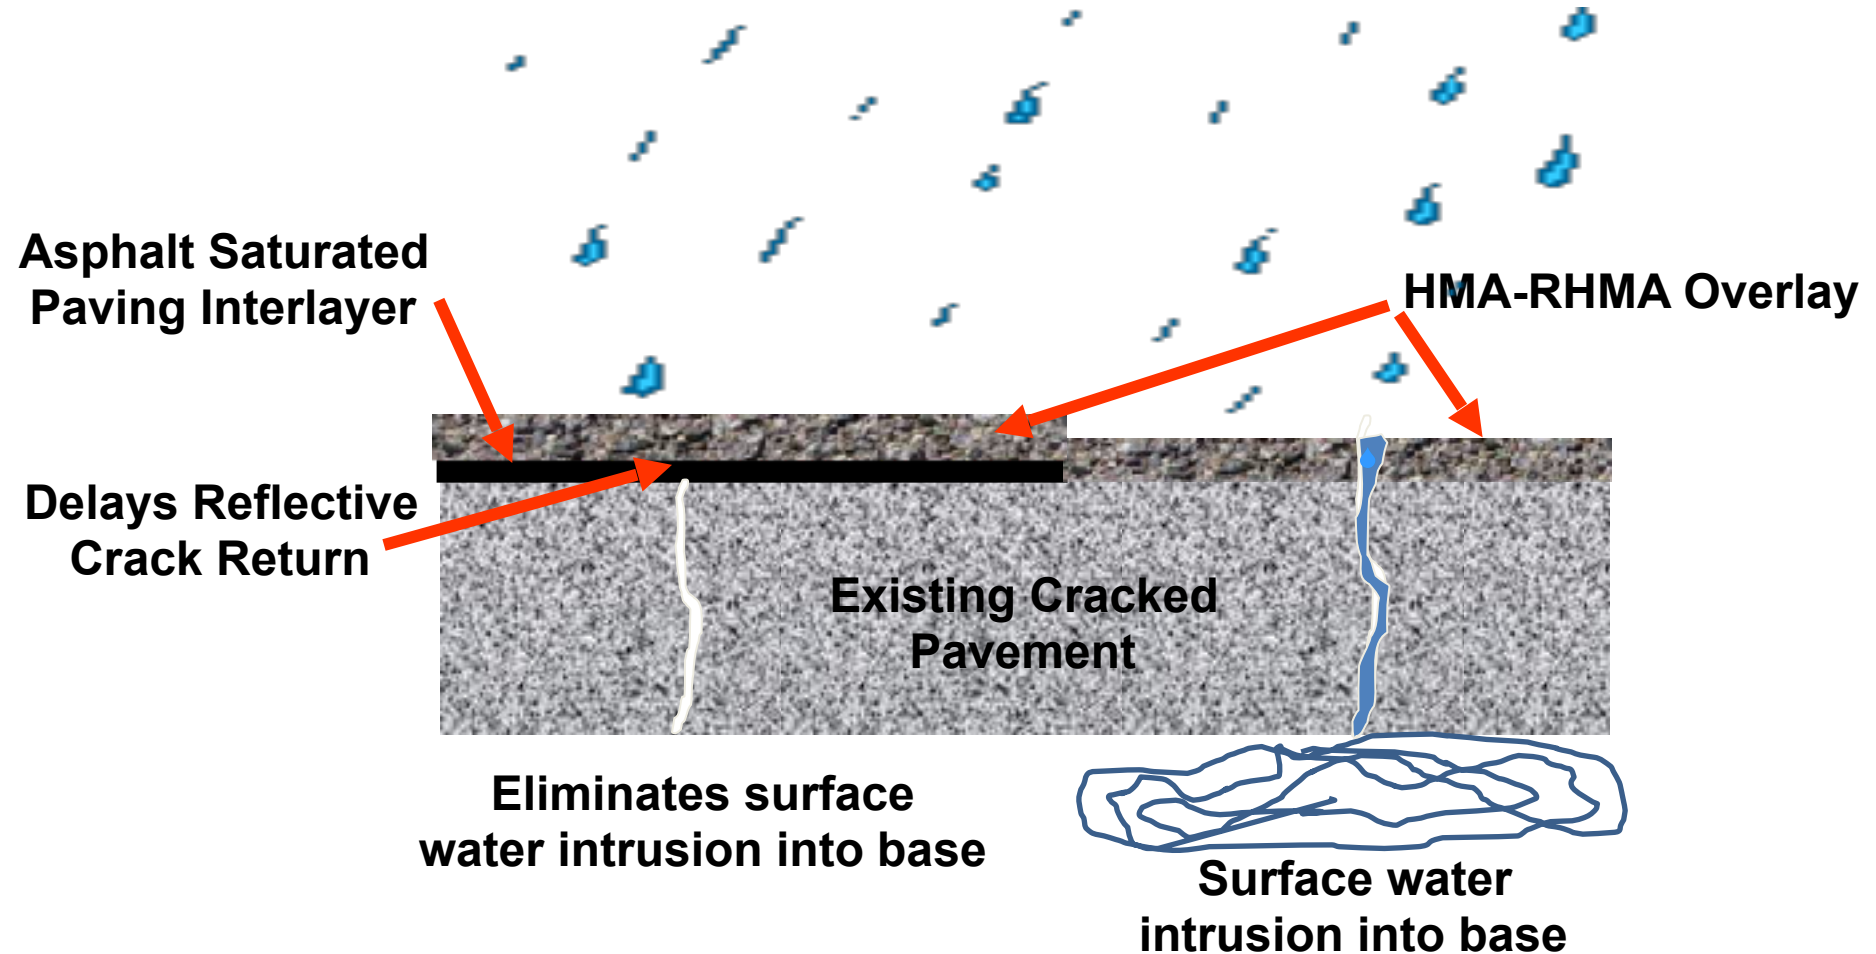
Mitigate Moisture Intrusion

Seals cracks to keep water out of base

Preserves load bearing capacity

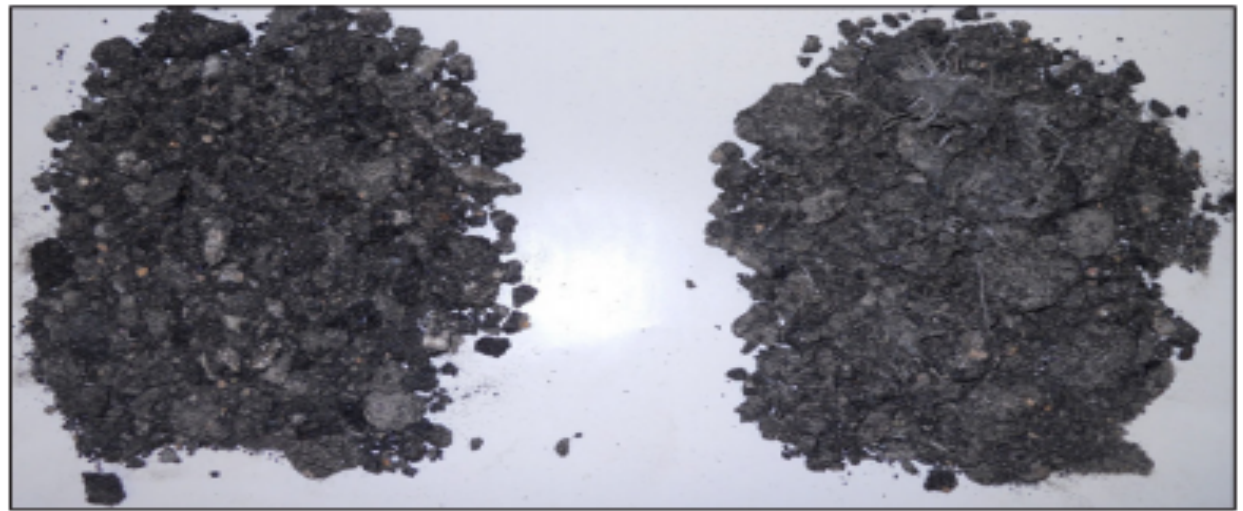
New HMA with up to 30% RAP containing it will pass AASHTO testing T281 for rutting and moisture susceptibility + T322 low temp cracking

Figure 2 Control RAP mixture (left) and RAP mixture containing GlasPave (right).
