Building **HIGHER PERFORMING** HMA Pavements with High Tensile **REINFORCEMENT**

HMA Pavement Reinforcement

HMA Pavements Rehabilitation for Higher Performance

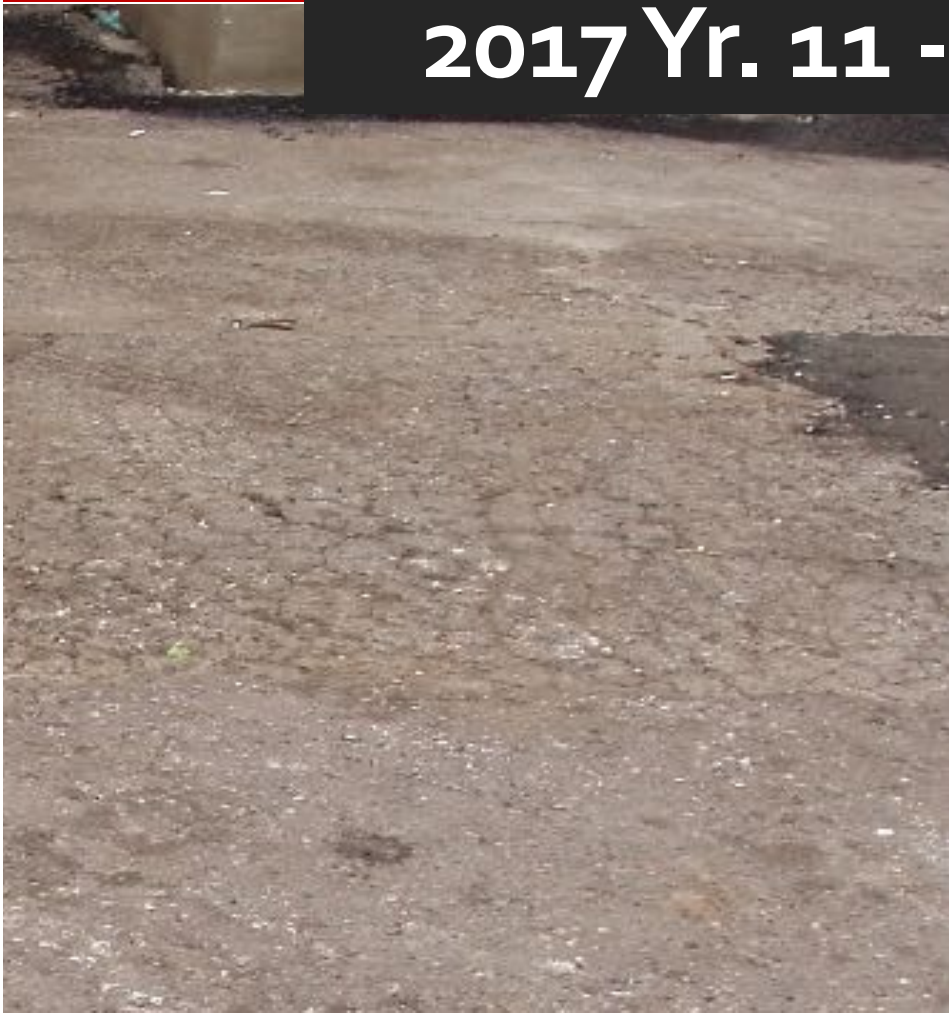
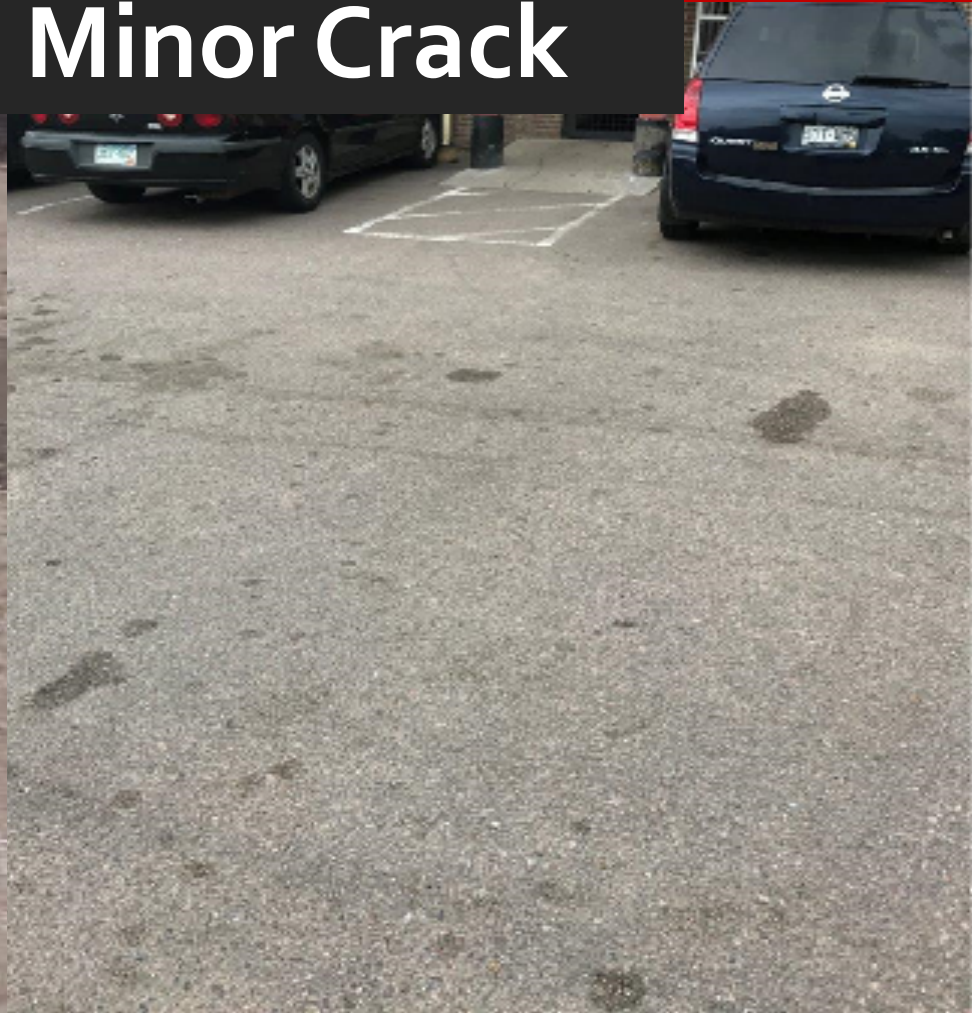
Loretta Heights, CO Installed 2006
2" HMA overlay on heavily alligator cracked HMA

← BEFORE 2006 Vs AFTER 2017 →

2017 Yr. 11 - Minor Crack

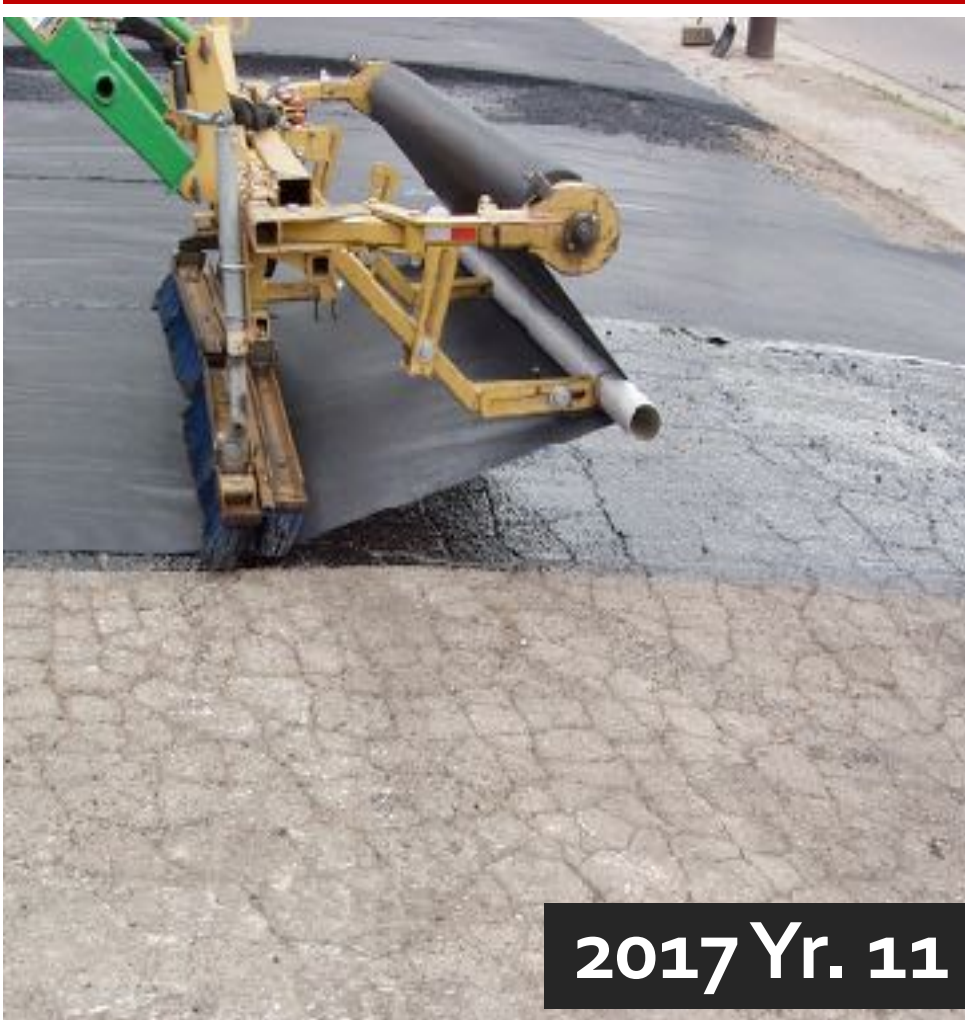
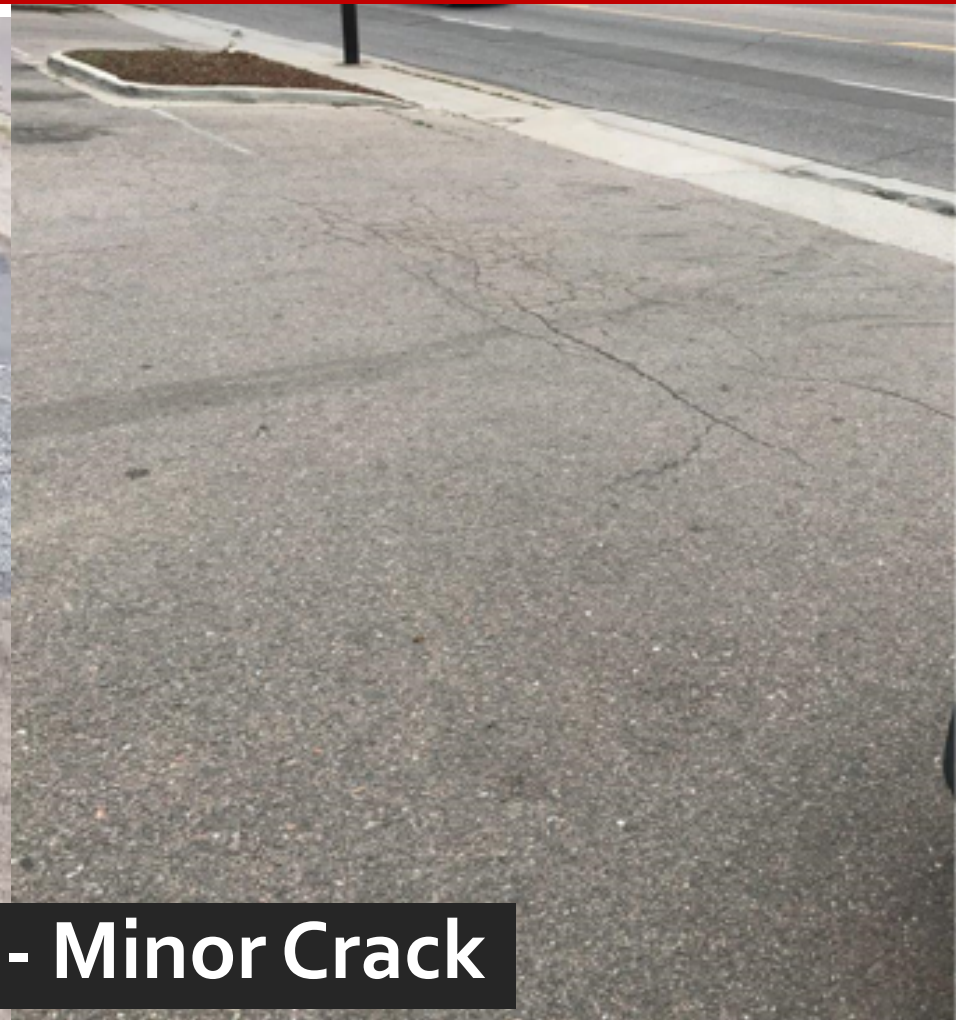
Loretta Heights, CO Installed 2006
2" HMA overlay on heavily alligator cracked HMA

← BEFORE 2006 Vs AFTER 2017 →

2017 Yr. 11 - Minor Crack

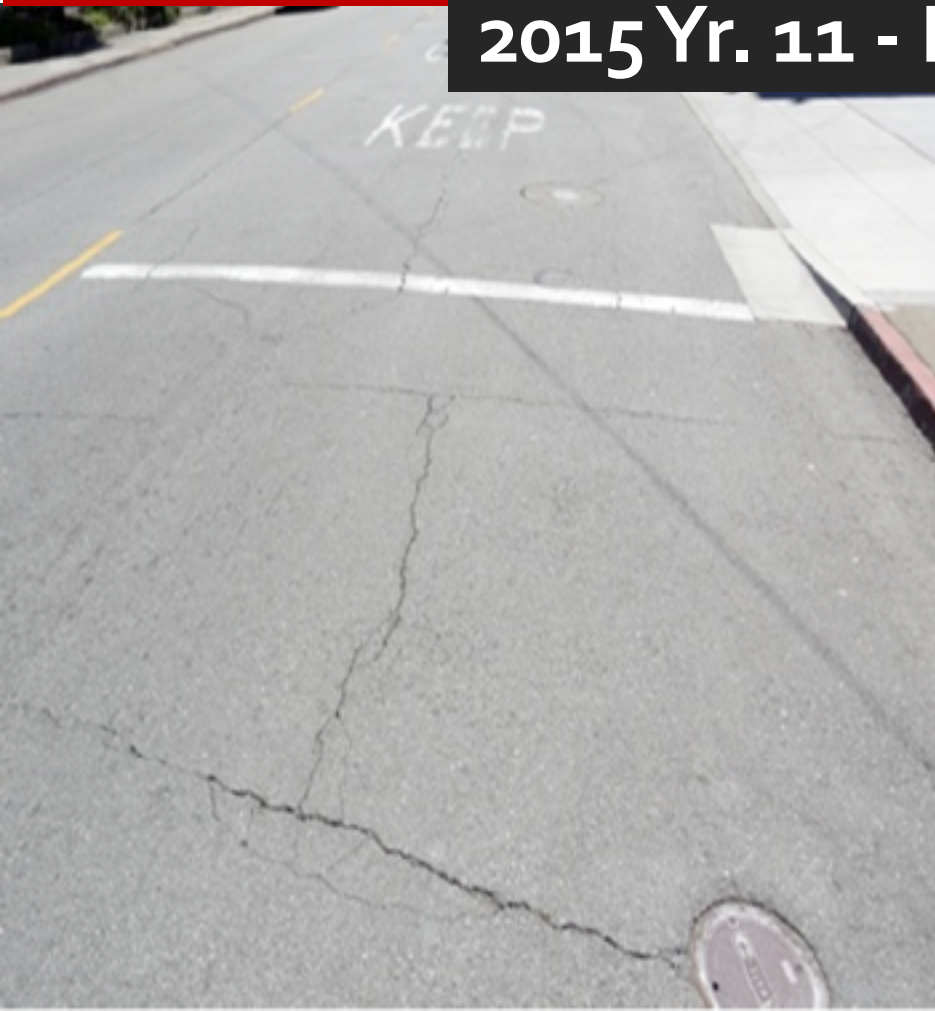
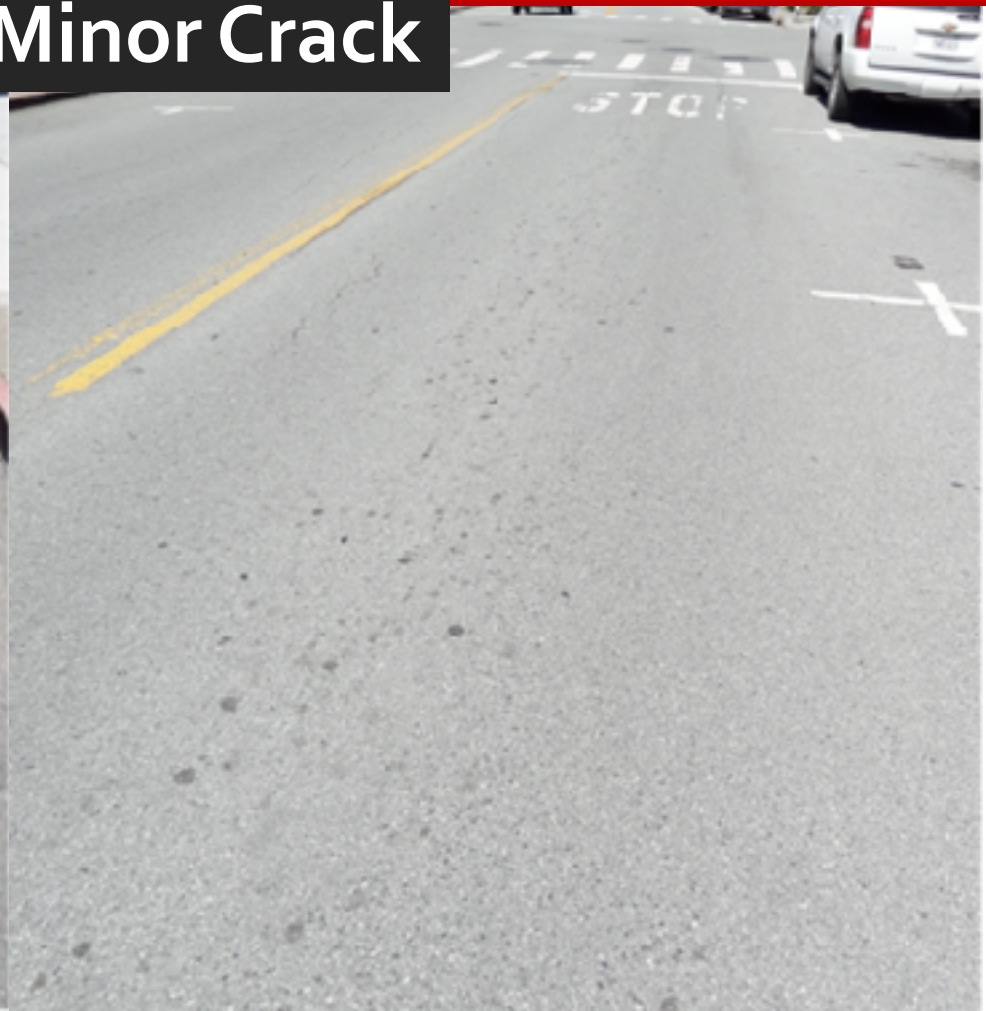
Santa Cruz, CA Installed 2004 2" HMA over PCC

← No mat Vs Paving Mat →

2015 Yr. 11 - Minor Crack

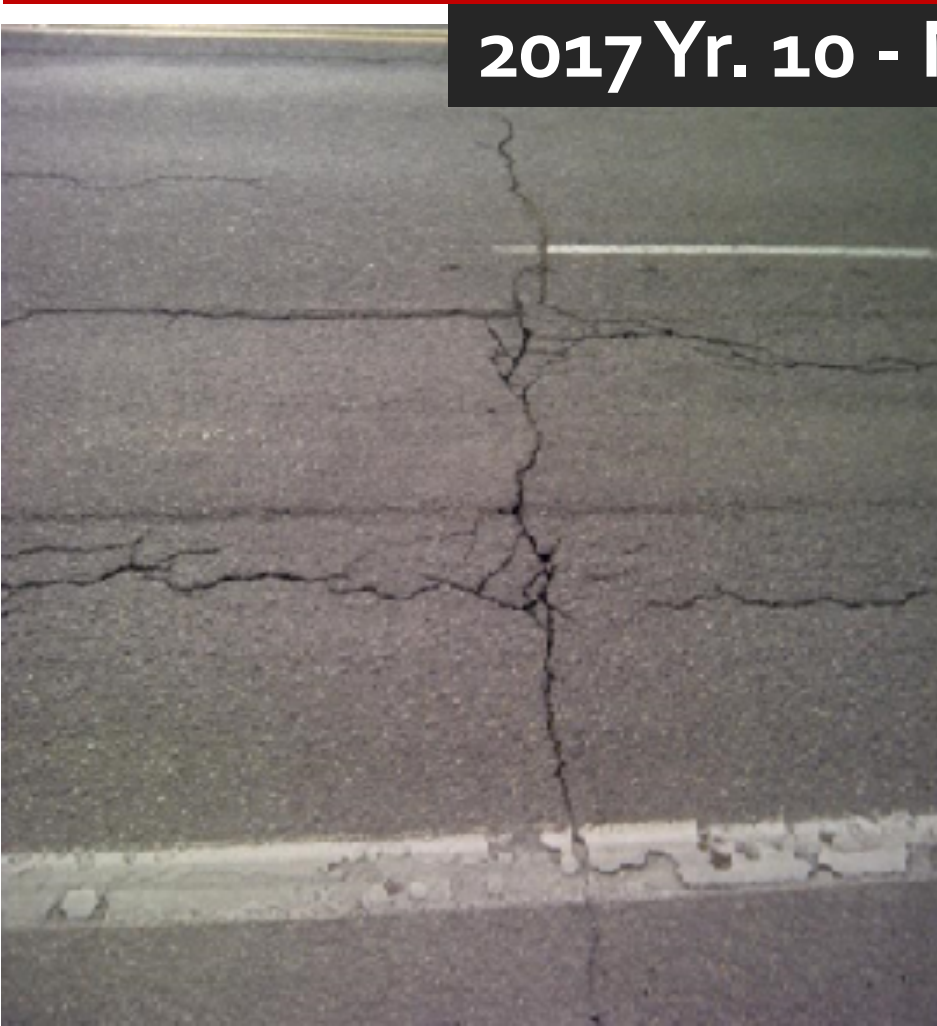
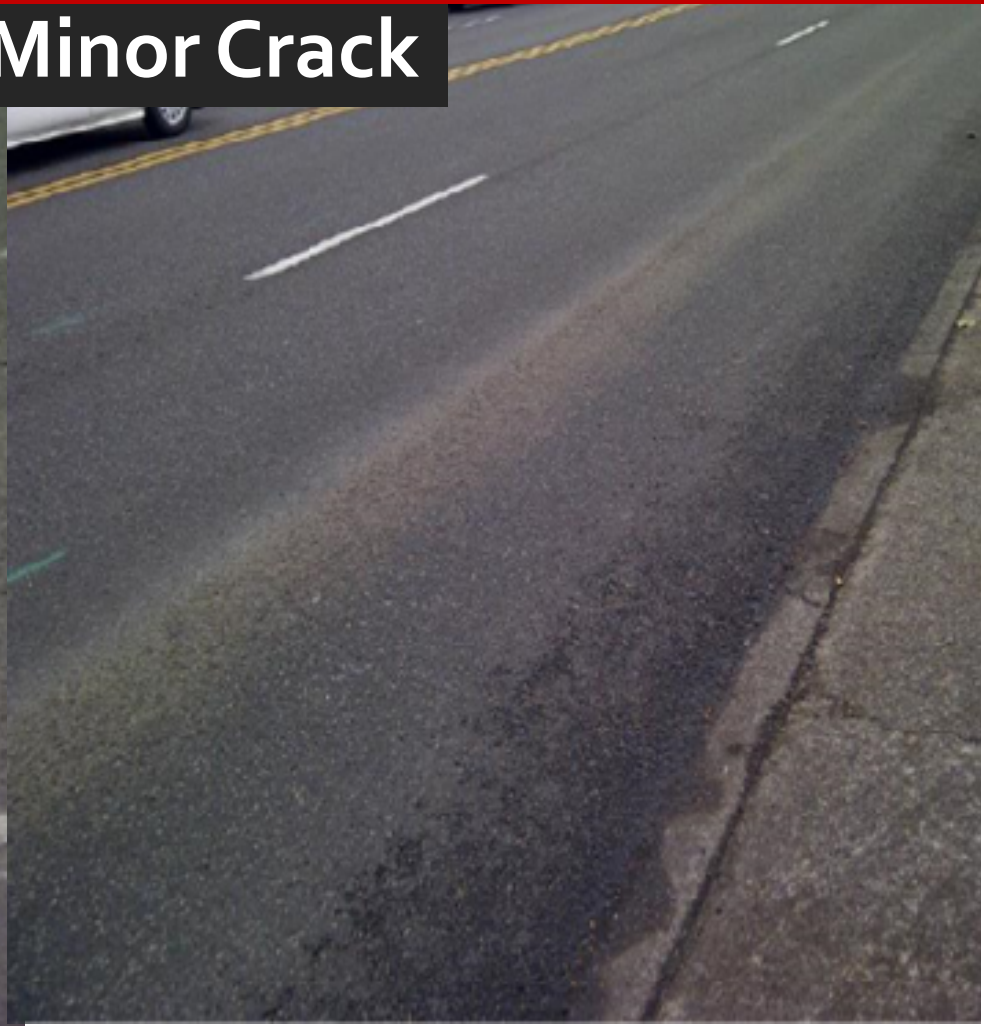
LAKE Oswego, 2" HMA over Milled HMA

← BEFORE 2007 Vs AFTER 2015 →

2017 Yr. 10 - Minor Crack

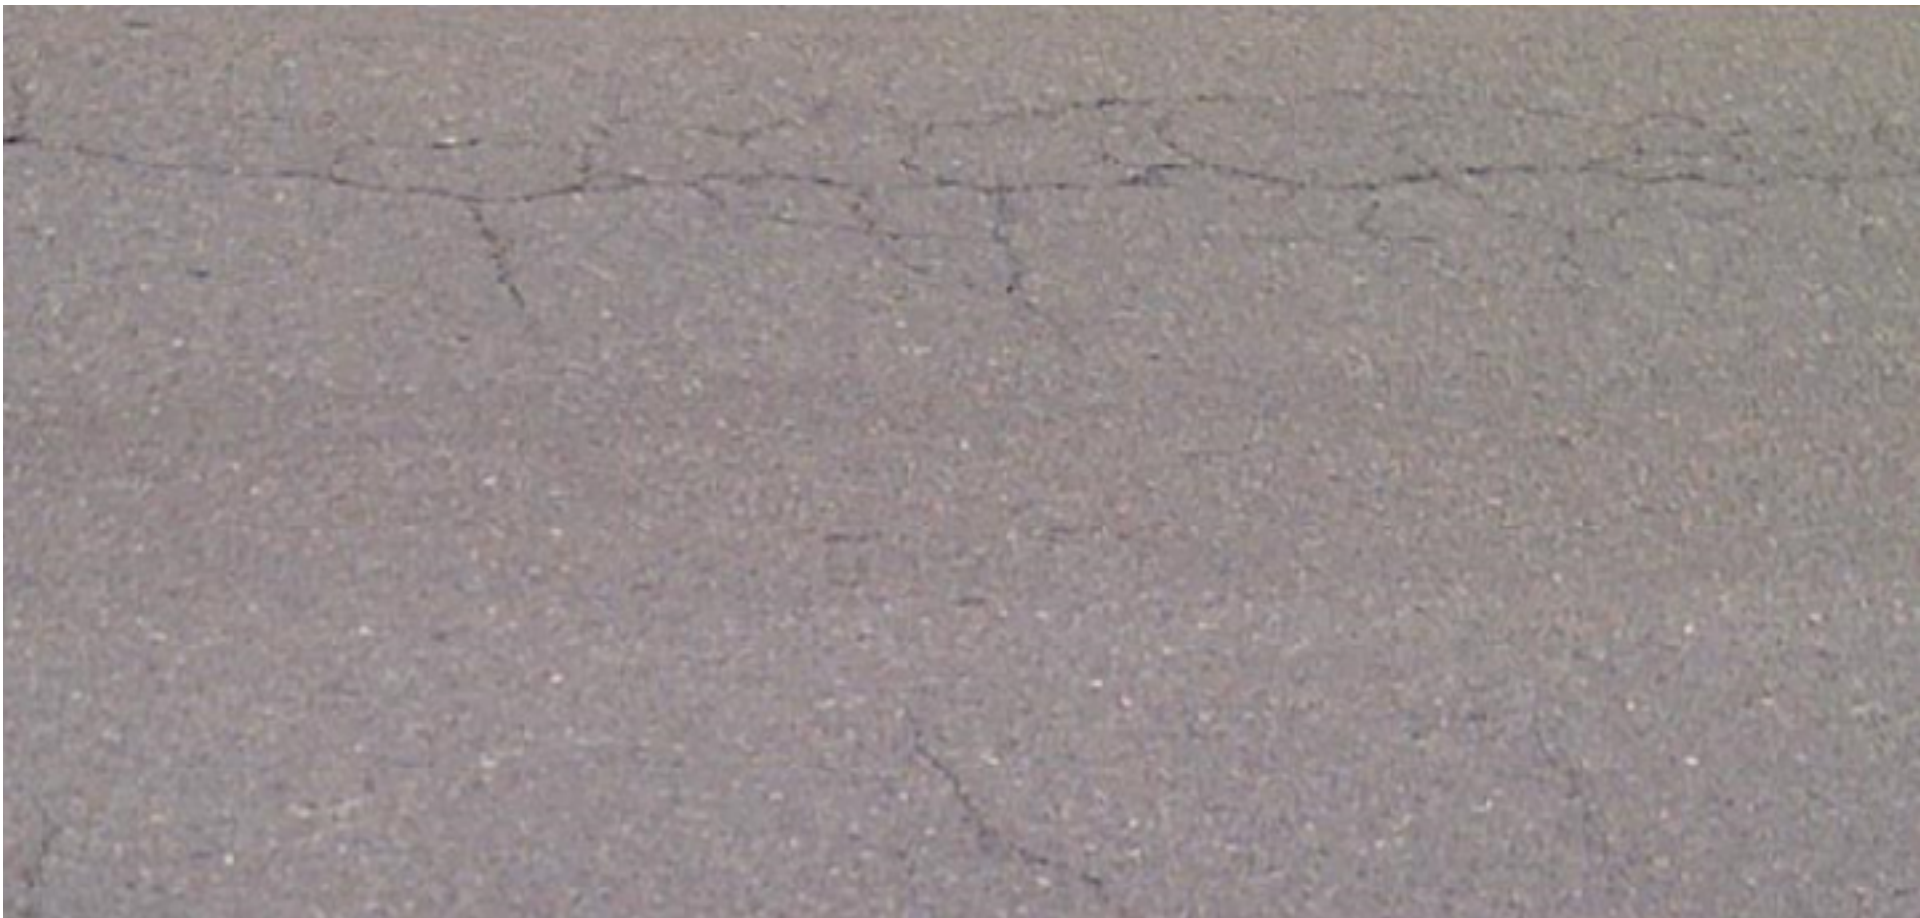
Lake Oswego, OR 2" HMA over Milled HMA

Same contractor, same mix, but No reinforcing

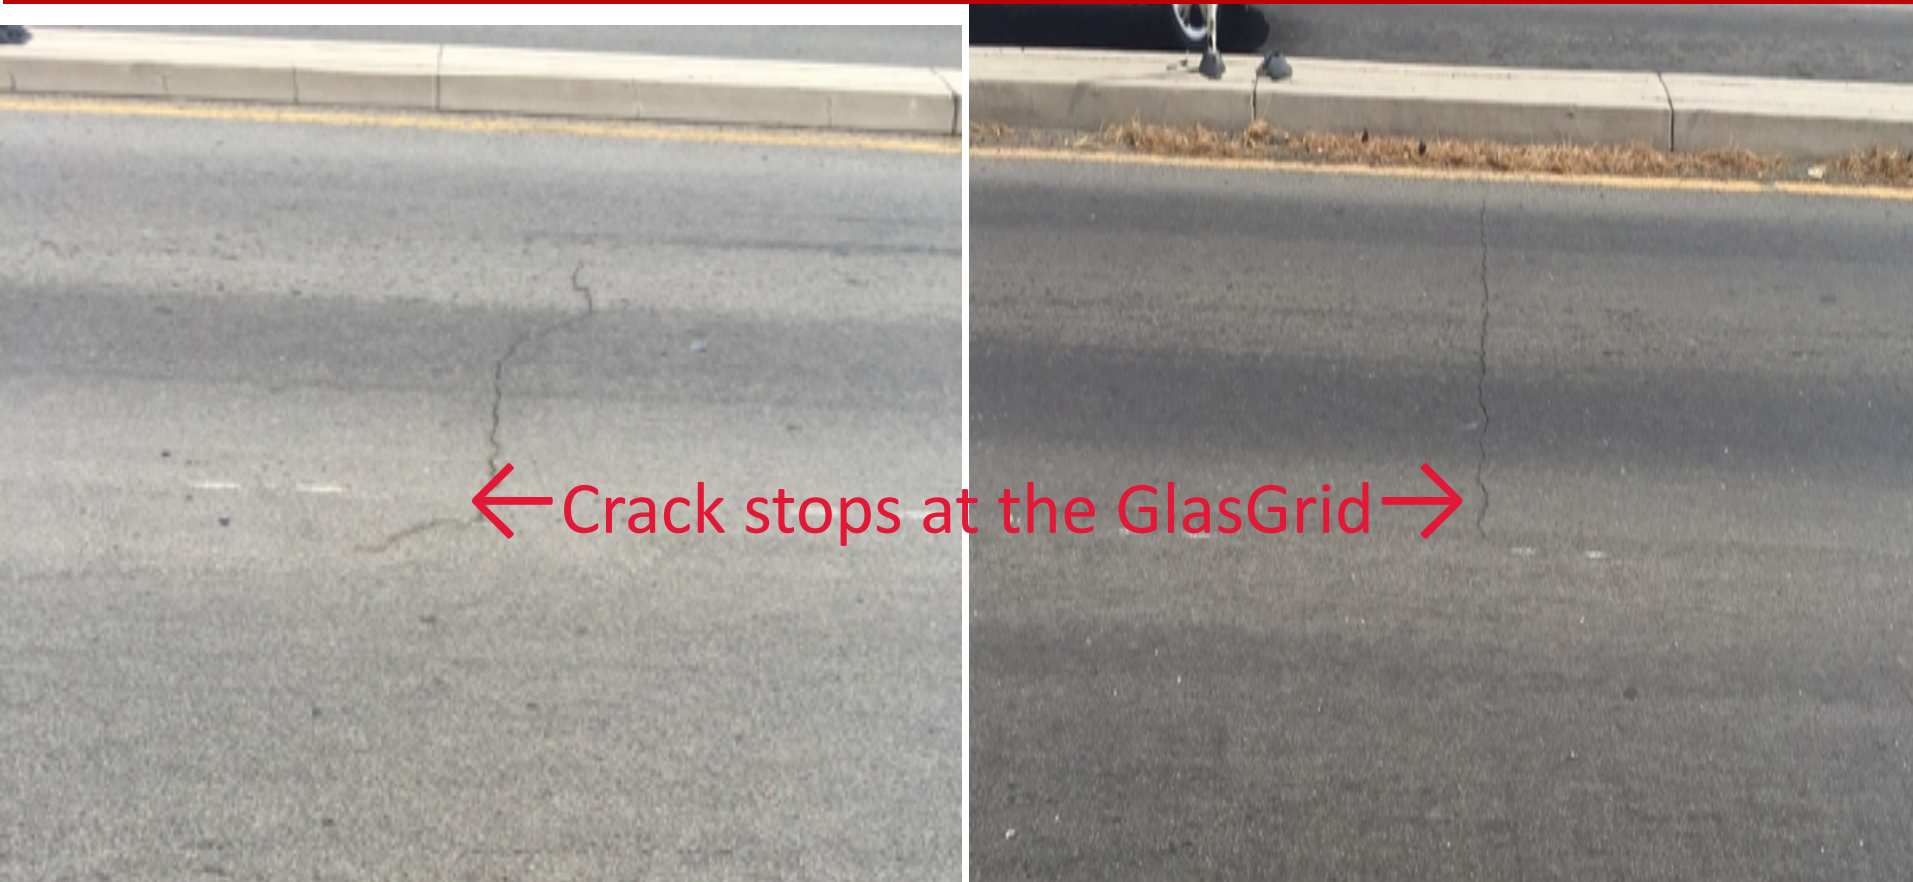
Pyramid, Sparks NV 4 lane, Heavy truck traffic, 3" HMA

GlasGrid 8501 Installed 2003 S/B curb lane only

← Crack stops at the GlasGrid →

2016 Yr. 13 Still NO CRACKS in S/B Curb Lane

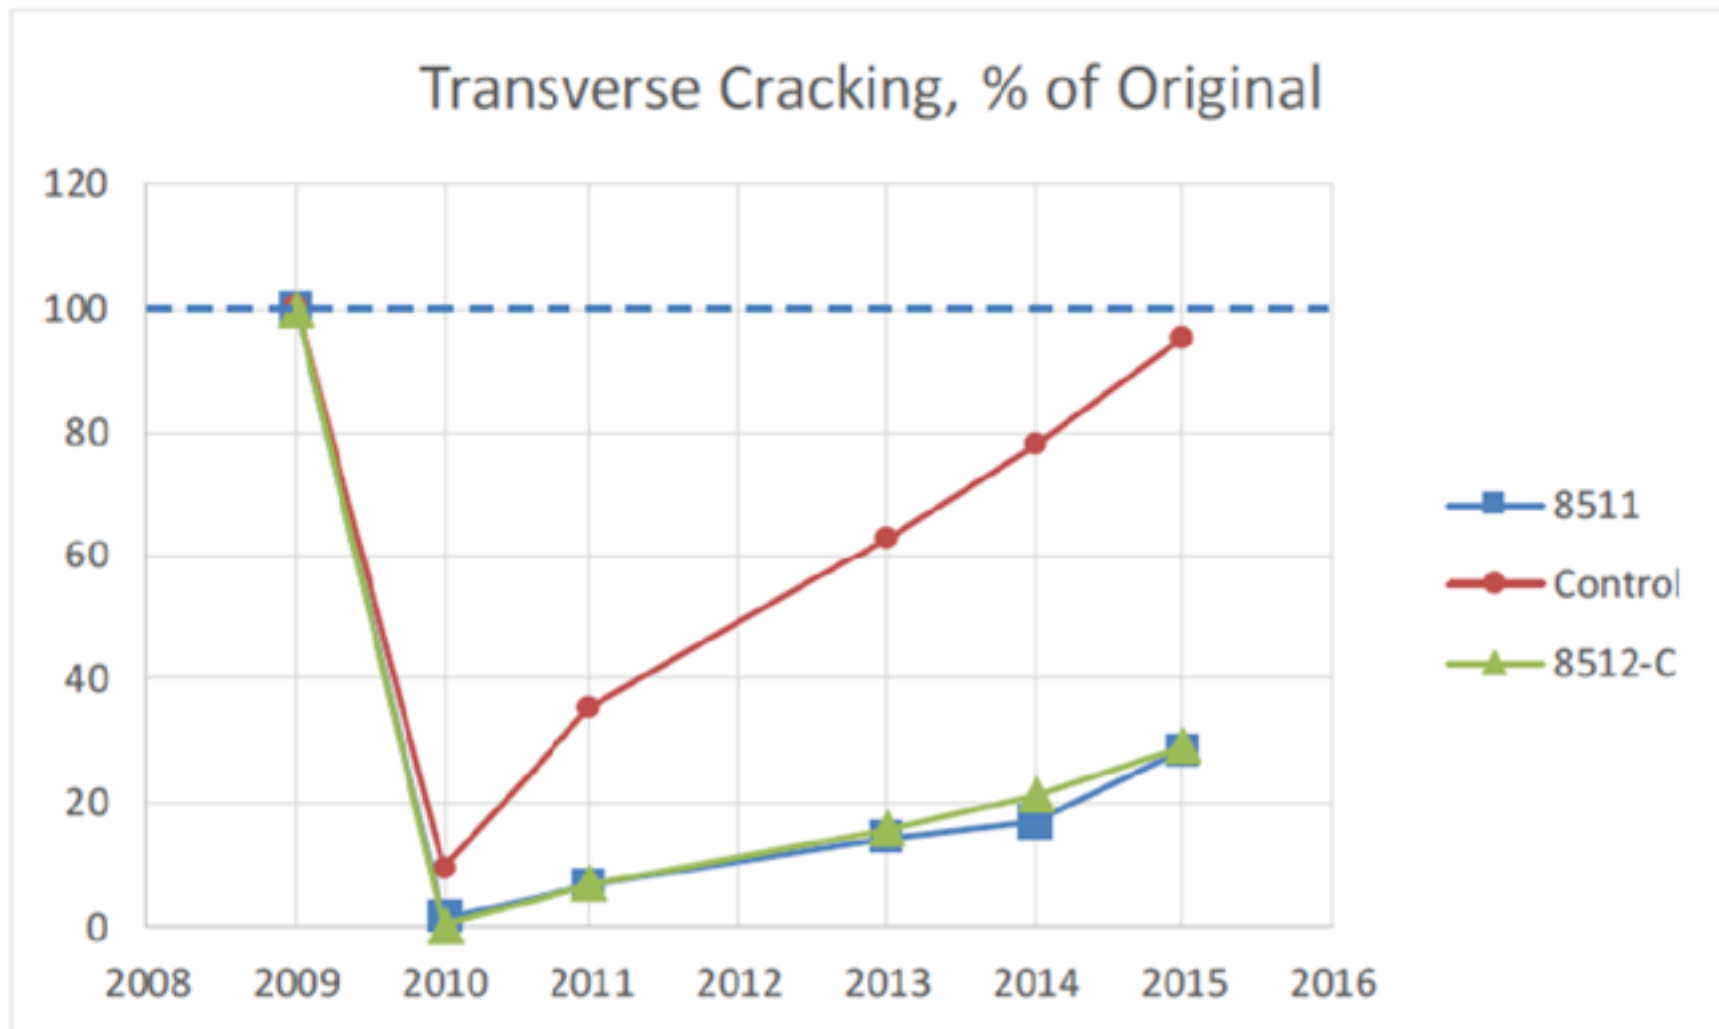
Figure 16. Transverse Cracking in Eastbound Median Lane

I-70 GlasGrid Trial Genesee CO 2" HMA over HMA

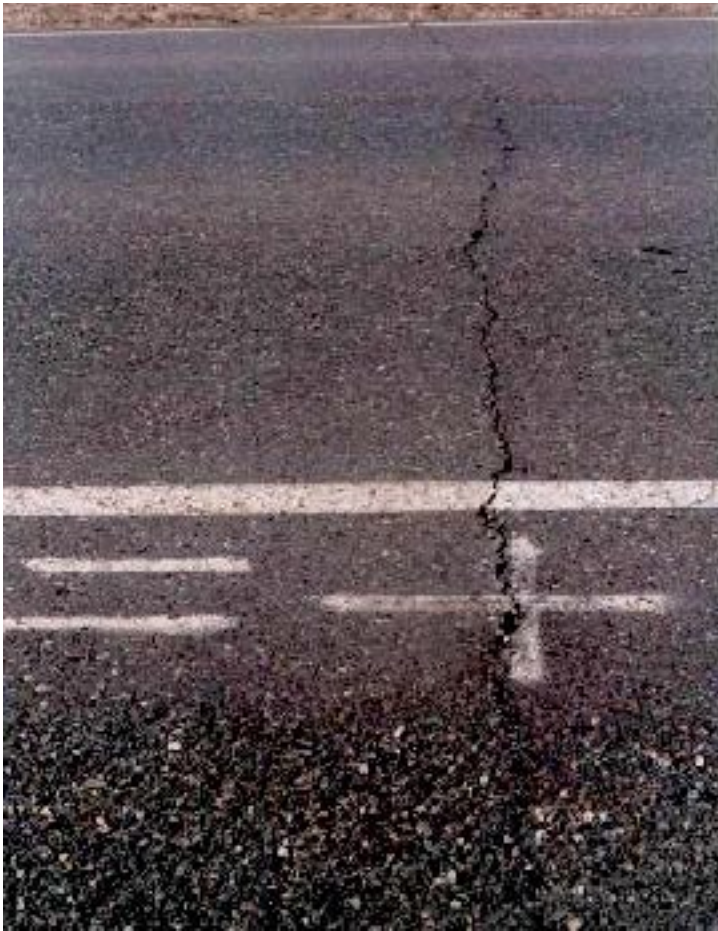
Crack #11
No GlasGrid

Highway 513, Lethbridge, Alberta, CAN Crack Repair after 2.5 Years

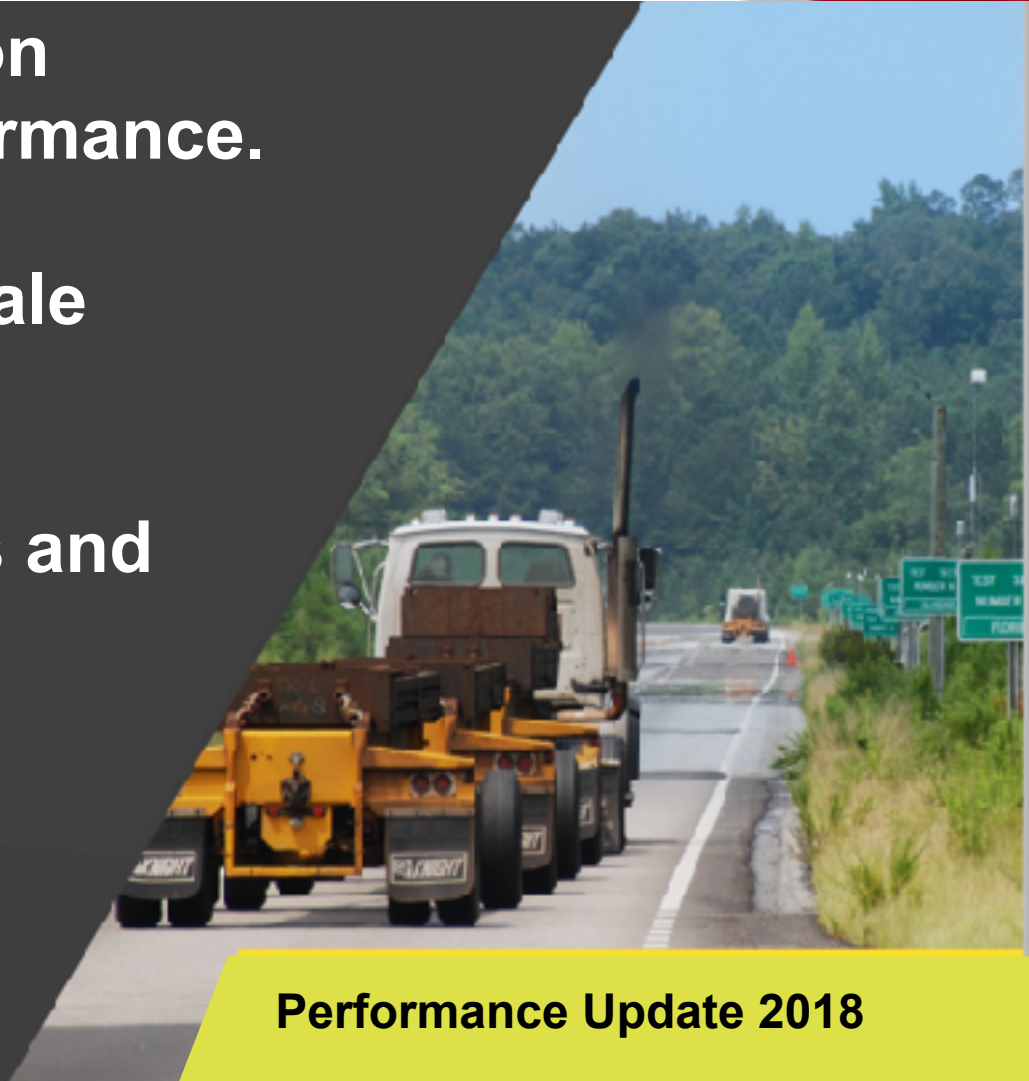
Performance Update 2018

- NCAT Ongoing full scale research
- 2018 Update: 18 years and 60 million ESAL's of accelerated traffic loading

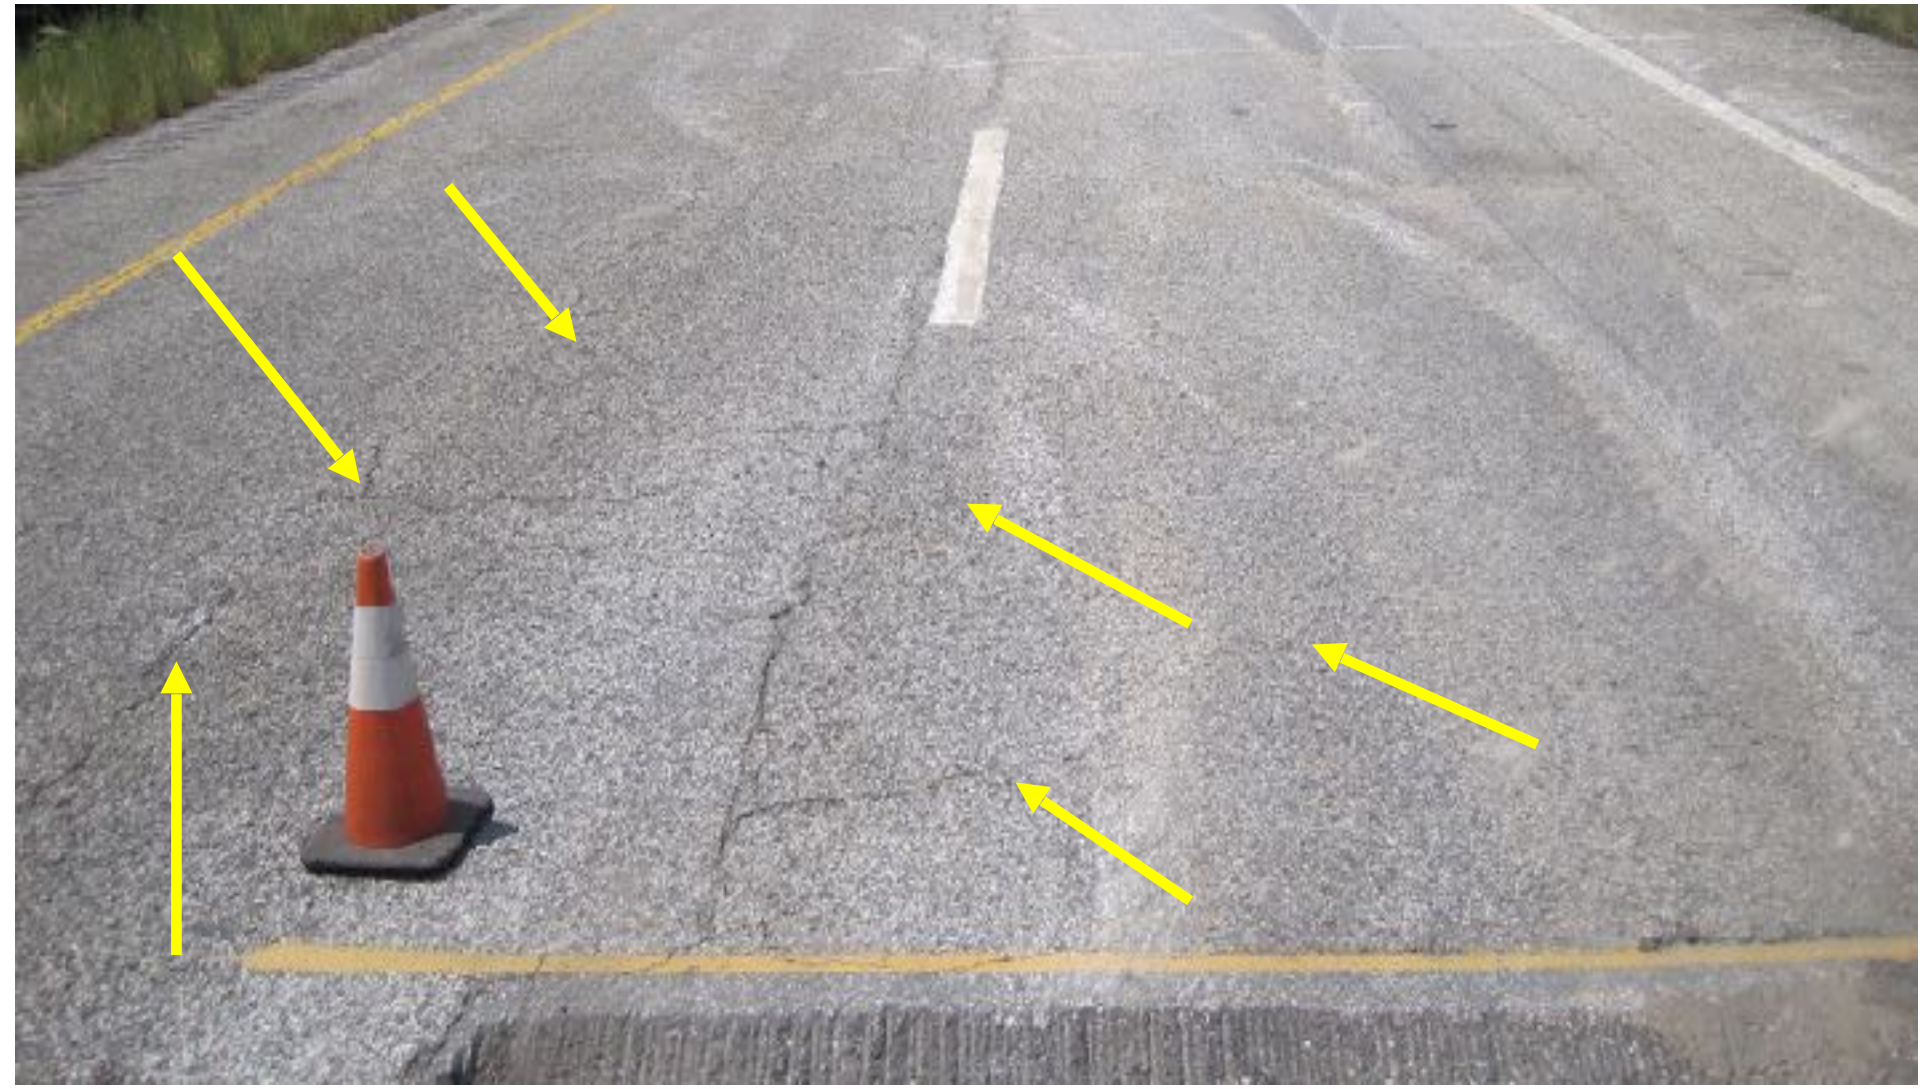
2018 Unreinforced Section: Cracking first observed in 2006. Additional cracking extending from the centerline cracking.

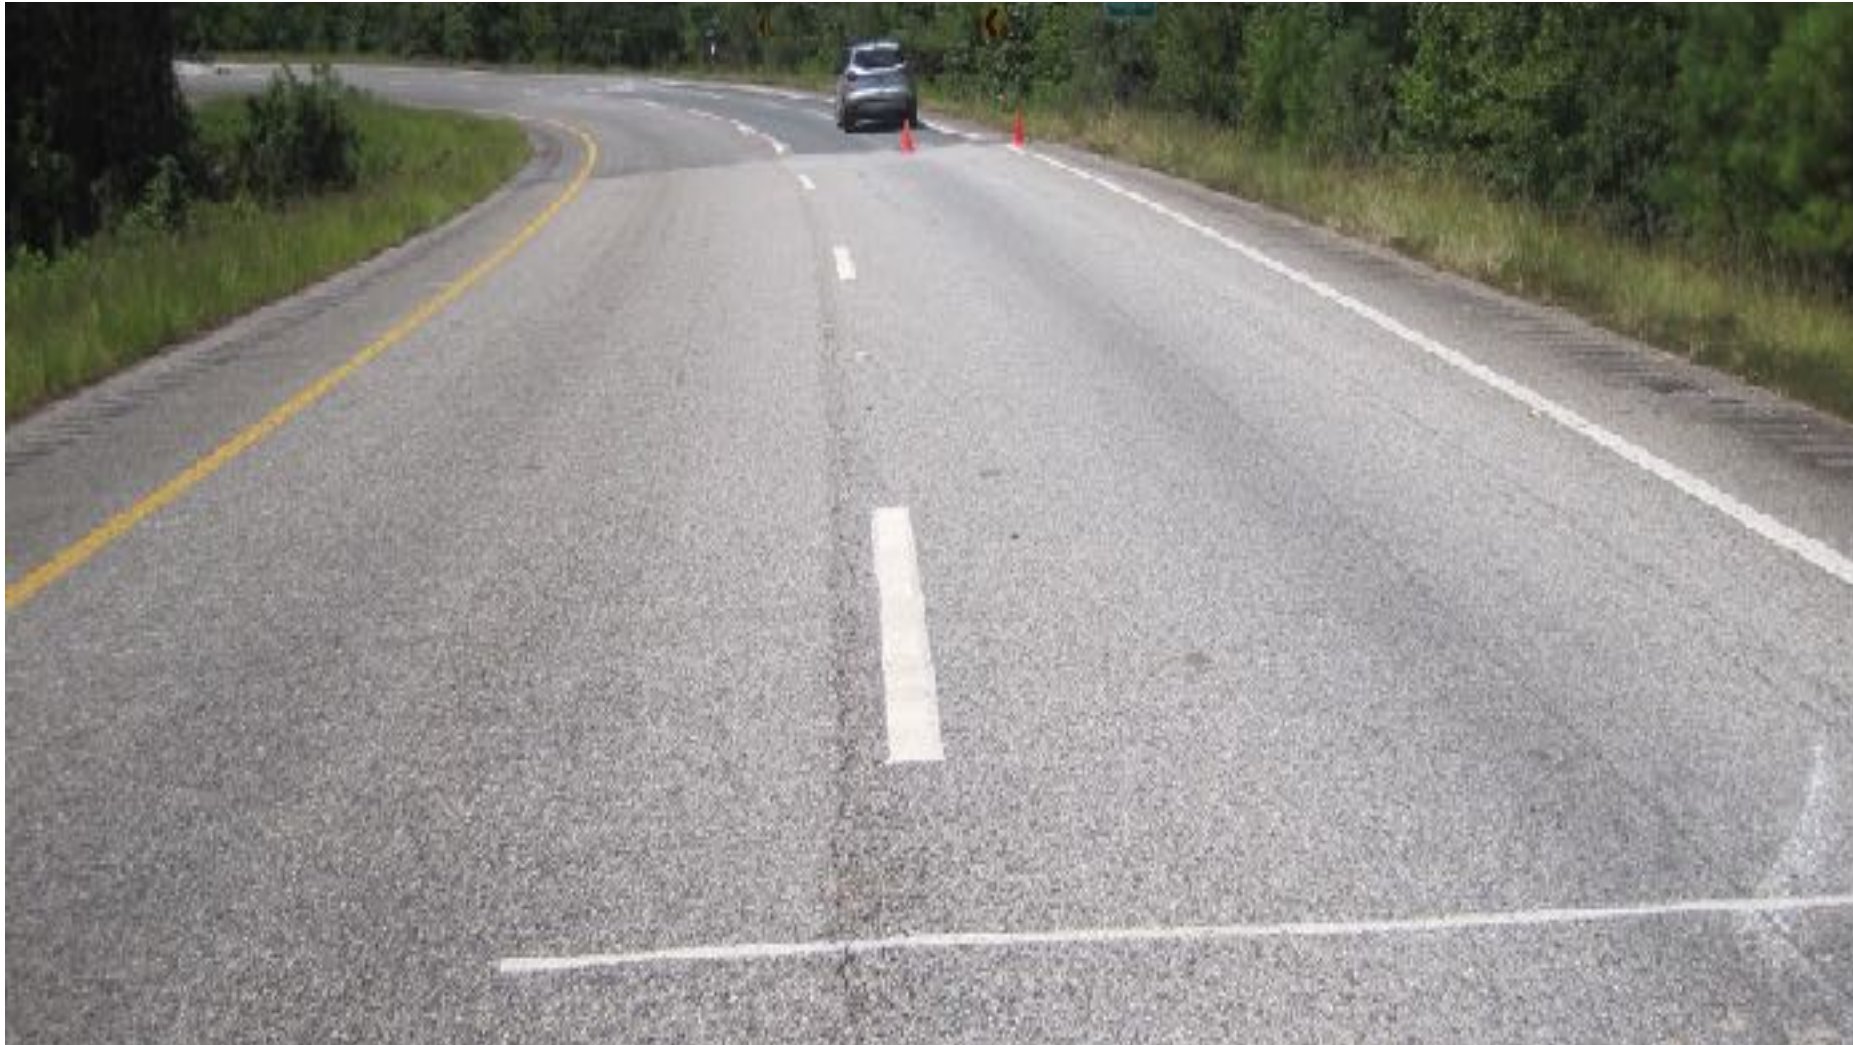
GlasGrid Reinforced Section after 60 Mil ESALs and 18 Yrs.

Cracking first observed in 2018 along the at construction joint

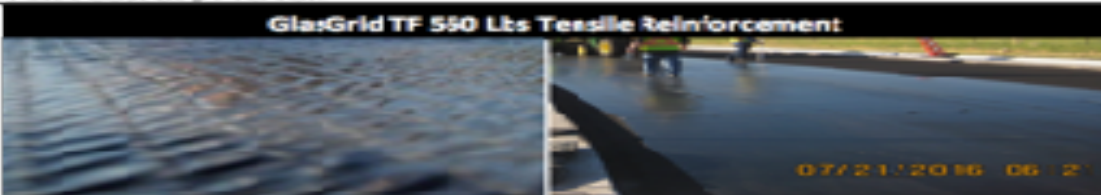
<p>Reinforcing Rebar 2.5" HMA Overlay 2.5" Existing HMA AB 2.5" Existing HMA 690,213 ESAL's</p>
Results:	<ol style="list-style-type: none"> GlasGrid reinforcement will increase unreinforced ESAL's of 248,873 (TI=7.63) SN 2.94 to 690,213K ESAL's (TI=8.51) and SN to 3.43 Structurally equivalent to adding 1.2" of HMA and is cost neutral Maximum Crack delay up to 18 longer than using no reinforcement (Sparks Pyramid project report and NCAT Study) The RAP containing the milled GlasGrid TF can be recycled back into a new hot mix up to 30% Long -term waterproof to preserve base structure 		
Assumptions:	These suggestions are based on and subserviant to the Black Eagle Consulting Evaluation and Pavement Design Report dated 10/2/18 and provided to quantify the suggestion to use GlasGrid to maximize the performance of the HMA layer to its highest level of performance using GlasGrid reinforcement. Areas of weak base, to be dug out and repaired. HMA cost at \$116/Ton

Product Installed	<p style="text-align: center;">GlasGrid TF 550 Lbs Tensile Reinforcement:</p>
